## CONCRETE '92

## CONDITION SURVEY OF FAIRFIELD BRIDGE, HAMILTON

by : Dr G.H. Rowe\* and Mr L. Leach\*\*

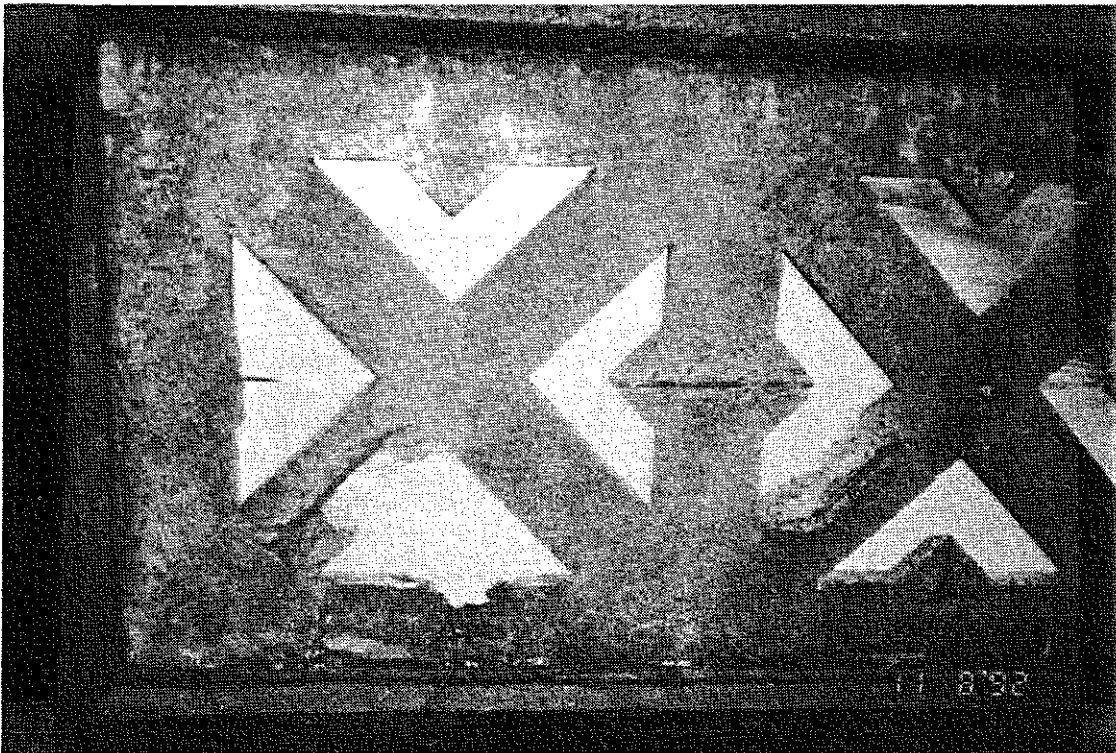
Fig. 2: Handrail Infill Panel Detail

Pedestrian footpaths are cantilevered off the arch bowstrings on both sides of the carriageway. The outer footpath balustrades are of cast in situ construction comprising columns and rails filled with latticework panels (Fig. 2). Panel thickness varies up to a maximum of 100 mm with 9.5 mm diameter plain reinforcement central through the latticework.

The majority of panels are showing signs of distress, with cracking and spalling concrete evident throughout most panels. This distress is clearly caused by corroding reinforcement which has often been placed to covers less than that recommended by NZS 3101 "Code of Practice for the Design of Concrete Structures". Repair of these panels is not realistic.

that the design of any replacement balustrades should not be altered from the original unless there is no other way of ensuring the long life of newly made panels.

The balustrade condition is not critical to the load carrying capability of the bridge, and they still afford appropriate safety to pedestrians. The decision on whether to permanently upgrade these balustrades will be made after negotiations with the Trust regarding funding from them.
