CONCRETE '93

SEMINAR:

THE RESTORATION OF THE HISTORIC FAIRFIELD BRIDGE, HAMILTON

Leroy Leach (*) and Robert Robinson (**)

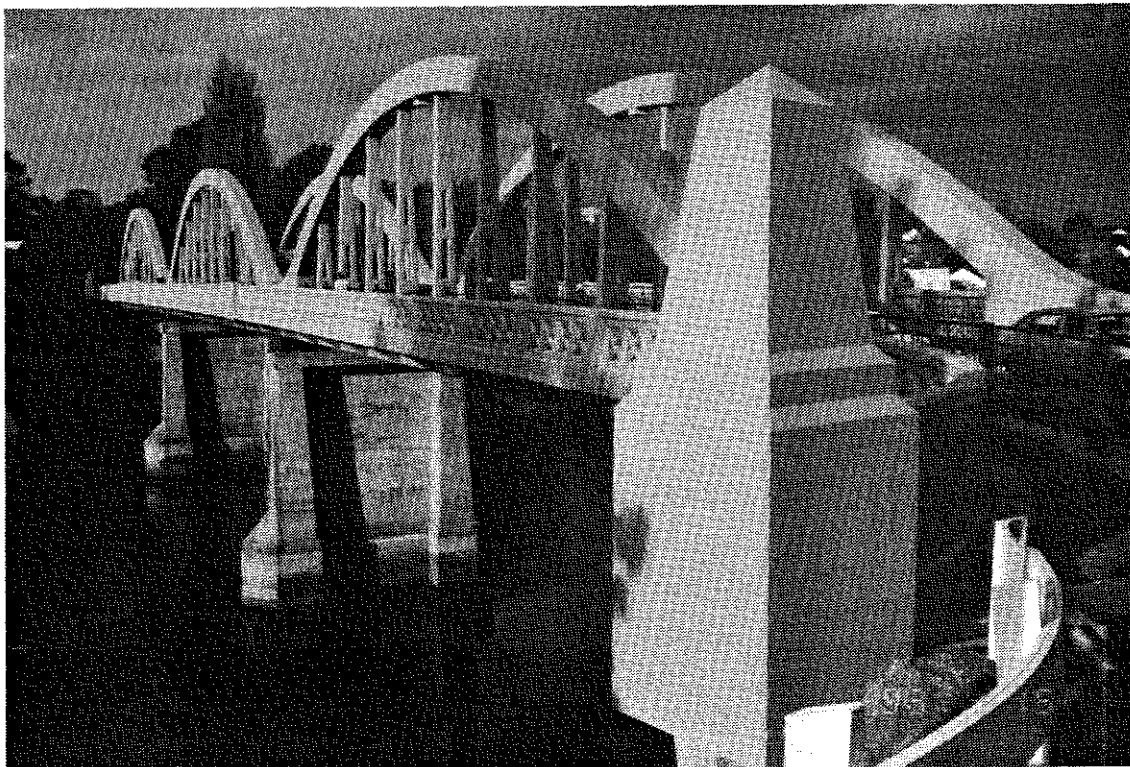
Fairfield Bridge : view of downstream elevation
