AUCKLAND DOWNTOWN FERRY TERMINAL UPGRADE

SUMMARY

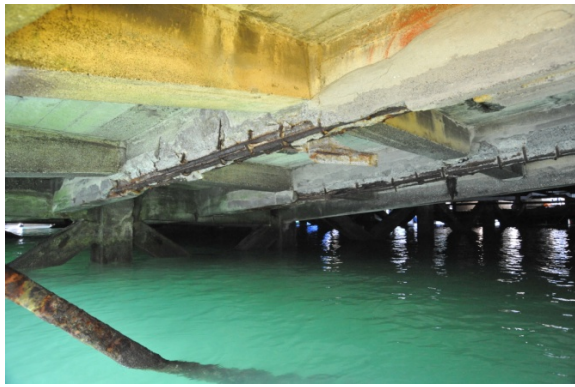
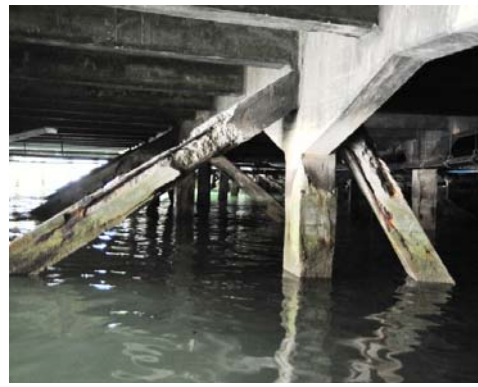
This report identified significant defects to many of the structural elements caused by chloride induced corrosion of the reinforcing bars and the subsequent splitting and spalling of the cover concrete, along with reduction in rebar cross section

As is almost always the case in marine structures, the most significant defects were found to be in the upper tide region and in the splash zone. The deterioration had affected the majority of the piles and cross braces on both wharves. Figure 4 illustrates typical deterioration of wharf elements.

Figure 4 – Typical deterioration of beam, pile and cross brace elements requiring remedial work.

The conclusion of the report was that in order to maintain the wharf in a serviceable condition for a further 20 years, an extensive partial rebuild of many of the primary structural elements would be required.

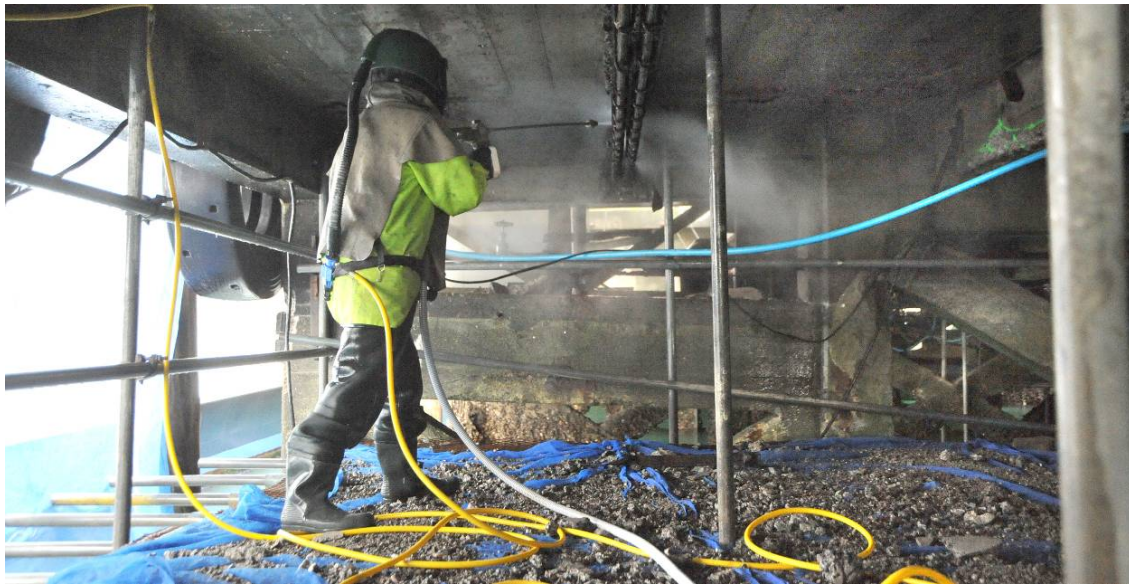
Figure 5 – Typical hydro-demolition of deteriorated concrete on a deck support beam.

To this end hydro demolition was the preferred method for removal of the spalling concrete, as it was not only to be the most technically appropriate method, but the one which would be the least disruptive to the terminal users, nearby tenants and the ferry operators.

Whilst the noise levels at the source of the hydro-demolition lance can reach 110dB it does not produce the vibration that is created when pneumatic breakers are used for concrete removal and it was this characteristic that makes hydro-demolition the most suitable method of concrete removal. The ultra-high pressure water blasting technique requires special attention to safety and there were close controls on the proximity of hydro-demolition operations to the public and other remedial activities. Protection screens were installed to isolate blast debris and keep the ferry users and general public protected from the potentially harmful activity. This was a particular requirement where the concrete removal was required at the edge of the wharf and when the direction of blasting was towards the water. In some instances, conventional hand breakout was used at the wharf edge to further minimise any potential harm to the public or property in close proximity. Figure 5 illustrates the hydro-demolition operation on a typical support beam.

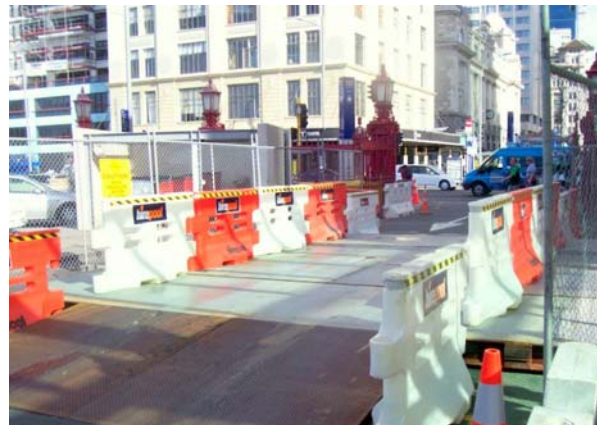
Figure 6 – Temporary ramp and structural support

A new technique was developed using a number of steel beams with ramps over them. These were constructed to both act as support for the beams below using hangers through the deck, and provide unimpeded pedestrian and vehicle access across those areas under repair.

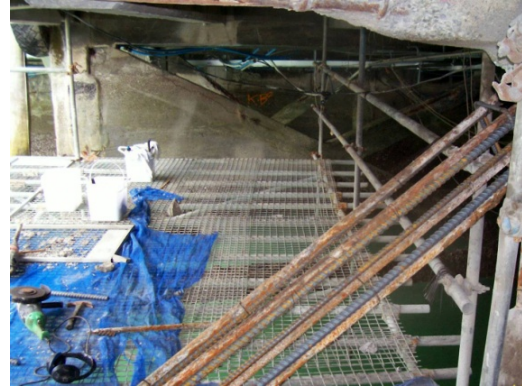
Figure 7 – Scaffold access platform

As the piers have been in constant use for over 100 years it was inevitable that a multitude of old services, both redundant and currently in use would lie beneath the deck. This fact and the construction of the old low level ramps meant that modular access systems could not be used for much of Pier 2 and a portion of Pier 1. In these areas a heavy duty clip and tube scaffold supported from the deck was installed to provide the required solid work platform for the substantial remedial works. Figure 7 shows a typical section of this scaffold.

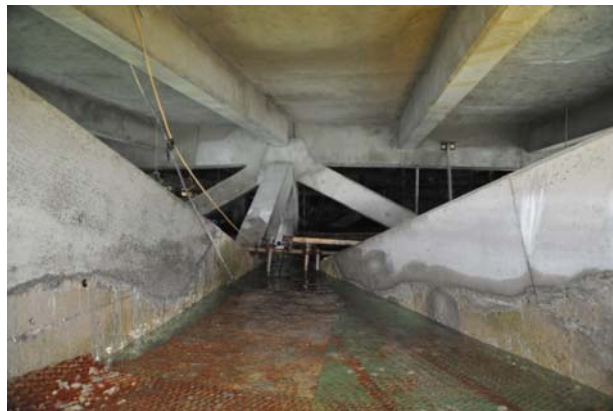
Figure 8 – Repairs using self compacting concrete.

Inspection of these elements cast in SCC some two years after casting show they have little to no signs of drying shrinkage. Some 256 piles, 185 braces and 200 beams were repaired using this technique.

As the repairs to the braces and piles extended deep into the tidal zone it was decided that the only practical way of rebuild was to recast them back to profile using formwork. A ready mixed self compacting concrete (SCC) was developed in conjunction with Allied Concrete in Auckland. Prior to the first remedial work being started, a number of trials were conducted and tests were undertaken to check that the proposed mix complied with the strength specifications for the contract and that workability would be suited to the various types of repairs required. This same mix was also used for the rebuilding of the primary and secondary beams and proved to be highly flowable allowing filling of the forms from only 2 or 3 positions on a shallow 6 metre beam. Figure 8 shows typical reinstatement on a number of beam and cross brace elements.

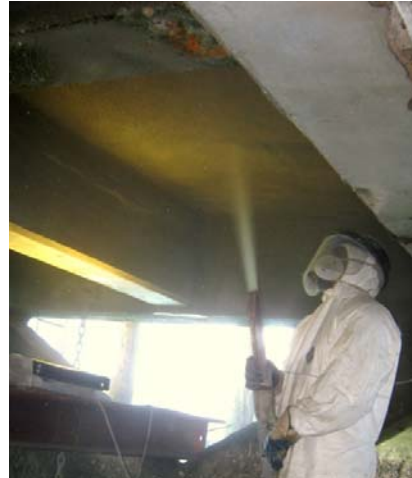
Figure 9 – Guniting of deck soffit.

Sikacrete-Gunite 103, a proprietary dry spray gunite was used for the rebuilding of 250 square metres of the slab soffits and for small edges of beams or piles above the high tide mark. Gunite had the advantage in this situation of being able to be conveyed to the work face down hoses over 150 metres allowing a gunite base station to be setup within the work compound so as not to disrupt any existing wharf operations. Figure 9 illustrates a typical gunite operation on the deck soffit.
