RESIDENTIAL CONCRETE SLAB PERFORMANCE AS A RESULT OF THE CHRISTCHURCH EARTHQUAKE SEQUENCE 2010-2012

C W ASHBY

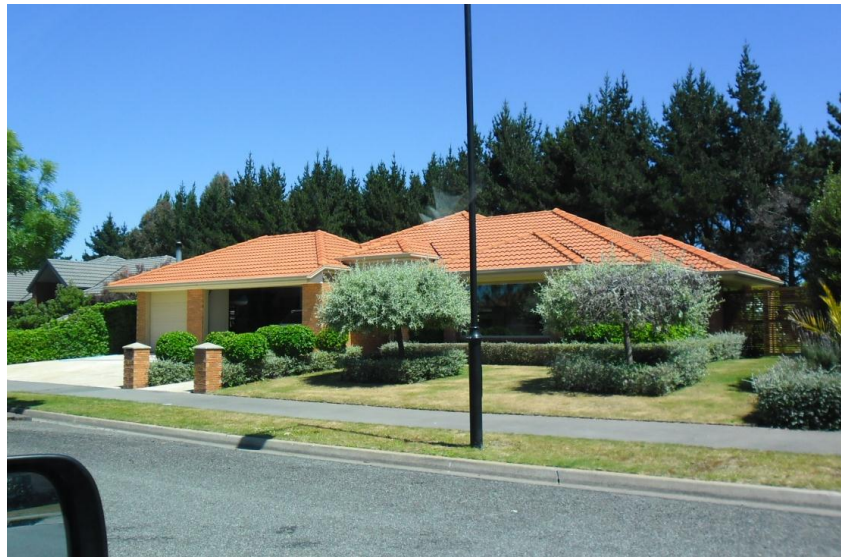
This photo is of a previously “written off” house with cracked unreinforced concrete floors, saved from the demolition by crack repair methods and brought back to code compliance condition. In this particular case there was no liquefaction on site and floor slab levels were within new house tolerances and did not require releveling. This is now the writer’s new residence.

The neighbouring house with the gray roof was also a “Write off”, but this one although “Safe and Sanitary” has differentially settled 54mm. It is intended that this be relevelled in due course using ground injection densification and lifting techniques.

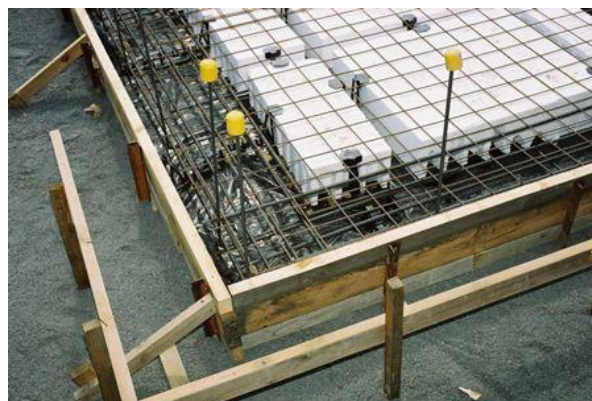
Waffle or Rib-raft Slabs (see photo) historically have been constructed as a deep slab typically 305mm to 385mm total thickness on top of the ground, without conventional foundations dug into the ground. The waffle slab consisting of a grid of reinforced ribs in both directions typically 100mm wide with a 300 or 400mm wide reinforced concrete perimeter beam, with a reinforced topping slab typically 85mm thick, all poured in one concrete pour, with void spaces formed typically 1.2m x 1.2m using polystyrene pods set out in a chess board fashion separated by the ribs.

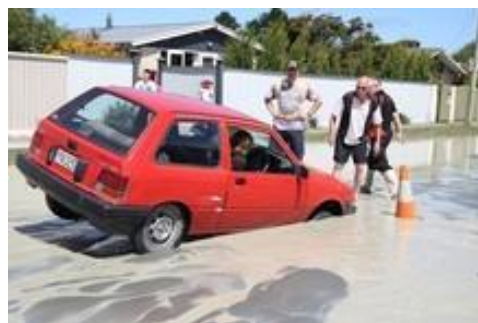
Under severe liquefaction conditions buildings founded on slabs on grade can tend to tilt. However this tendency does not tend to happen on light timber framed buildings raised off the ground and founded on shallow pile foundations. Possibly part of the reason is that under liquefaction conditions ground water tends to migrate upwards. Under a house on piles it can come up and flood the subfloor area releasing local pore-water pressure. Whereas under a slab on grade water is entrapped without adequate drainage, leading to the slab acting like a "waterbed", very sensitive to weight distribution, like a top heavy boat.
