## **LESSONS LEARNT FROM CANTERBURY EARTHQUAKES: DAMAGE ASSESSMENT AND NUMERICAL ANALYSIS OF CONCRETE BRIDGES**

ALESSANDRO PALERMO, MARIA BRANDO

University of Canterbury

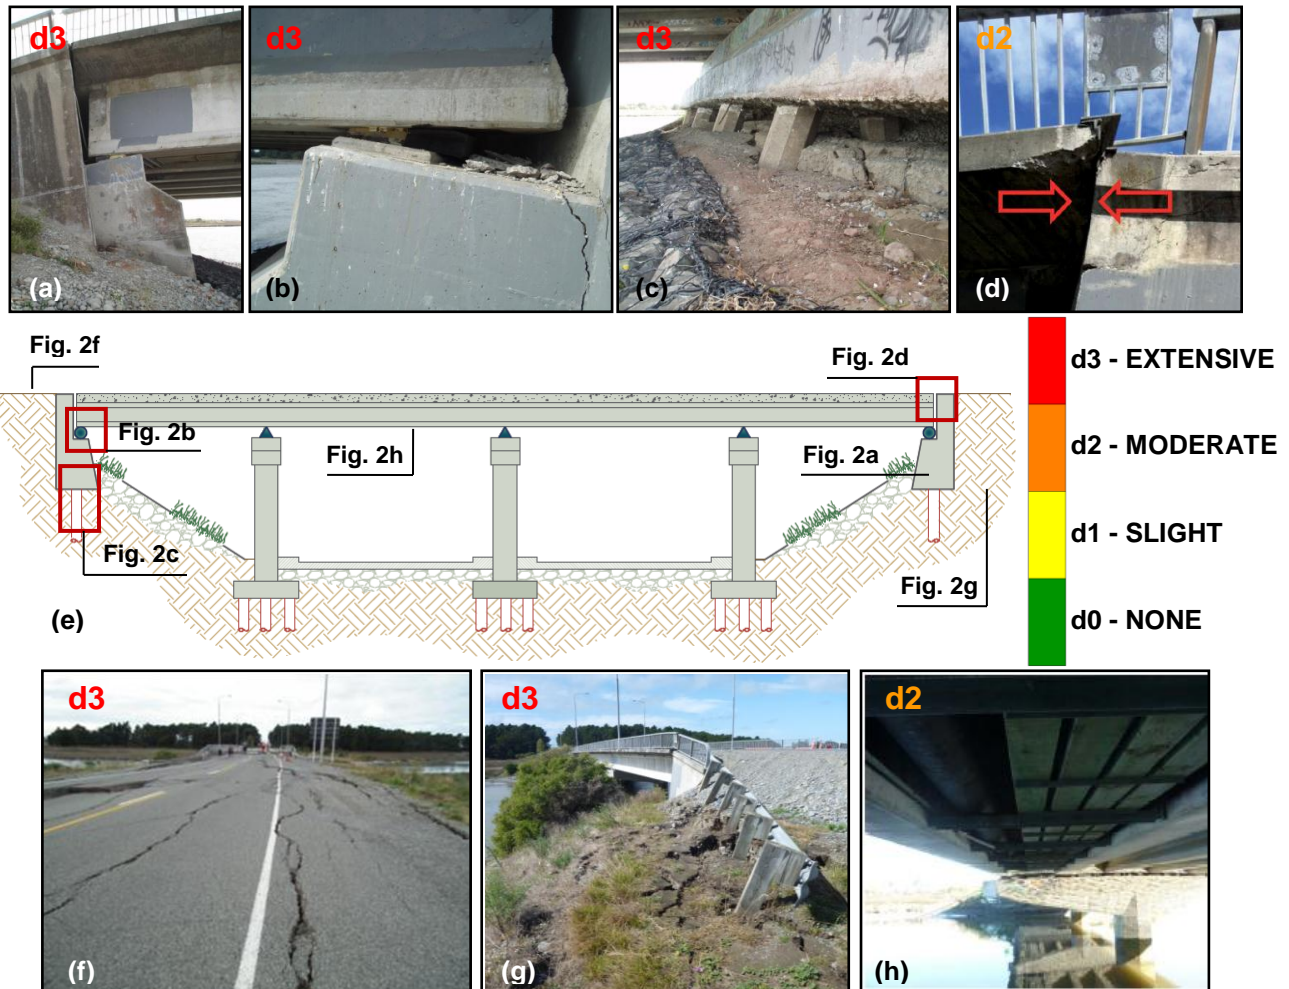
In order to provide a more comprehensive and detailed damage quantification, the assessment was carried out by looking at bridge components or elements (deck, bearings, abutments, piers, foundation, approaches, services). Figure 2 shows some examples of the main damaged elements of South Brighton Bridge (-43.5252, 172.7241) (Figure 2e) after the 22<sup>nd</sup> February earthquake.

As shown in Figure 2a, one commonly observed effect of lateral spreading was backward rotation of abutments combined with the inward horizontal movement toward the riverbanks. The latter was sometimes close to 1m and caused bridge superstructure pounding. The deck also acted as a stiff strut while the foundations underwent forced rotations or movements in the direction of lateral ground flow. The lateral spreading of river-banks caused high demands also in the connection within the deck (Figure 2b) and the abutment piles, causing the formation of plastic hinges in the latter (Figure 2c), which in some cases were exposed.

Bridges constructed in 1950s-60s were very robust and sturdy. Therefore the above-mentioned forces didn't bring the bridge to collapse. Figure 2d shows an example of typical deck damage which was caused by pounding against the abutment. In general, the damage was most evident between the bridge deck and the approach. Lateral spreading of river-banks caused significant differential movements; the formation of large vertical offsets at the ends of the bridge, made its access difficult or impossible.

Bridges generally affected the movements of river-banks. In fact, while the lateral spreading crack pattern was usually parallel to the river, the presence of the bridge restrained the lateral spreading movement inducing a sort of "strut effect", resulting in cracks perpendicular to the river as shown in Figure 2f.

Many bridges are "utility links" for the Christchurch lifelines. Many services, such as power, water and waste-water pipes were running along the bridges. Damage of these services was significant. The relative displacements of the bridge superstructure to bridge abutments and foundations, induced by either the ground motions or land-movements caused leaking/breaks of linkages on water and waste-water pipes and distortion of power and telecommunication cables (Figure 2h).

Figure 2. Damage at South Brighton Bridge with the indication of the level damage according to the database scale: a) Rotation of the abutment; b) Damage at the bearing; c) exposure of the piles with the formation of plastic hinges; d) Pounding of the deck on the abutment; e) general view of the bridge; f) Damage at the approach pavement; g) West approach settlement; h) Damaged pipelines.

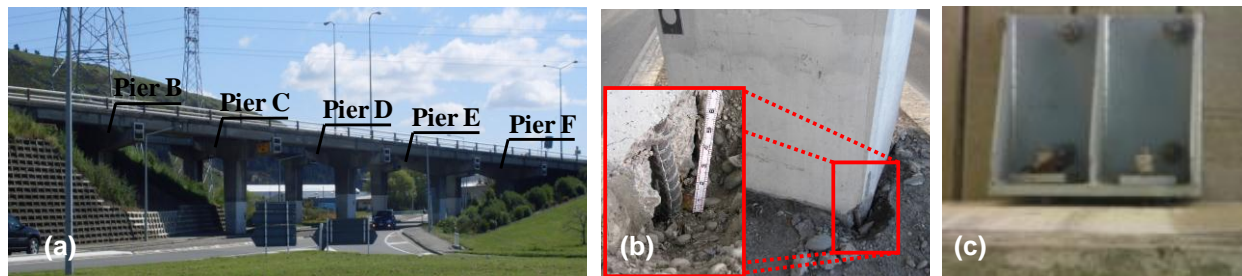
As part of seismic retrofit programme [1], the overpass bridge has recently been strengthened by fixing fabricated steel shear keys to the underside of the beams at both the abutments and piers to resist longitudinal earthquake loads. Linkage rods were fitted between brackets located on either side of the piers by drilling through the tops of the piers to form a tight linkage between the adjacent spans. The down-stand of the brackets prevents relative movement between the spans and the piers. Linkage at the abutments was provided by rods extending between the brackets and the abutment side facing the soil. New shear keys fixed to the the abutment and pier sides provided resistance to transverse loads. Circular steel shrouds were added at one pier column on each bridge to prevent soil restraint of the pier, which may have cause undesired plastic hinging due to ground motion in the transverse direction.

During the February event, flexural cracking developed in the lower halves of all pier stems of both bridges except those adjacent to the abutments. In fact, despite the increased deck stiffness, the central piers underwent displacements greater than their yielding displacements. Soil gapping at ground level occurred at the faces of most of the pier stems with separation cracks up to 15 mm wide. Spalling occurred at the base of the central pier, and the longitudinal bars buckled at the corners (Figure 4b). The damage increased during the June 13, 2011 aftershock. The nominal 10mm gaps between the new shear keys and the abutment face at the South-East abutment closed up with no clearance on two of the four keys.

**Figure 4. a) Overall view of Port Hills Road Overpass b) Buckling of reinforcing steel at the base of the piers [Courtesy of OPUS]; c) Elongation of the links between the spans [Courtesy of OPUS].**

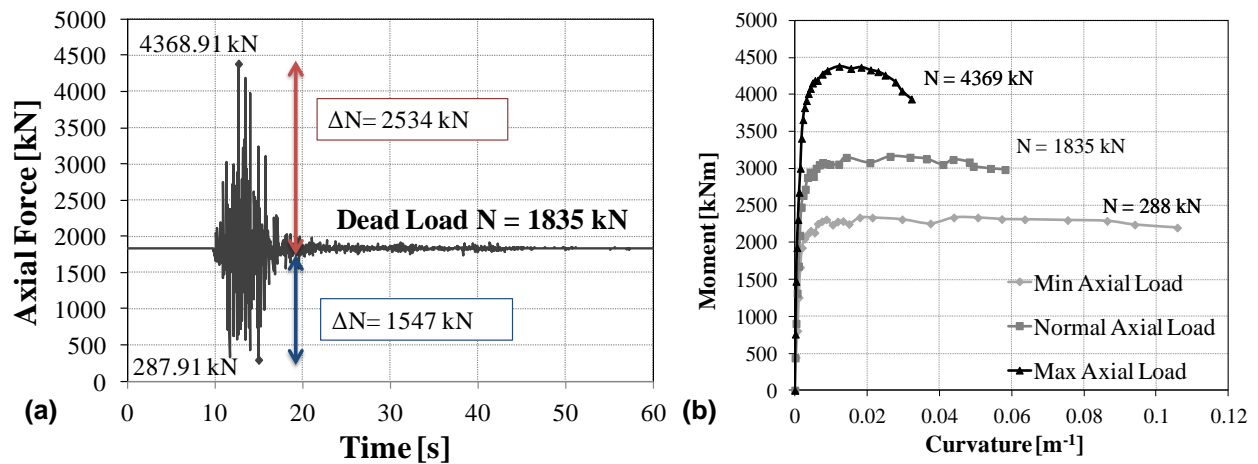
The performance of the bridge was also assessed through a numerical model implemented in Ruaumoko3D [6]. Non linear dynamic time history analyses were carried out using the closest recorded accelerograms. The HVSC station seems to be the closest station and representative of the real earthquake demand occurring to the bridge. As shown in Figure 1a, the HVSC spectral acceleration is characterized by a short period ( $T < 0.4s$ ) ground motion with a rapid fall-off in spectral ordinates at longer periods. The trend is similar for both horizontal (solid line) and vertical (dashed line) accelerations. The natural period of the structure was found to be in the range of 0.17 - 0.27s and the vertical accelerations acting on the central pier resulted in the axial force – time curves shown in Figure 5a. This led to a significant variation of the axial force in the columns, which caused a curvature ductility reduction of the piers for positive increments, as shown in Figure 5b. When the axial load variation sums to the static load there is an increment of 39 % in the moment capacity but a reduction of 49% curvature ductility respect to the situation with no axial variation effect. Conversely for the lowest total axial load ( $N-\Delta N$ ), the moment capacity reduced by 28% while the ductility increased by 94%. The capacity reduction caused the longitudinal bars buckling. According to numerical analyses, this occurred when the deck displacement reached 3.30 cm.

Figure 5. (a) Time history of the axial force loading the central pier (Pier D) when subjected to HVSC records. (b) Evolution of the moment-curvature with varying axial force.

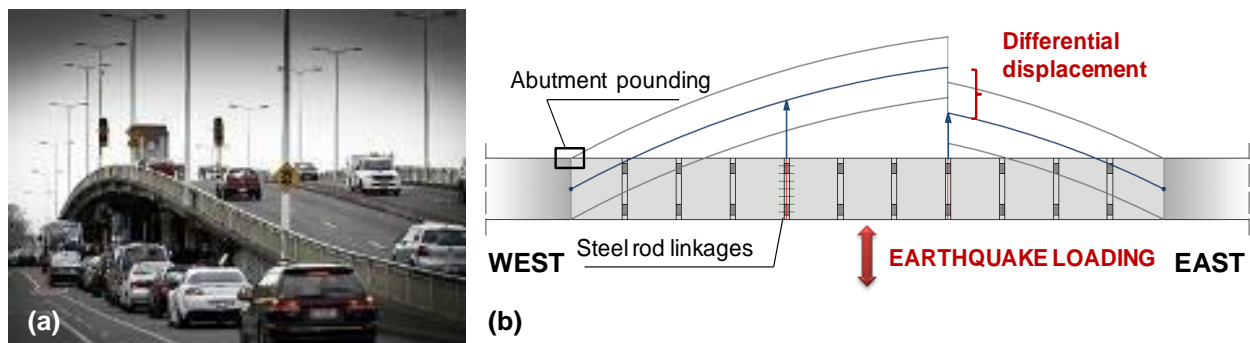
However, some bridge irregularities given by lack of proper design detailing have been seen and this caused unexpected and unpredicted damage to the structure. An example is Moorhouse Ave Overbridge, (-43.5399, 172.6367) (Figure 4a), an eleven span reinforced concrete structure and one of the four avenues that encase the CBD of Christchurch City, allowing traffic to flow around the CBD. Built in 1964, the reinforced concrete T-beam superstructure is supported by two column bents. The bridge is founded on 406 mm diameter octagonal reinforced concrete piles. The structure was constructed in three separate sections, linked with expansion joints. The performance during the February event was unsatisfactory: although the results of the preliminary spectral analysis are good, the insertion of steel rod linkages in the deck only at the expansion joint between the west and the central part of the bridge caused irregularity in structure and the mechanism of damage shown in Figure 6b.

Figure 6. a) Overall view of the bridge; b) Plan on bridge showing qualitative displacement profile under transverse loading.

The pier at the East expansion joint suffered extensive displacement demand. The slenderness of the pier affected the vertical load carrying capacity of the structure along with the lateral capacity. The columns had also widely spaced transverse reinforcement, making the structure susceptible to a brittle failure mechanism (Figure 7b). Observations after the Christchurch event indicated that the damaged columns had started to buckle putting the central span at risk of collapse (Figure 7c-d). Due to the higher displacement demand in the West-Central part of the bridge, the deck pounded against South-West abutment of the bridge causing extensive spalling and bar buckling.

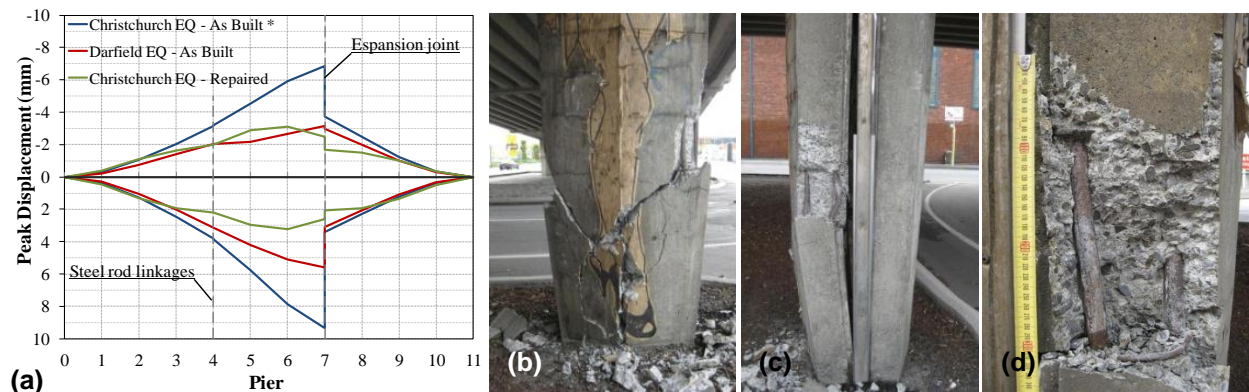
Figure 7a shows the results of the time history analysis carried out on the numerical models with the CCCC records of the Darfield and Christchurch earthquake. The blue line represents the maximum displacement profile of the structure during the February event; it is clearly highlighted the asymmetry in the response of the bridge with significant different displacement demands in the pier 7.

**Figure 7. a) Displacement profile of each model; South column: (b) West face (c) South face; d) Exposure of the steel bars at the North face of the north column.**

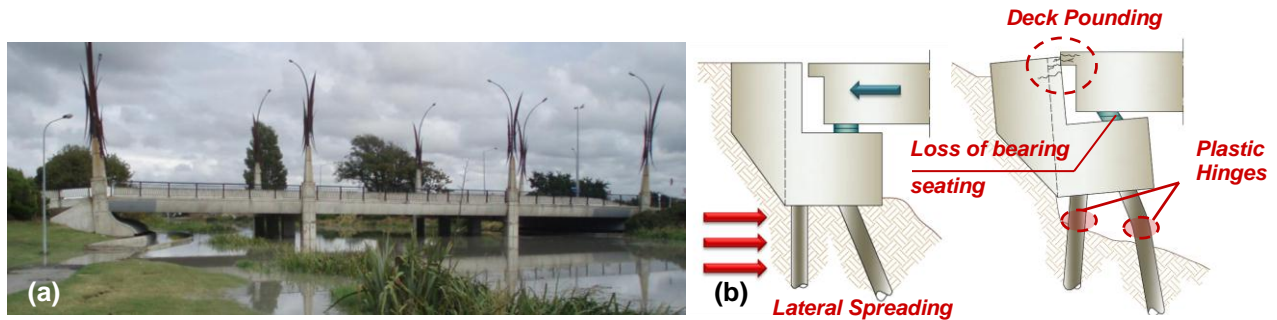
Most of the bridge damage was mainly due to liquefaction induced lateral spreading throughout the Eastern part of the City and in the rural areas in the surroundings. The effects of February event were mainly localized in the East part of the city, while the Darfield earthquake caused wide-spread , but less significant land-damage. The high intensity level of the ground motions resulted in large areas of severe liquefaction damage [9,10]. The bridges along both the Avon and Heathcote Rivers suffered from varying levels of damage due to lateral spreading, depending on the ground conditions and the ground shaking level. The effects of the lateral spreading were more significant in precast bridges, such as ANZAC bridge (Figure 8a), where the foundations underwent forced rotations or movements in the direction of the lateral ground flow (Figure 8b). Preliminary analyses have been carried out to determine lateral loading capacity of the piled abutment and the location of potential plastic hinges in the piles [10,11].

Figure 8. a) Overall view of ANZAC Bridge; b) Sketch of the mechanism of the lateral spreading.

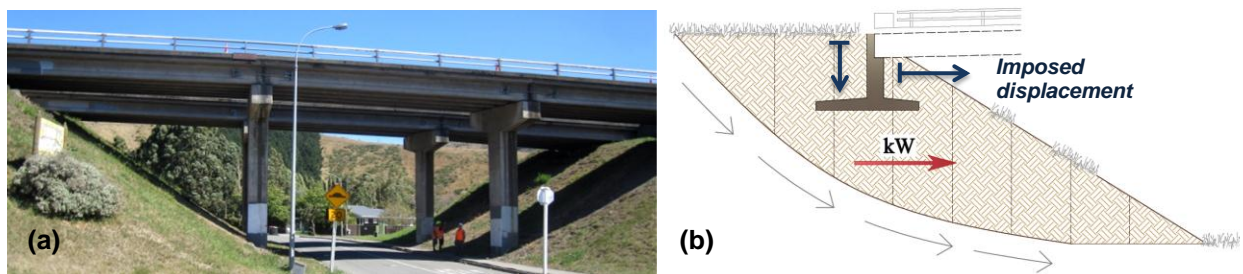
Slope failures of the embankments were recorded in the Port Hills area, close to the epicenter of the February event. Horotane Valley Overpass (-43.5725, 172.6947) (Figure 9a) suffered extensive damage and there is still speed restrictions due to loss of vertical alignment.

Figure 9. a) Overall view of Horotane Valley Overpass; b) Cracking from down-slope movement at abutment at Lyttelton end; c) Cracking in abutment at Lyttelton end.

The structure is very stiff; this was also confirmed by the numerical analyses as the natural period was found to be in the range of 0.085 and 0.092 s. The stiffness positively influenced the performance of the bridge, which did not suffer any damage due directly to the ground shaking. Nevertheless the strong motion caused slope failure of both the embankments, which resulted in some damage of the structure.

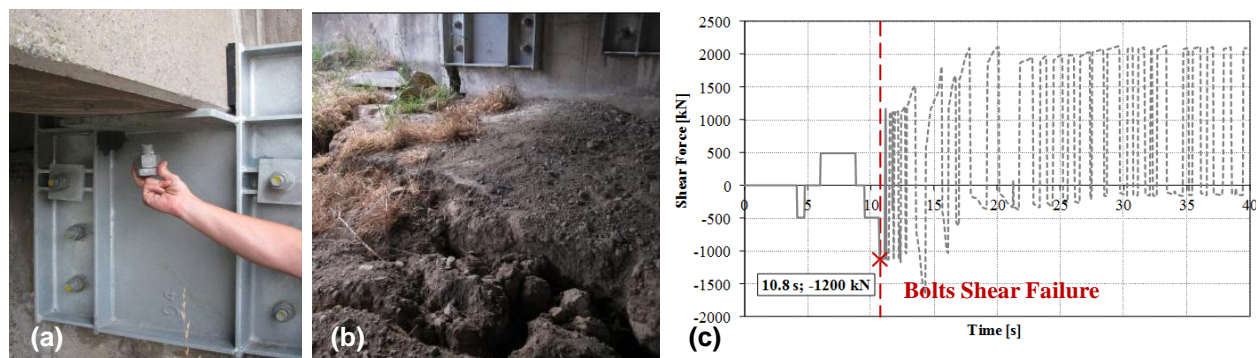
In fact following the Christchurch earthquake, the east end of the No 2 Bridge displaced horizontally about 100 mm in a southwards direction. This resulted in severe vertical cracking at the junction between the abutment seating and the abutment wall between the two bridges. There was minor spalling at the ends of the beams where they were seated on the abutments. All four abutments appeared to have moved forward by up to 20 mm. This movement caused severe shear cracking in the back-wall and shearing of two of the bolts on the new linkage brackets (loaded in shear) at the west abutment of the No 1 Bridge (Figure 10a). Bolts on the

new linkage brackets also sheared on both abutments of the No 2 Bridge. The west abutments had settled by about 60 mm. This was particularly visible on the south side of the No 2 Bridge. Surface sliding of soil was evident under the west abutments and wide cracks and separation gaps between the soil and abutments were evident at the east abutments indicating significant down-slope movements (Figure 10b).

A simplified numerical model based on Newmark methodology [12], which provides an index of permanent deformations, has been developed [13]. Dynamic non linear time history analyses which includes the activation of the slope failure mechanism have been carried out. Figure 10c shows the results of the analyses (shear force vs time), with the indication of the breaking point of the retrofit bolts. Their failure occurs after 10 seconds in correspondence with the activation of the slope movement.

**Figure 10. a) Cracking from down-slope movement at abutment at Lyttelton end; b) Time History of the Shear Force acting on retrofit bolts, with the indication of the breaking point; c) Sheared bolt at the abutment retrofit [Photo by J. Allen].**
