STRENGTHENING AND HERITAGE RESTORATION – THE ARTS CENTRE OF CHRISTCHURCH

JOHN TROWSDALE, PETER CARNEY, ALISTAIR BOYS

Holmes Consulting Group LP

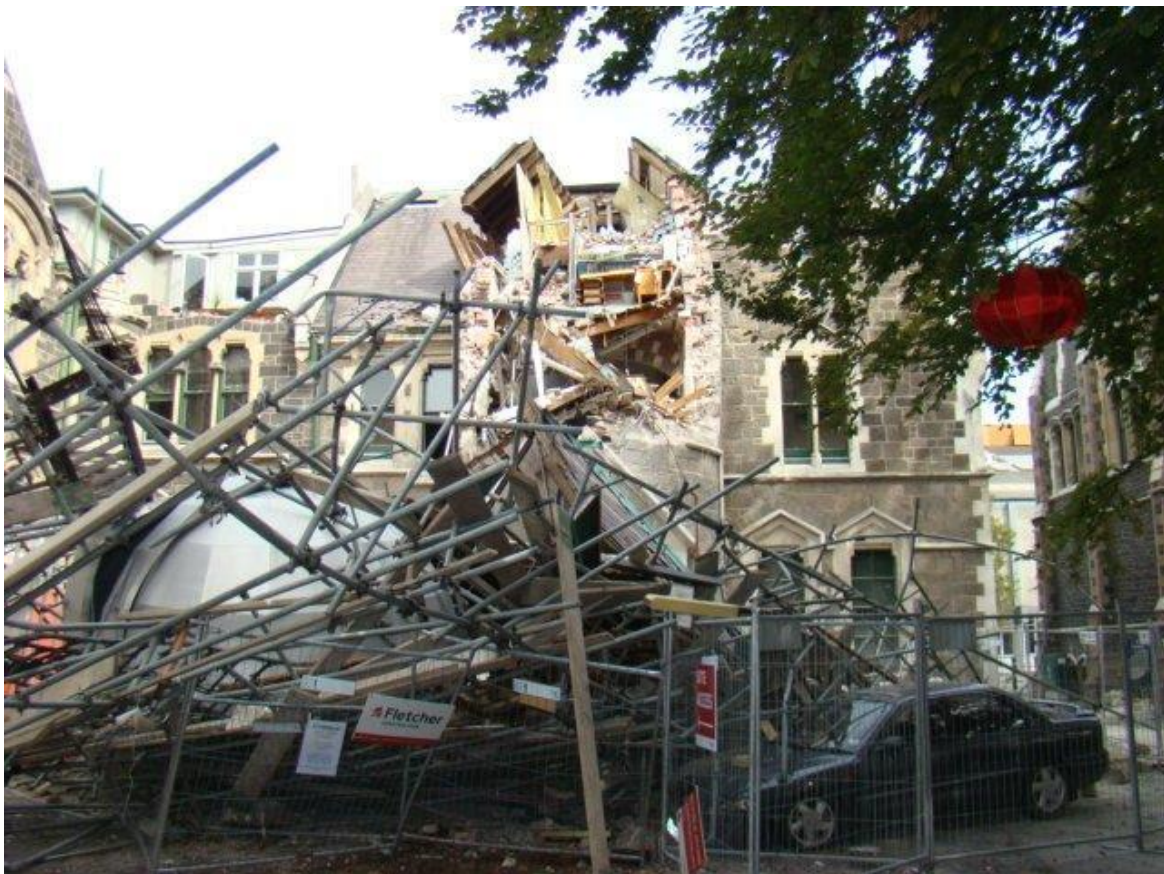
The result of the February 2010 event had a significantly different outcome. Building resilience across the entire site was severely reduced with a number of building elements suffering partial collapse; most notably the Observatory tower shown below in Figure 2. Following initial assessments and reactive securing to the most critical elements (primarily to prevent further deterioration) it was apparent that all buildings would require significant works and the site was closed.

Figure 2. Photograph Showing the Damage to the Observatory Tower Incurred from the February 2011 Earthquake

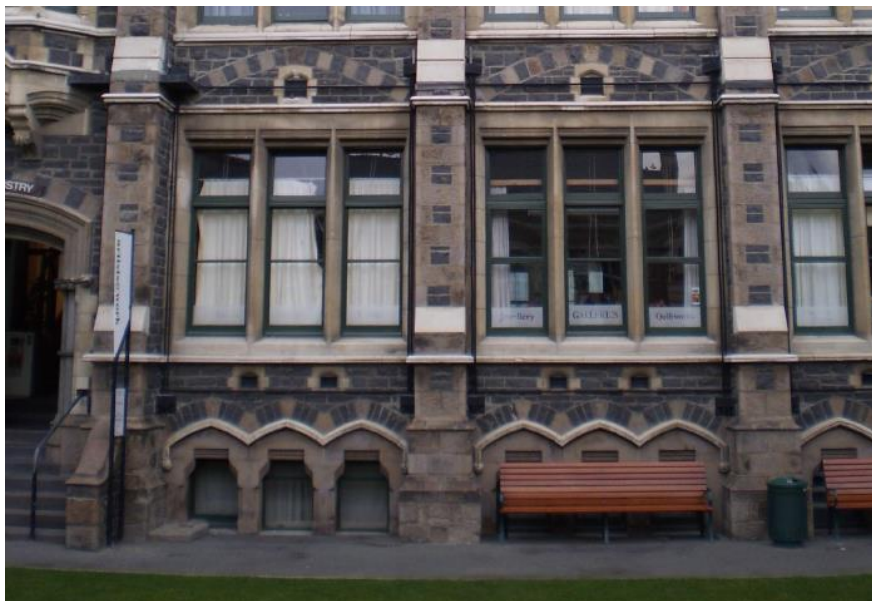
The Chemistry building used both vertical and horizontal strands primarily to add flexural capacity to the buttress (column) and spandrel (beam) arrangement to the north and south elevations. Anchored externally as shown in Figure 3, paired strands run from below the elevated ground floor to above first floor levels at the re-entrant corner of the buttress and spandrel panels. The horizontal strands at each floor plate are paired equally internally and externally at each floor plate.

Figure 3. Photograph Showing Post Tensioning to the Chemistry Building

In each instance these elements performed incredibly well with behaviour significantly limiting the extent of damage sustained to the building. Notably for both Chemistry and College Hall, the final design solution is a mimic or refinement in detail of the original installation.

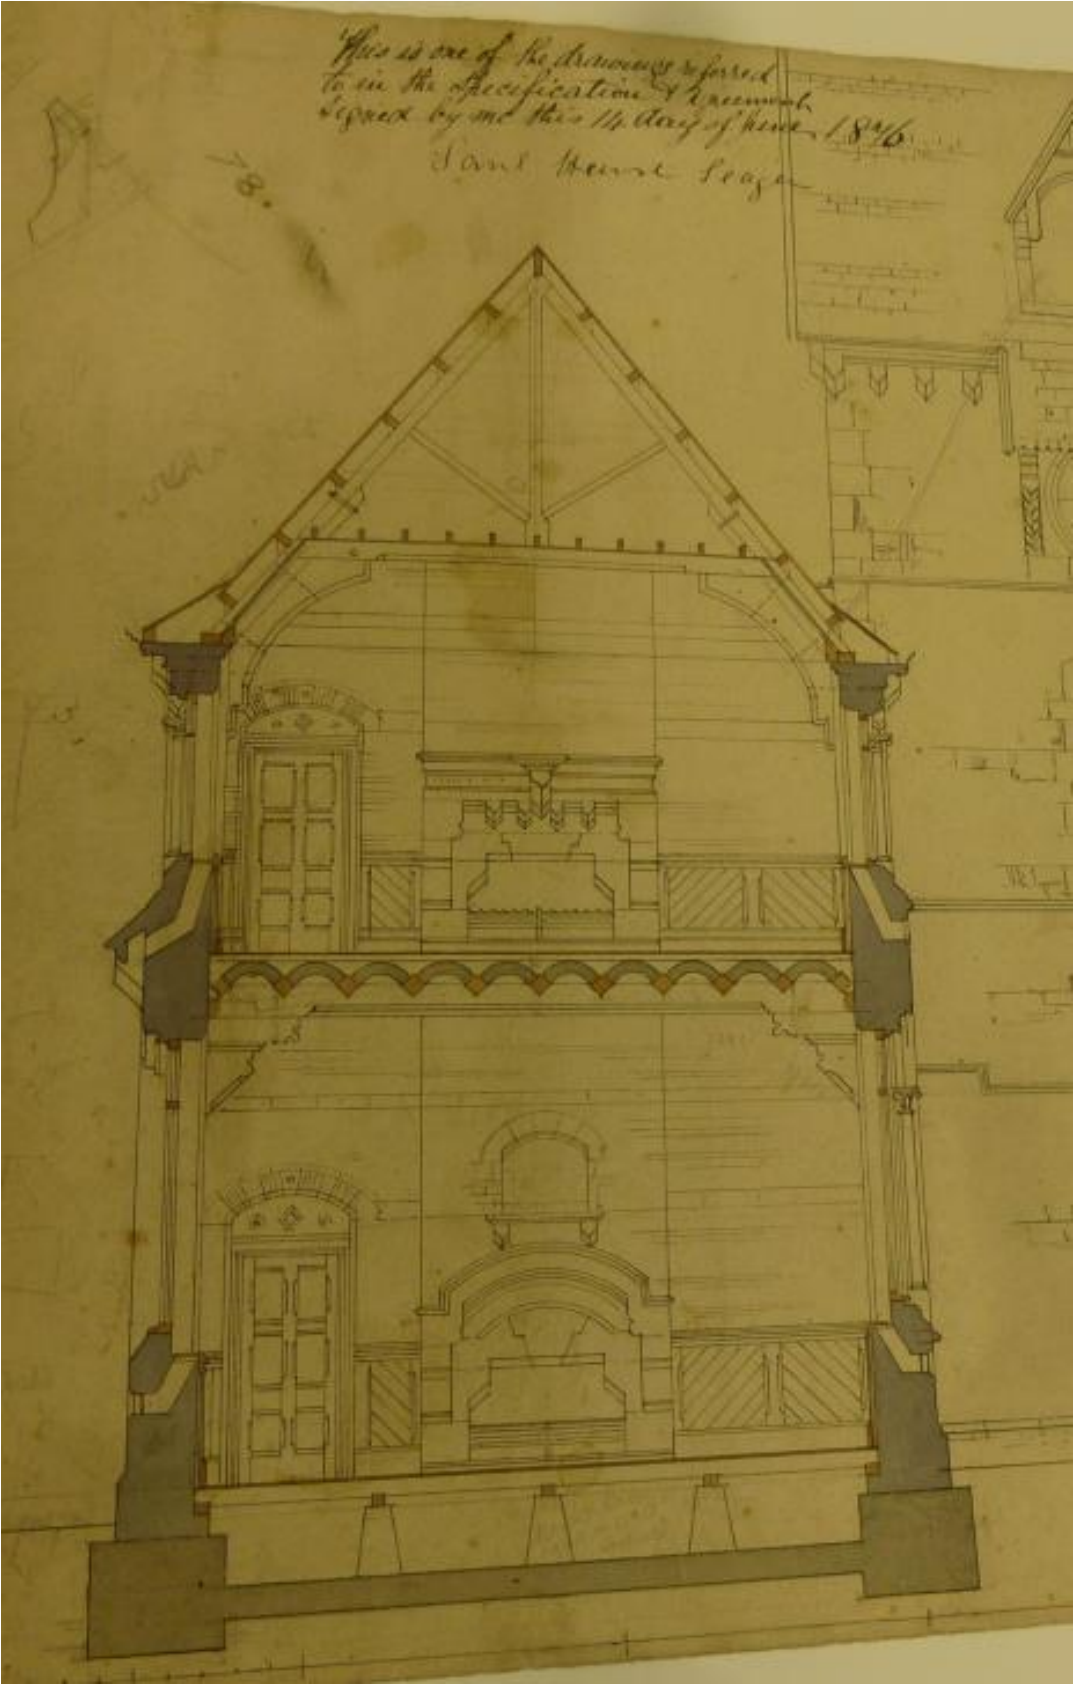
Of real interest in the C block buildings is the original construction methodologies employed in the construction of the arched ceiling panels; an original 1876 drawing associated with the Canterbury College's specification is shown in Figure 4. Whilst traditionally we would have assumed these to be formed in plaster, they were found to be formed in 50mm thick pre-

fabricated pieces of concrete. Given these would have been fabricated in 1877 these are one of New Zealand's earliest examples of pre-cast concrete construction.

Figure 4. An original 1876 drawing of Canterbury College showing the arched ceiling panels made from 50mm pre-fabricated concrete
