BRIDGE OF REMEMBRANCE SEISMIC STRENGTHENING

F SHERSON¹; D COOK²

SUMMARY

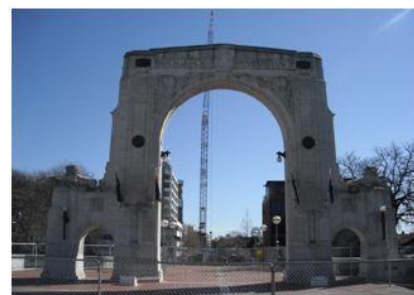
As a result of the 2010 and 2011 Christchurch Earthquake sequence, the Triumphal Arch experienced significant structural and non-structure (stone fabric) damage. Built in 1924 as a memorial for soldiers who fought for New Zealand, the Triumphal Arch stands on the east abutment of the Bridge of Remembrance crossing the Avon River. The resulting damage included; differential settlement across the four columns, horizontal displacement of the top half of the structure above the minor arches, cracking and spalling of stonework in a number of locations and damage to the ornate Lions. Structural assessments following the earthquakes deemed the structure to be earthquake prone, meaning strengthening work was required to meet the requirements of the Building Act 2004 and Council Policy of Earthquake Prone Structures and to once again provide safe public passage under the structure.

Figure 1. Location of Triumphal Arch and east elevation of the structure after the earthquake

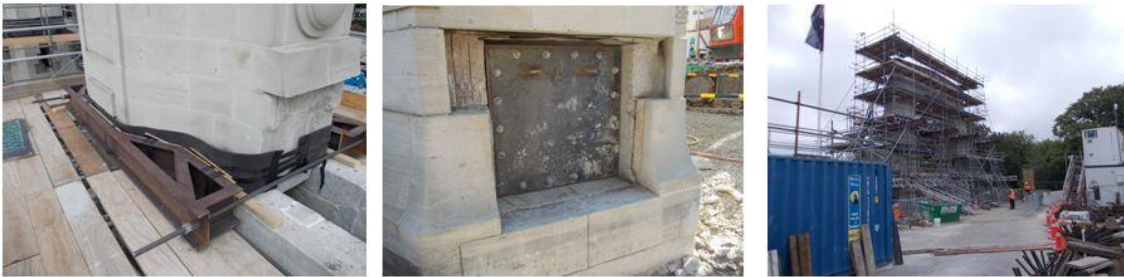
As a result of the damage sustained, the likely action of the main Arch under a seismic event was rocking about the existing crack line at the level of the Lions, midway up the major columns, but it was unlikely to topple as a result. However, uncertainties existed around the integrity of this hinge point, specifically the possibility of degradation of the rocking surfaces under prolonged seismic shaking. This issue was addressed by installing steel circumferential reinforcement clamps above and below the cracks on the major columns to reinforce the hinge point and provide residual capacity to the crack line. The clamps were

Figure 4. (L-R) Steel Column Clamp, Temporary Access Hatch in side of Column, Scaffolding

designed to fit the profile of the columns, then lifted into place and tensioned to provide the required circumferential confinement.

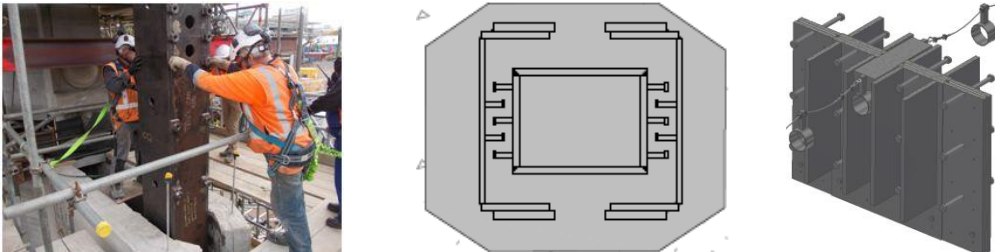
Figure 7. (L-R) Positioning Steel Box, Steel Box configuration, Sliding Joint section view

A fundamental element of the rocking mechanism was the construction of a vertical sliding joint detail at the crown of each of the three arches to allow the in-plane rocking. This involved cutting the arches in half vertically and installing a stainless steel plate sliding assembly. The construction of the sliding joints also involved the horizontal post-tensioning of the arches through the sliding plates. The post tensioning system provided the strength across the arches, while still allowing the sliding plates to function in earthquakes. A bespoke post-tensioning system was detailed to allow future controlled de-stressing or load testing of strands following a significant earthquake.

The sliding plate assemblies were installed in two stages to reduce the need for temporary propping of the arches during installation. Stage one involved installing the main sliding plate, post tensioning elements and pouring concrete into the arch cavity. Once the concrete had reached its 28-day strength, the arch was post-tensioned. Construction of stage two could begin after post tensioning by removing the stonework around the center of the arch. With stones removed, the concrete walls of the arch were removed to expose the stage one plate. The second stage of the plate was connected to the first stage and new concrete poured. The stones were replaced and a new mortar joint was cut into the stones at the joint position.

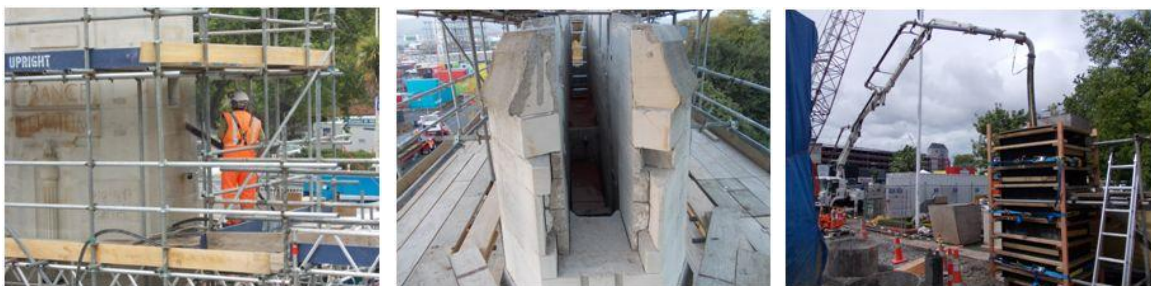
A major portion of the works involved repairing the damaged Tasmanian Sand Stone cladding on the structure. In order to retain as much of the original stonework as possible, damaged stonework was repaired in-situ. In many places the stonework was too badly damaged to fix, in which case stones were removed and replaced with new stones. The original Quarry was located in Tasmania, Australia, and matching stone was shipped to New Zealand. To preserve the ornate Lions that sit on top of the minor arches, the delivery team removed them before any other work began. This gave the Stonemasons an opportunity to fix the damage off-site. The Lions were replaced at the completion of the strengthening work.

Figure 8. (L-R) Stonemason working, Limited space inside Major Arch, Concrete Test Pour

Stones were replaced on the structure using stainless steel threaded rods epoxied into the stone and structure. New mortar joints were pointed and the remaining gaps filled with grout. The new stones were roughly cut to size and then positioned in place on the structure in the same way as the original stones were replaced. Once in place, the face of the stone was cut to the correct profile and when an area had all the stones replaced, the face of the new stones were levigated to achieve a smooth transition between the new and old stones.
