## **CHRISTCHURCH TOWN HALL – POST-EARTHQUAKE REPAIR AND STRENGTHENING PROJECT**

MARK BROWNE, GARETH MORRIS, JOHN HARE

Holmes Consulting, Christchurch, New Zealand

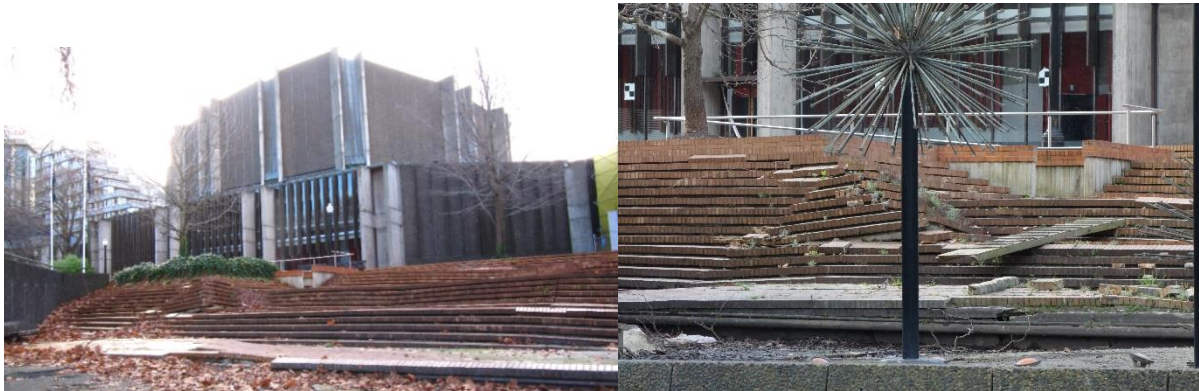
Tonkin and Taylor was engaged to review the geotechnical aspects of the site. Significant volumes of liquefaction ejecta had forced its way into the building through damaged slabs and basement walls. The southern landscaped area in front of the Avon River was the most spectacularly damaged as it was uplifted and tilted out of shape as shown in Figure 2.

Figure 2: Southern landscaped area damaged. Left: facing the Auditorium, taken 2011, Right: 2013 from Wikipedia.

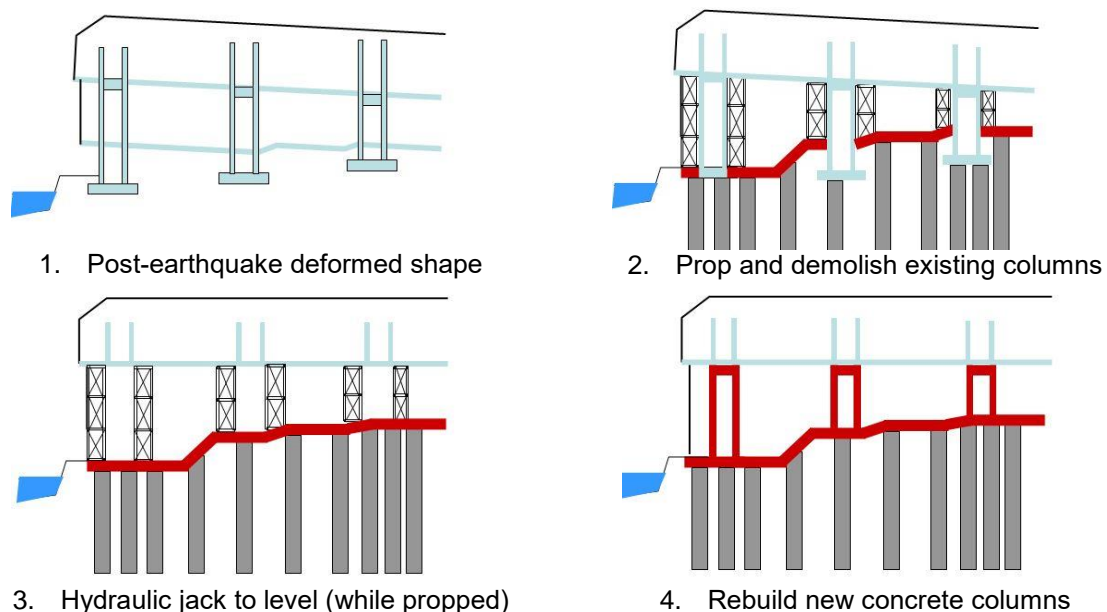
Figure 4: Limes Room building, adjacent to the Avon River - a schematic illustration of the re-leveling and temporary propping and rebuild sequence.

The **Limes Room** building experienced significant residual ground movement. The ground movement behaved as a slip circle, moving towards the Avon River. The slip circle caused the southern end to be tilted upwards, as illustrated in Figure 4 above. The decision to re-level the building was made in tandem with the rebuilding of the columns to achieve strengthening targets. Figure 4 shows the sequencing required to construct the new raft slab (shown in red) on the ground improvement, before temporarily supporting the Limes room to allow the original RC columns to be demolished. The building is re-levelled using hydraulic rams, to lift the floor in some locations, and lower it in others. The rebuilding of the new RC columns is undertaken on completion of the re-levelling. The Limes Room columns were identified as having a similar deficiency to the Foyer columns, with insufficient strength and stiffness. In this case however, the options for strengthening the Limes Room were less limited by its building function. The retrofit has adopted new Buckling Restrained Braces (BRB's) inserted between the pairs of rebuilt RC columns.

- **Limes Room:** is currently supported on a temporary steel cross-braced frame structure, part way through the column rebuilding works in the last illustration of Figure 4. Following this, eight new BRB's are to be installed between the new columns. The BRB's have been delivered to site, with some of their gusset plates cast into the new RC columns and raft slab.

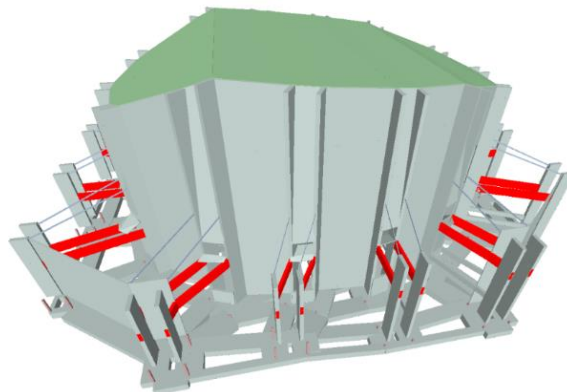
In the **Auditorium building**, the analysis reported shear capacity deficiencies in the concrete beams that support the promenade floor. To address this deficiency, the adopted retrofit strategy was to selectively weaken the beams by cutting some of the beam flexural reinforcement at the beam-column interface, and to wrap the potential plastic hinge zone (PPHZ) with FRP carbon fibre to for additional shear strength. The selectively weakened beams are shaded red in Figure 6 below. The reduced beam flexural strengths were updated in the model and the analysis was repeated to re-assess the structural performance.

Figure 6: Selectively weakened beams in Auditorium. The promenade floors are hidden for clarity in this figure.

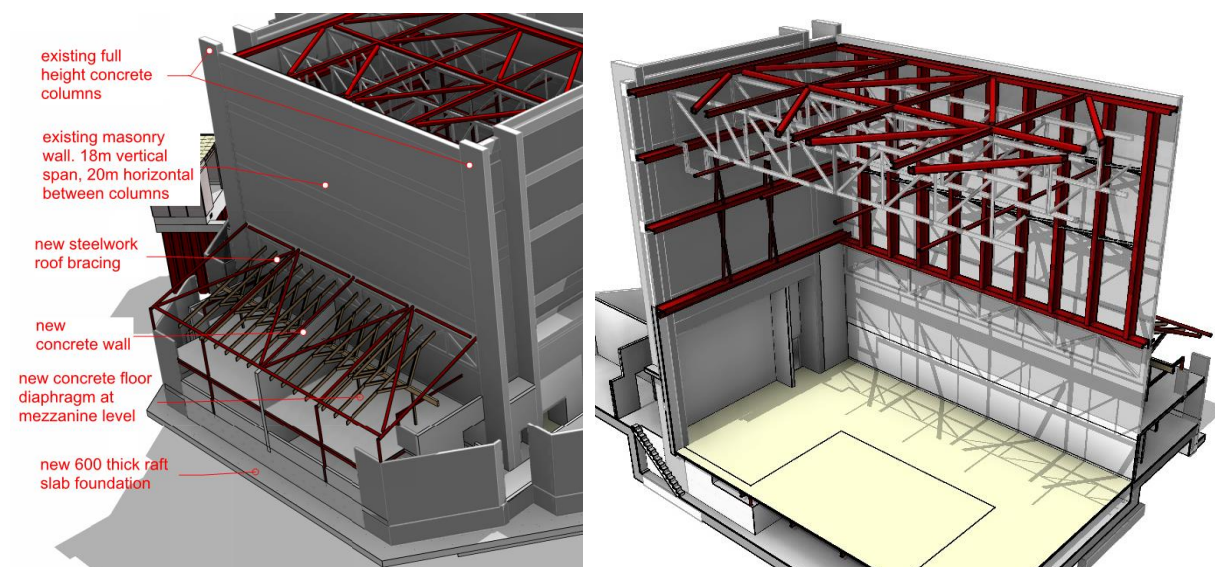
In the **James Hay Theatre**, the fly-tower around the stage area had inadequate out-of-plane lateral restraint of the original 190mm masonry walls. The approximate vertical span of the most critical eastern wall is 18metres and 20metres long. Due to the Heritage status of the building, all strengthening needed to be concealed on the inside the building. New vertical and horizontal steel beams (610UB and 530UBs) are fixed to the wall at regular spacing and span between new steel roof bracing of the fly-tower and to the back of house area. Figure 7 from the Revit model illustrates the extent of new structural works being carried out inside the fly-tower and on the eastern side.

Figure 7: 3D Revit perspective views of James Hay Theatre fly-tower. Left: south-west facing the back of house; Right: North-east facing, inside the fly-tower. (Note dark grey elements show existing concrete and masonry).

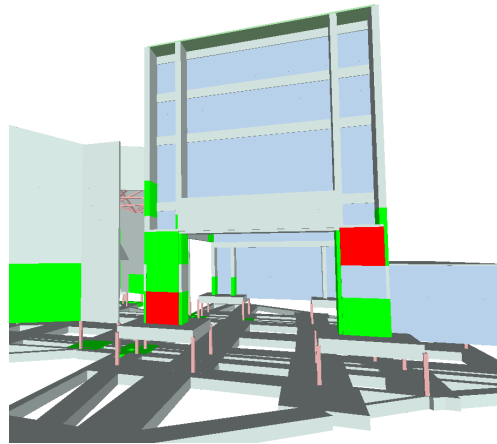
The analysis of the **James Hay Theatre** also reported that the existing masonry walls in the fly tower had excessive shear strains at lower level. This is illustrated in Figure 8 showing these wall elements failing the Collapse Prevention (CP) criteria defined in ASCE 41-06. An important clarification of the CP criteria is that this is not a state of collapse, but rather a state which collapse is unlikely to occur, although the damaged structural elements has little residual strength. This was considered a critical structural deficiency as these masonry walls provide lateral restraint to the full-height concrete columns. The shear strains in the masonry walls were reduced by the addition of new RC wall in-fills around the perimeter of the fly-tower structure, from ground to mid-height.

Figure 8: NLTHA output of the fly-tower elements at the Collapse Limit State (CLS).

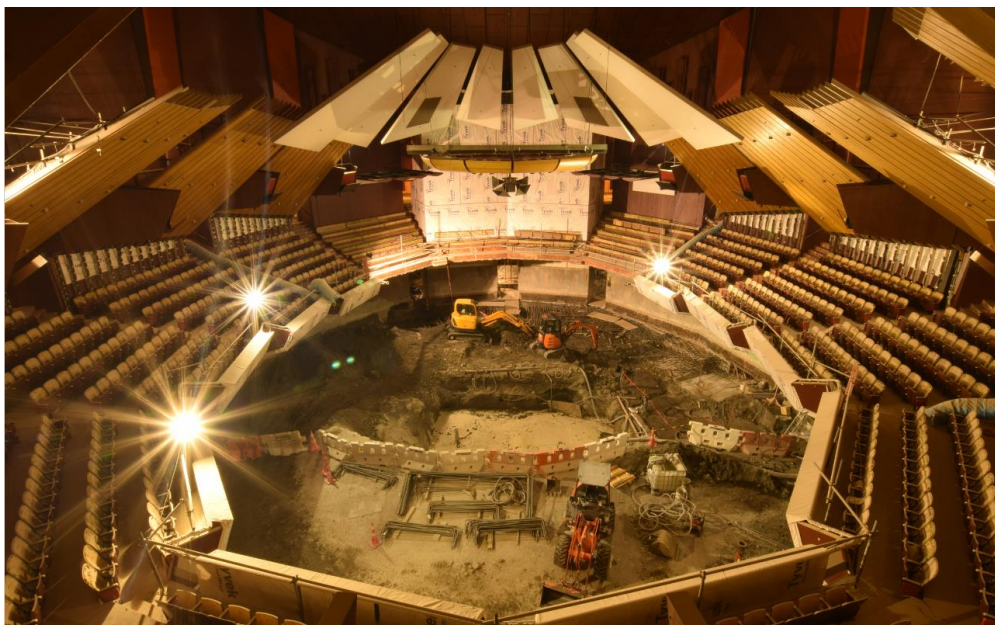
The sequence of works to rebuild the new foundations was somewhat repetitive, albeit with different constraints in each location around the site. Core-drilled holes through the existing foundations were done first to allow the machine equipment to inject the jet-grout. After ground improvement was completed in a given area, the existing foundations were partially demolished to enable the construction of the much thicker new RC raft slab foundation. Figure 9 below illustrates the preparation work being done in the Auditorium to allow the new 900mm deep raft slab.

Figure 9: Inside view of Auditorium in preparation for the new raft slab foundation (photo dated May, 2016).

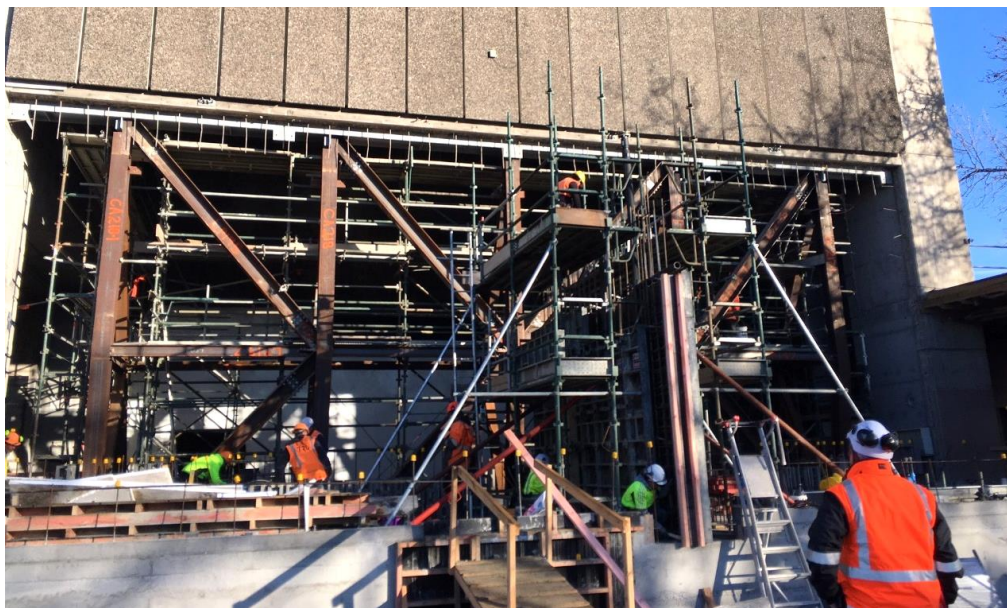
- **James Hay Theatre:** As shown in Figure 10, the upper portion of the eastern wall of the fly-tower is supported by a combination of temporary and permanent structural steelwork. In the west end of the theatre, adjacent to the Foyer, the architectural fit out is progressing for the ticket booths and toilet areas.

Figure 10: James Hay Theatre back of house area. (Taken August, 2017).
