## SEISMIC PERFORMANCE OF CONCRETE STRUCTURES IN THE 2017 KERMANSHAH EARTHQUAKE IN IRAN

N K HAZAVEH<sup>1</sup>, C ASHBY<sup>1</sup>, A A RAD<sup>2</sup>, H FARSHCHI<sup>3</sup>, B H HASHEMI<sup>3</sup>, B MANSOURI<sup>3</sup>,  
A KALANTARI<sup>3</sup>, S MOGHADAM<sup>3</sup>

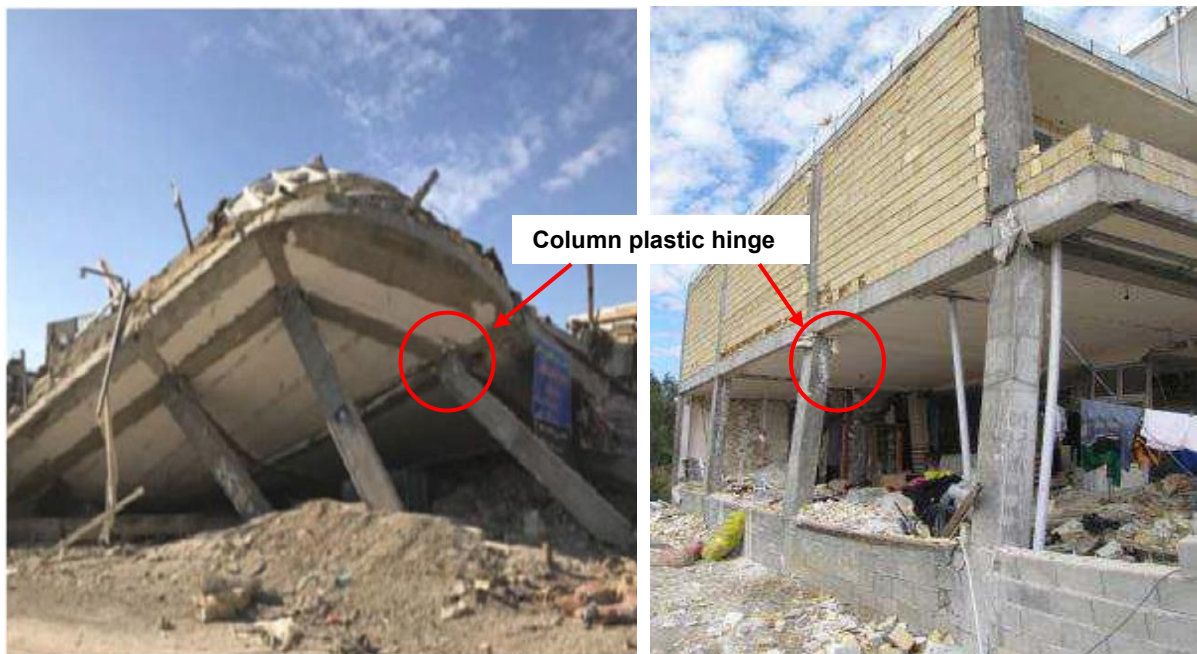
According to the Iranian Standard, for high ductility structures, the flexural capacity of the column should be 20% more than flexural capacity of the beams. However, in the standard this is not specifically required for structures with nominal ductility. This type of structures covers most of the residential buildings. Therefore, in many residential RC frame buildings, column plastic mechanism, were observed instead of beam plastic mechanism during the earthquake, as shown in Figure 4.

Figure 4. Soft story due to the weak column-strong beam

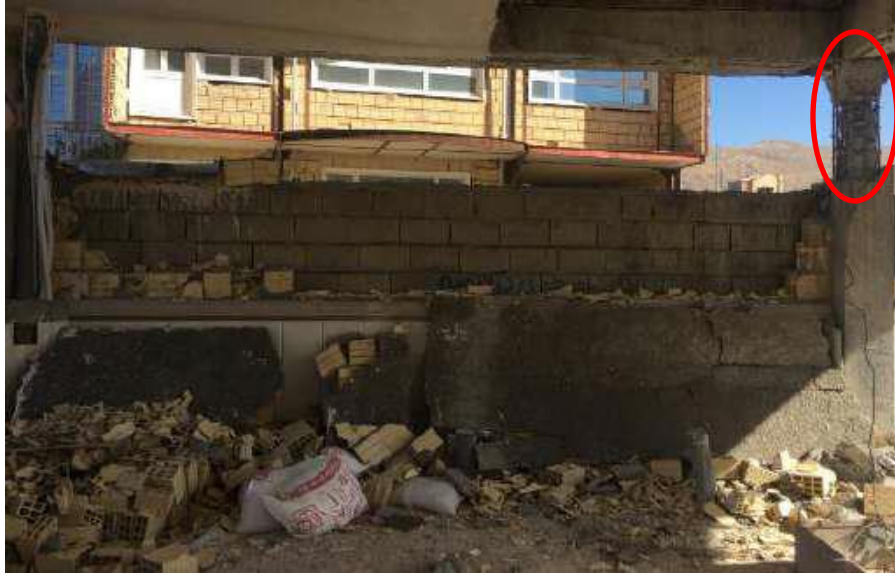
However, a common observation was in the design of the buildings in this region that this has not been considered. This resulted in short column failures and irreparable damage such as building twist, weak floors, and local damage of structural elements, as shown in Figure 5.

Figure 5. Short column failure due to presence of masonry infill

Short columns failure can happen when the effective clear shear span of the columns is reduced due to presence of masonry, concrete infill or stiff non-structural facades. Therefore, non-structural components such as partition walls and facades in buildings shall be detailed in such a way that they do not impose any restraint for the displacement of structural systems during an earthquake. Otherwise, their interaction with structural system shall be considered (Iranian Standard 2800 section 1-5-6).

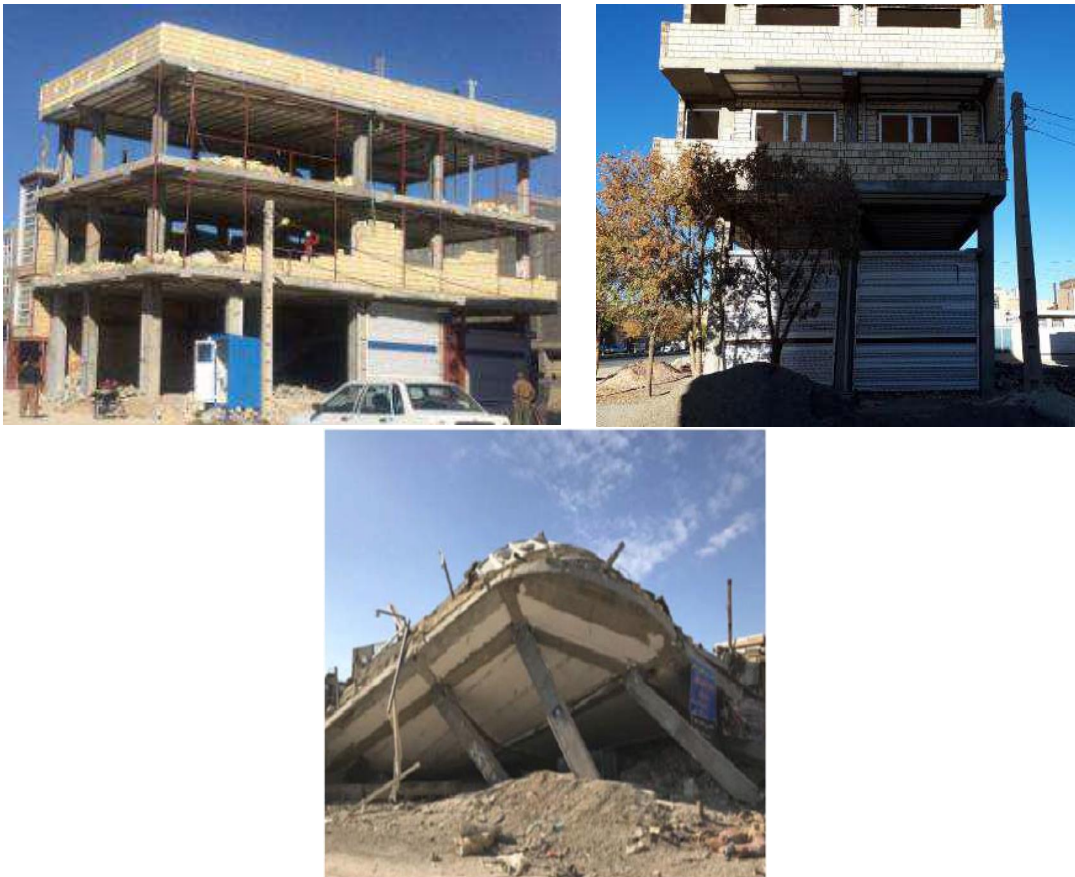
One of the advantages of using moment frame systems is the ability to provide openings on the ground floor for commercial or parking reasons. Therefore, in this story the number of interior walls are usually less than other stories and resulting structural irregularity. Horizontal and vertical plan irregularity is one of the main reasons for torsion failure in the many observed high-rise commercial unit with parking on the ground floor, as shown in Figure 6.

Figure 6. Torsion Failure

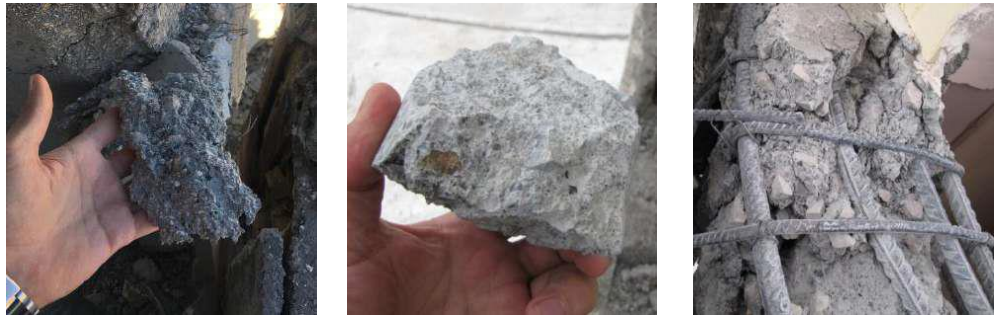
One of the key factors to providing reliable shear capacity is the concrete strength should be not less than 20 MPa for structures with regular ductility (Iran Concrete code- Guideline 9- section 1-2-1-9). In most of the collapse or damaged buildings during this earthquake, brittle failure due to poor condition and quality of concrete (concrete without sand, grains or discrete aggregate) has been observed. Figure 7 shows some sample of poor concrete that was used in buildings of this region. Figure 8 shows some observed brittle failure of RC building due to poor condition quality of concrete.

Figure 7. concrete without sand, grains or discrete aggregate

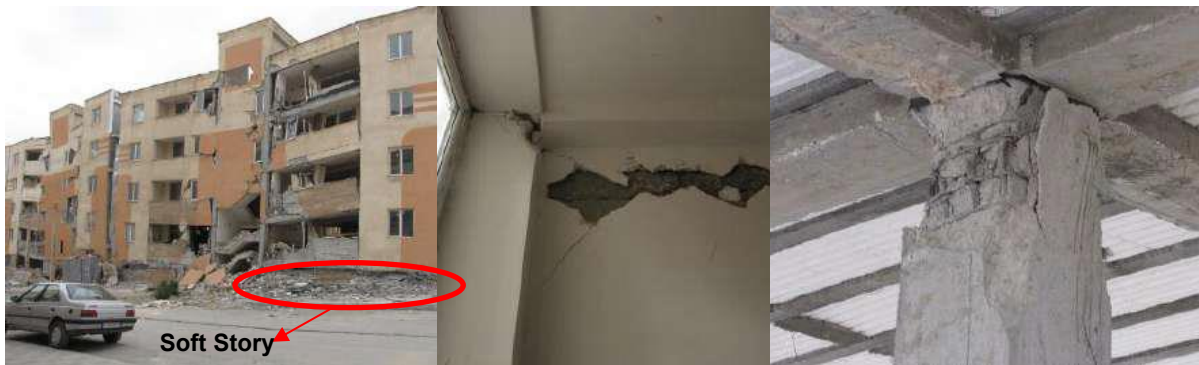
Figure 8. Shear failure in column and shear wall and soft story because of poor quality concrete.

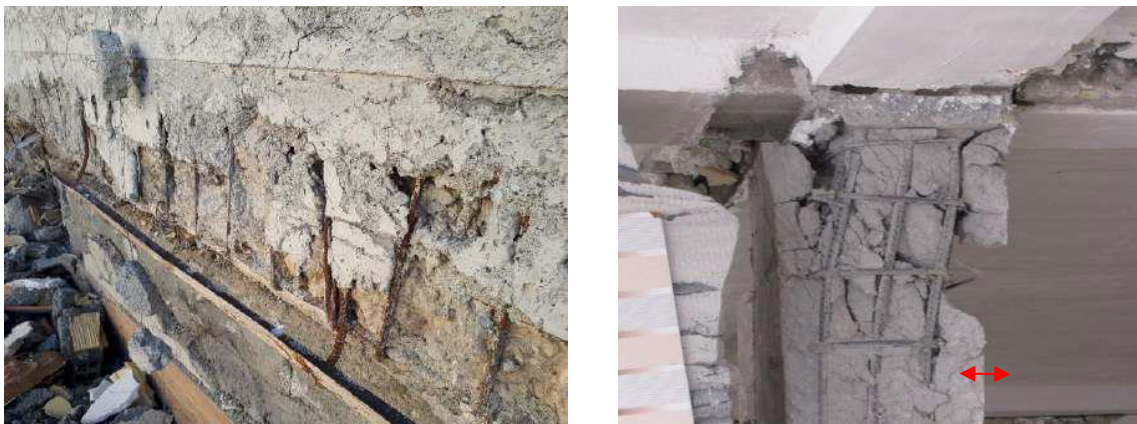
Insufficient or excessive thickness of concrete cover have been observed in some of the buildings. Increasing the thickness of the coating cause concentrating the stress and covers completely cut off from the column. A large part of the section capacity is lost at the first cracking point due to loss of the concrete cover because of either insufficient or excessive cover.

Figure 9. a) Insufficient concrete cover, b) excessive column concrete cover and spalling of concrete cover.

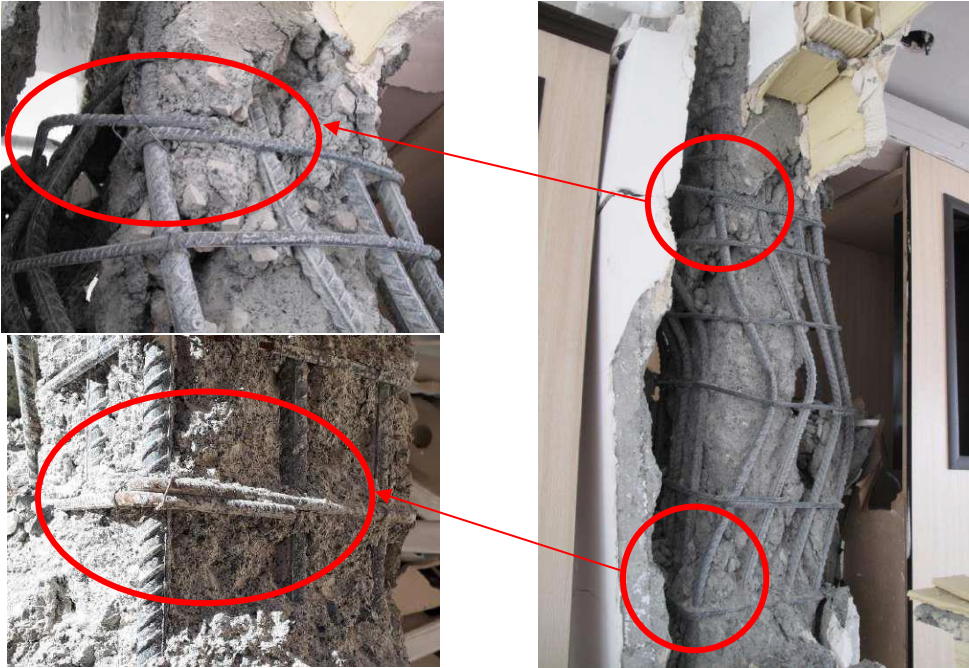
Also, in some observed column failures, the stirrup hook was bent 90° instead of 135°. Therefore, after losing the cover these hooks opened and caused dramatic column failure, as shown in Figure 10.

Figure 10. Inadequate anchorage detail in column

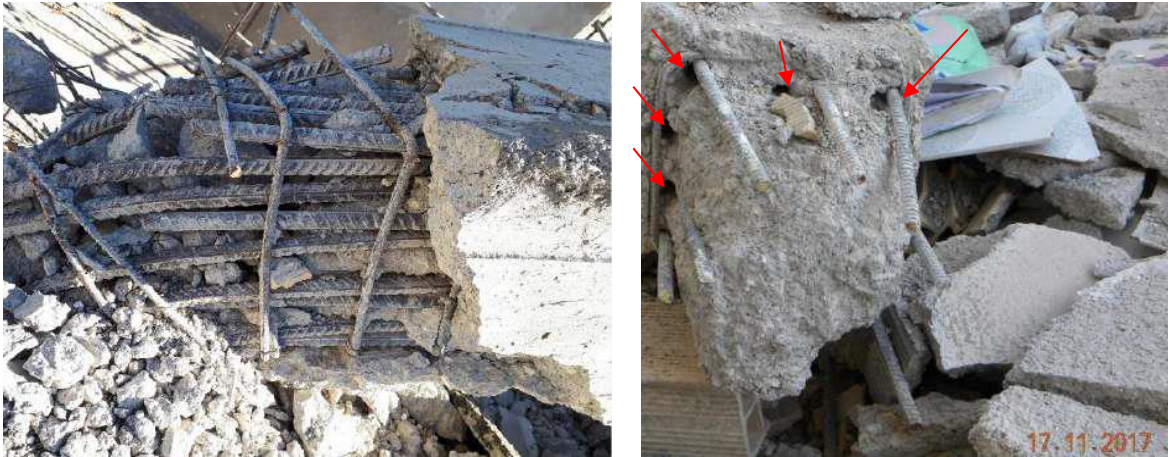
The lap splice length should be sufficient to create a bond as if there was no break and the run is “continuous” to transfer tension and compression. With insufficient lap lengths, the capacity of the lap quickly degrades and within one cyclic of loading the lap splice may be assumed to have failed. It worth mentioning that, the poor concrete strength condition of some structures magnified failures due to insufficient lap splice and development length, as shown in Figure 11.

Figure 11. Insufficient lap splice in column

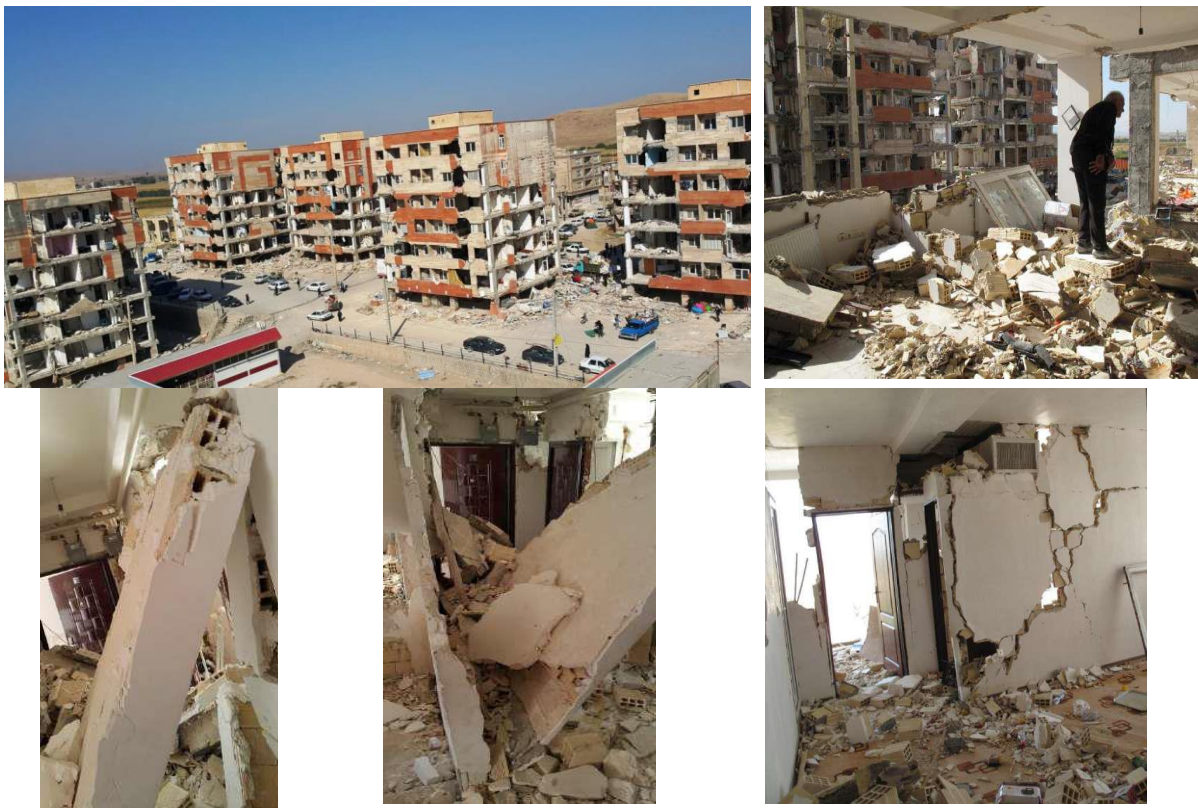
Poor performance of non-structural elements including infill cladding, non-structural walls, facades and suspended ceiling, were observed in most of the buildings. Even when structural damage was limited or negligible, the non-structural damage was the main contributor of

losses and downtime for the majority of the RC buildings. Figure 12 shows non-structural failure of 24 residential 7-story reinforcement concrete buildings at Shirodi development.

Figure 12. Collapse of facade, infill panel and non-structural walls of Shirodi development.

The damaging earthquake has highlighted many instances of poor performance of non-structural elements, particularly in multi-storey buildings. While primary and secondary structural elements are designed and detailed as part of the structural engineering design of a building, non-structural elements can be overlooked or poorly managed during the design, procurement, or construction phases of the project. Careful detailing is required for non-structural elements so they can resist earthquake actions. Critical details, such as connections, restraints and, where required, flexible elements and/or separations should be identified and documented.
