TOKOMARU BAY - HISTORIC WHARF RESTORATION USING MODERN MATERIALS

R HUDD¹, M DYER¹, J BROTT¹

^{1, 2, 3} School of Engineering, University of Waikato, NZ

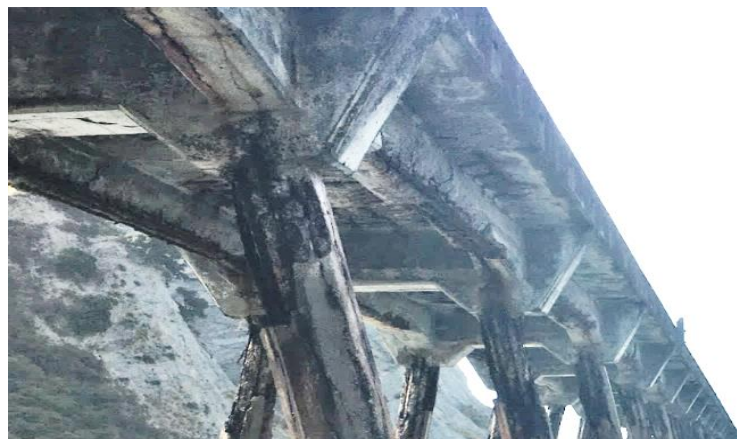
Figure 1. Cracking and Spalling of Concrete on the Wharf Structure Local Heritage

Inspection of the wharf between 2007 and 2013 attributed the observed spalling and loss of reinforcement to chloride induced corrosion due to the age of the structure in the marine environment (Tokomaru Bay Heritage Trust 2014). The effects were apparent to varying degrees throughout the structure but most obviously in the wharf piles. Based on the overall condition of the structure, repair was considered to be feasible with restoration of the piles as the highest priority. It was judged that no action would lead to increasing loss of structural integrity with failure of individual elements with either a progressive or a catastrophic collapse of the entire structure. Restoration options suggested at the time were either: complete replacement of the damaged piles; or, repair with a concrete jacket similar to the methodology employed for the Tologa Wharf Restoration (Williams 2009).

The proposed method followed conventional practice, removing the damaged concrete and steel, and strengthening the remaining core concrete with a concrete jacket reinforced with FRP rebars. The intention being to trial the method on the four piles at the landward end of the wharf.

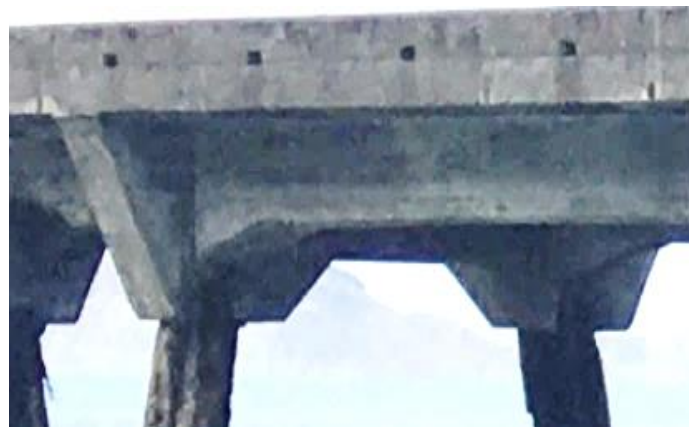
Figure 2. Photograph Showing Profile of the Headstocks and Longitudinal Beams

The drawings show that, after installation, the concrete at the pile ends was removed and the longitudinal steel bent out to be integrated into the cast in situ headstocks. The headstocks are of rectangular cross section, 405 mm wide, varying in depth from 600 mm over the centre 900 mm, then tapering to a depth of 915 mm over the piles. (Figure 2). The tops of the piles are 2.1 m apart.

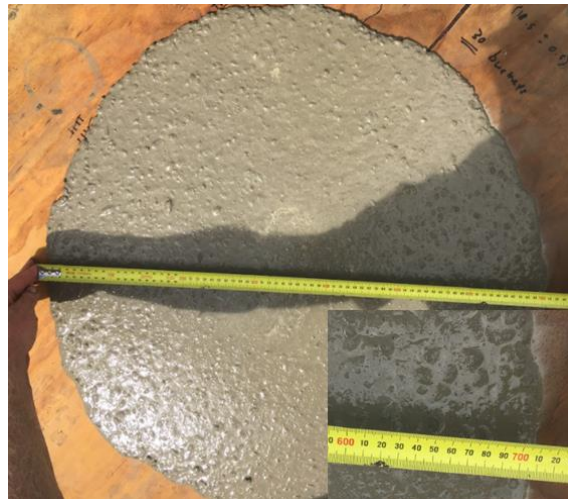
The tests were used to confirm that acceptable flow spread using an inverted slump cone, could be obtained with the mix (Figure 3). Stable flow spreads between 650 and 750 mm were achieved with water: binder ratios between 0.35 and 0.4 and superplasticiser dosed at 0.3 to 0.5 litres per 100kg of binder (Figure 3). At higher flow spreads bleeding and aggregate segregation were observed.

Figure 3. On-Site Flow Test of Trial Self-Compacting Concrete Mix

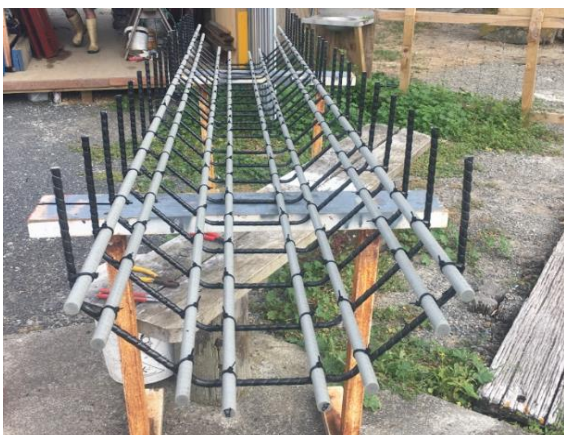
The FRP reinforcement cages were assembled in two halves each consisting of eight 22 mm bars arranged in pairs with each bar centred 35 mm from the corner of the links (Figure 4). Links were spaced at 150 mm centres secured with plastic zip ties at each intersection. Gloves were recommended when handling the longitudinal bars as they were machined during manufacture to give a ribbed profile resulting in exposed glass fibres.

Figure 4. FRP Reinforcement Cage Half

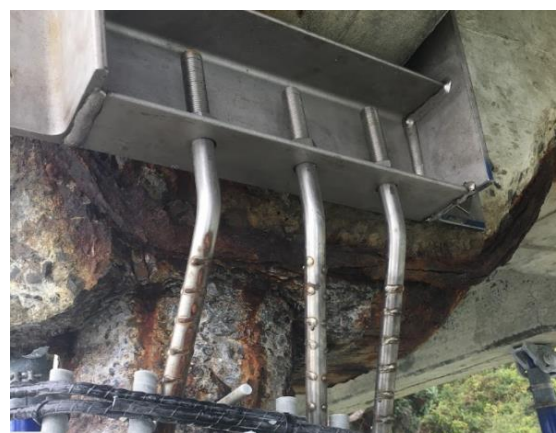
The reinforcement cage sections were positioned either side of the piles with the top ends tied to stainless steel starter bars bolted to a purpose made bracket (Figure 5). The bottom of each cage was positioned over the undamaged pile section using spacers. The sections were secured at points around the pile with short lengths of GFRP bar fixed into the substrate concrete. The two halves of the cage were tied together with additional links to give continuity around the pile.

Figure 5. Starter Bar Connection
