Proof of Concept Tests for Hollowcore Floor Unit Connections

Professor Des Bull and Jeff Matthews

This report has been prepared for Precast NZ Inc.

Research Report 2003-1

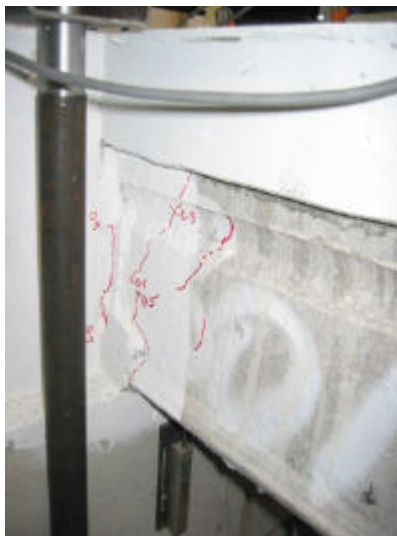
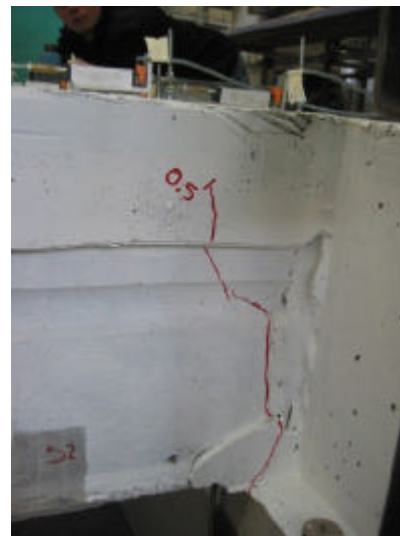
Figure 5-1. Damage at 0.5% (0.35%) drift

At 0.5% (0.35%) drift a crack formed at the bottom of the hollowcore unit at the beam face (Figure 5-1). This crack formed in the same location as seen in the Matthews test. Some longitudinal cracks also formed in the bottom of the unit. These cracks were visible externally and internally.

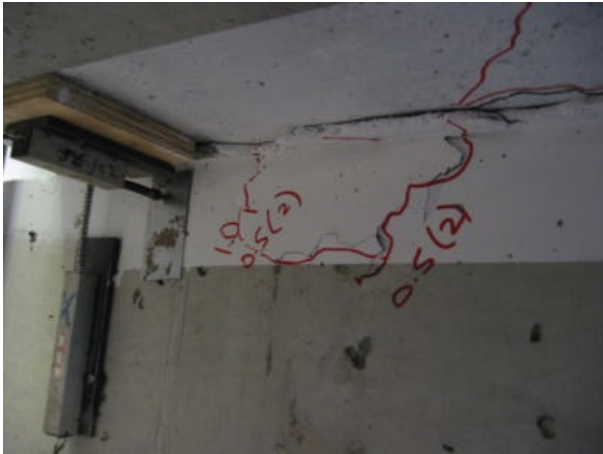
The second cycle to 0.5% (0.43%) saw a small area of the beam cover concrete spall (Figure 5-2(a)). At zero percentage drift the residual crack width between the end of the hollowcore unit and the supporting beam was 0.3mm.

(a) Spalling of the beam cover at 0.5% (0.43%) drift

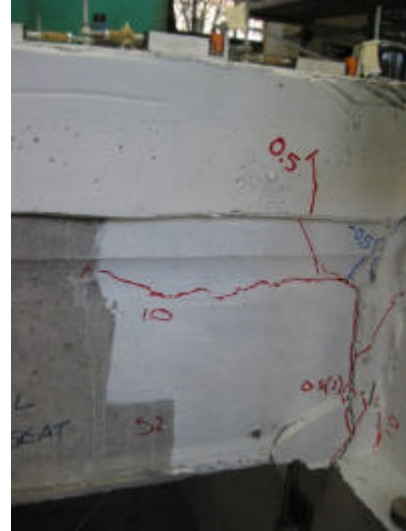
(b) Split web at 1.0% (0.93%)

At 1.0% (0.93%) drift a longitudinal split, 300mm long, formed in the web of the hollowcore unit (Figure 5-2(b)). The crack in the bottom of the hollowcore unit on the beam face was now 3-4mm wide. More of the beam cover concrete had spalled.

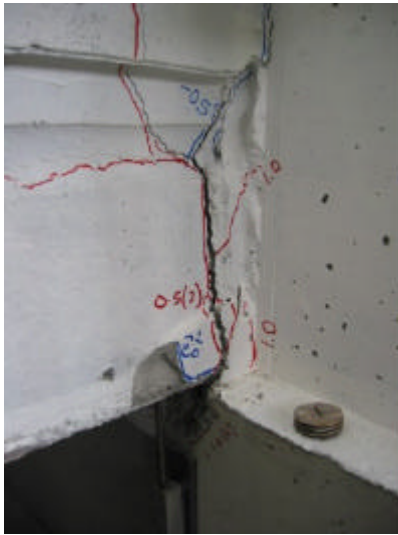
The crack at the beam face opened to 8mm wide at a drift of 2.0% (1.95%) is shown in Figure 5-3(a). More of the beam cover concrete spalled but no additional cracks within the unit formed.

(a) Damage to the seat connection at 2.0% (1.95%) drift

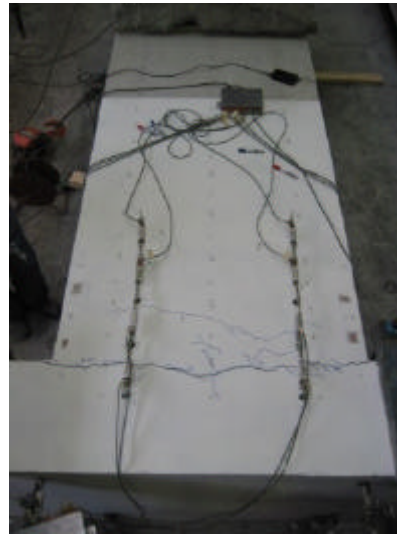
(b) Topping cracks at -2.0% (-1.98%) drift

At -2.0% (-1.98%) the continuity crack was now 7-8mm wide (Figure 5-3(b)) and the unit had lifted 4mm relative to the top of the beam. At zero drift the residual width of the crack between the hollowcore unit and the beam was 4mm at the top and 3-4 mm at the bottom. A crack had formed in the topping concrete at the termination of the starter bars.

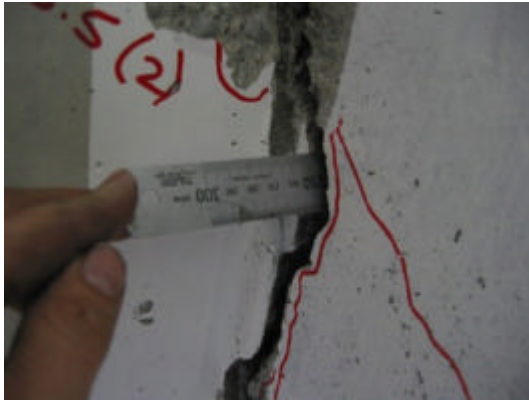
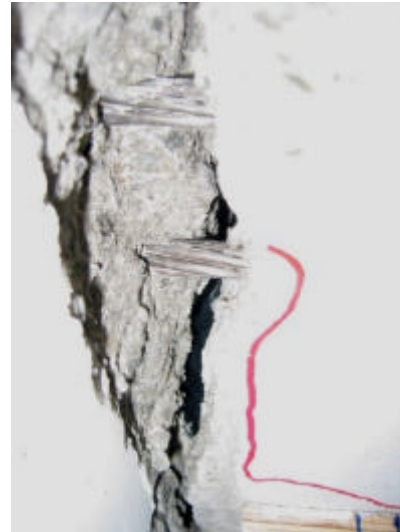
Figure 5-4. Damage to the hollowcore unit (Drift=3.0%).

At 3.0% (2.92%) drift it was possible to pass a ruler through the crack in the bottom of the hollowcore unit (Figure 5-4(a)). The end of the prestressing strands could be seen as the strand pulled through the broken section of the hollowcore unit. This can be seen in Figure 5-4(b). When a torch was shown up the end of the core it was possible to see the light coming through the cracks in the bottom of the unit.

(a) The crack was large enough to pass a ruler through the gap between the unit and the beam.
(b) The prestressing strands pulling out of the fractured hollowcore unit.

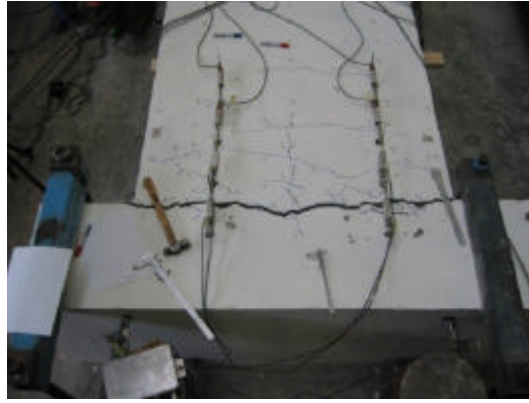
At -3.0% (-2.89%) drift, numerous cracks had formed within the topping, see Figure 5-5). The length of delamination of the topping from the hollowcore unit varied across the width of the unit between 350-400mm.

Figure 5-5. Cracks in the topping at -3.0% (-2.89%) drift

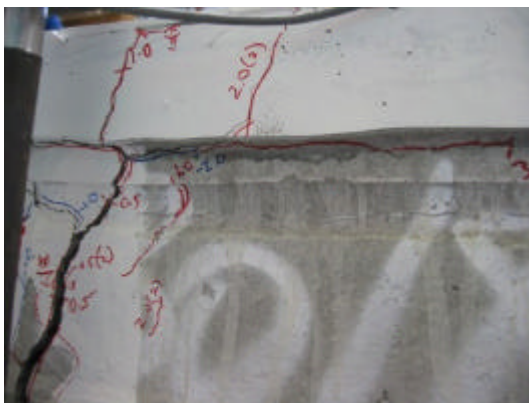
During the second cycle to 3.0% (3.10%) drift the unit had now dropped 5mm at the floor-beam junction. Sizeable cracks could be seen in the webs on both sides of the unit and the delamination on the north side had extended out to the end of the starter bars (i.e. 600mm into the floor slab). This damage can be seen in Figure 5-6.

(a) A crack had formed between the hollowcore unit and the topping, leading to delamination of the topping

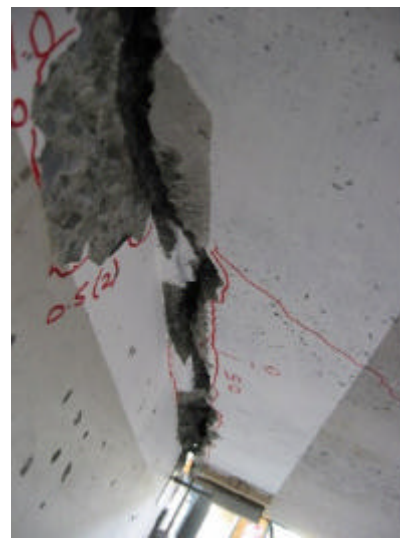
(b) Dropping of the hollowcore unit and damage to its seat.

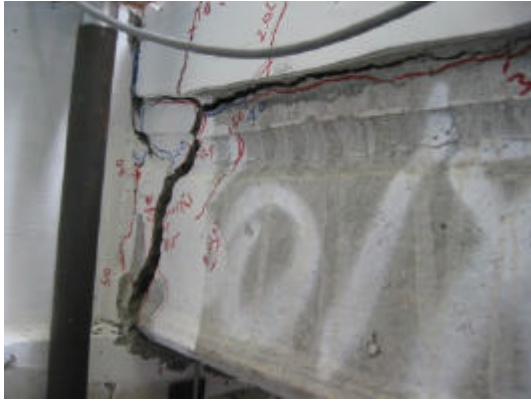
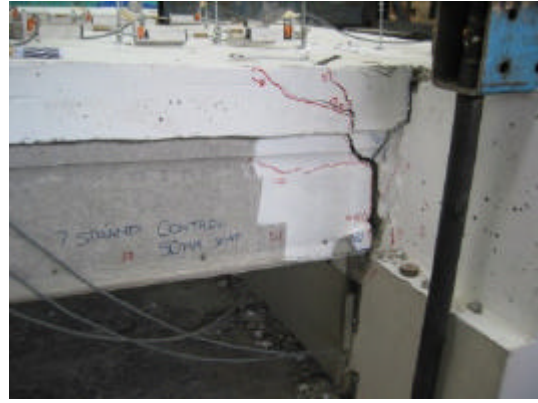
Figure 5-7. Damage at 4.0% (3.98%) drift.

At 4.0% (3.98%) drift more cracks formed within the webs of the unit. The light from a torch could easily be seen through both the side and the bottom of the hollowcore unit. It was possible to see the prestressing strands kinking as they were trying to carry the weight of the unit since the seat had been lost. The south side of the unit now had 500mm of delamination while the north side stayed at 600mm.

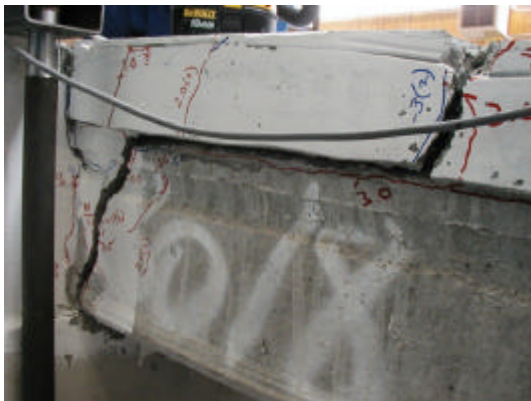
On the way to -4.0% (-3.99%) it was possible to hear the HRC mesh at the end of the starter bars fracturing. The crack width between the end of the hollowcore unit and the supporting beam varied between 3-4mm. The hollowcore unit dropped by 12mm at the floor-beam junction.

(a) The topping peeling away from the hollowcore unit

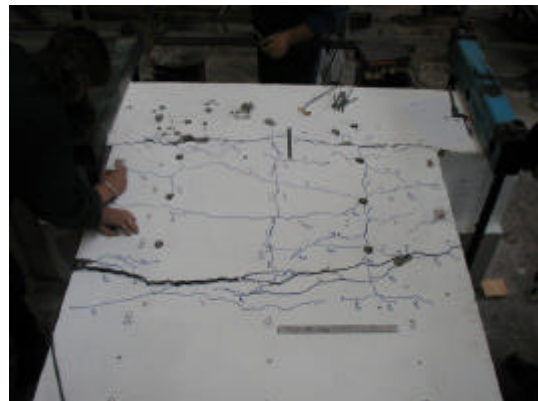
(b) The large crack that formed at the end of the starters and caused the mesh to fracture.

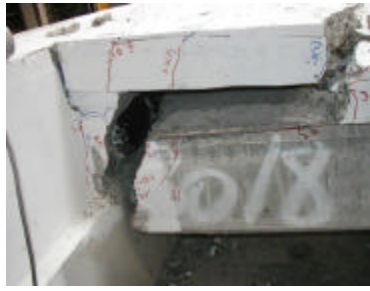
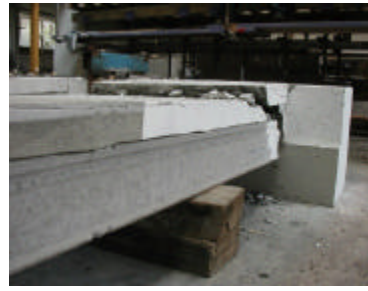
Figure 5-9. Failure plus removal photos of the HC1.

On the next cycle to 4.0% the unit failed completely and fell off its seat. Photos of both the failure and removal of the specimen is shown in Figure 5-9.

(c) Overall failure

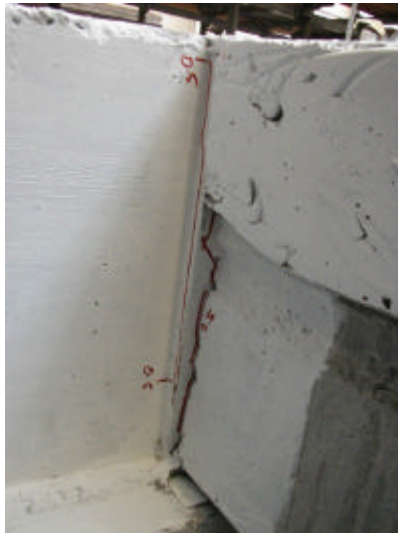
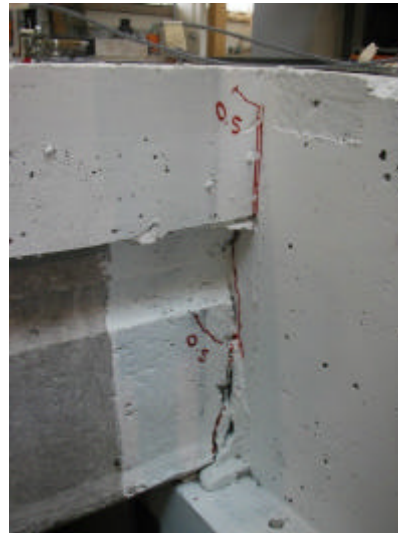
Figure 5-10. Damage at 0.5% (0.54%) drift

At 0.5% (0.54%) drift one small crack formed in the underside of the hollowcore unit. It was possible to see a crack forming around the edge of the compressible material (Figure 5-10). At this early stage it appeared that this connection detail was performing considerably better than the previous test.

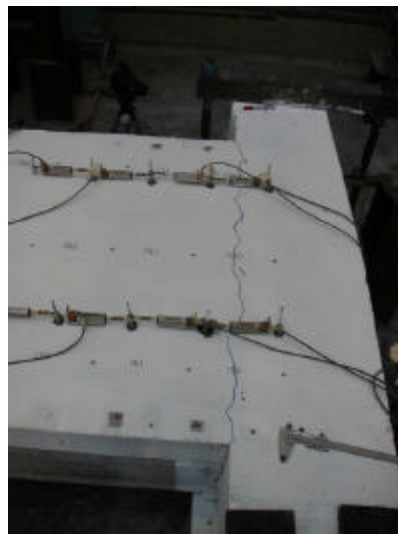
At -0.5% (-0.40%) drift the continuity crack formed at the end of the hollowcore unit. This can be seen in Figure 5-11. No other cracks formed.

Figure 5-11. Continuity crack at -0.5% (-0.40%) drift.

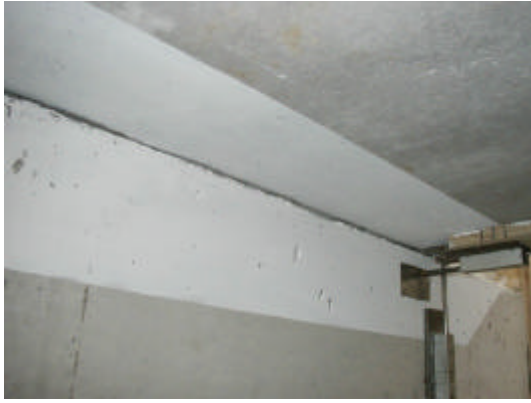
The second cycle to 0.5% (0.52%) drift saw a small crack form in the web of the hollowcore unit (Figure 5-12). It was also possible to see the movement of the hollowcore unit relative to the beam. This can be seen in Figure 5-12 by the grey unpainted line at the interface of the two components.

(a) Sliding of the hollowcore unit relative to the supporting beam.

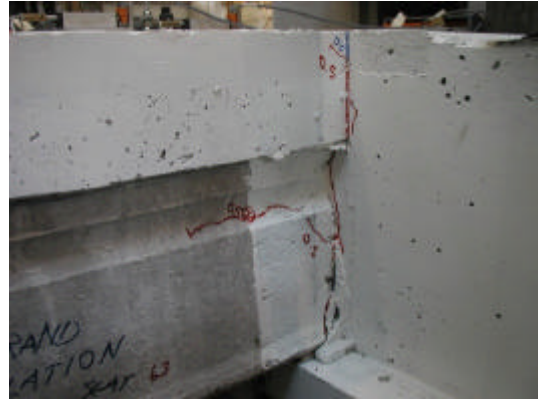
(b) Web split in the south face of the hollowcore unit.

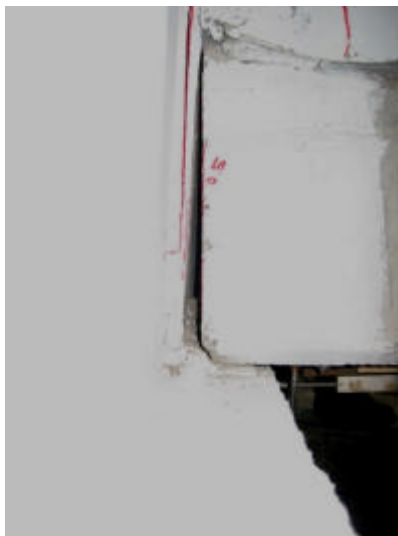
At 1.0% (0.93%) drift no new cracks formed. The unit could be seen to be sliding on the low friction bearing strip (Figure 5-13(a)). The connection was still performing extremely well.

(a) The unit sliding on the low friction bearing strip at 1.0% (0.93%) drift

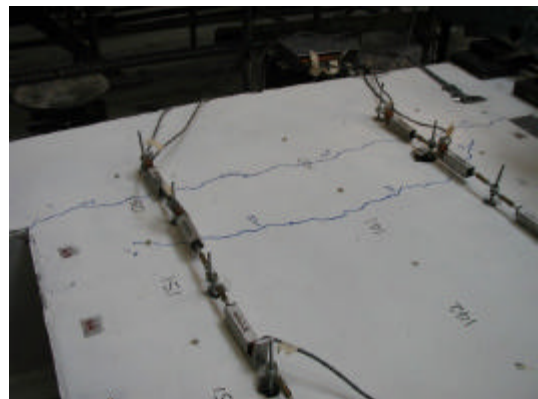
At -1.0% (-0.90%) drift a second crack formed within the topping (Figure 5-13(b)).

(b) Cracks within the topping at -1.0% (-0.90%) drift

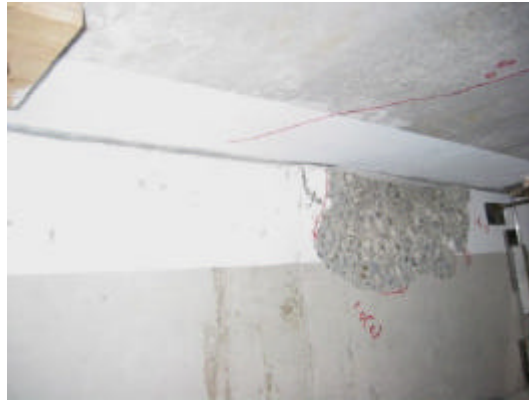
The second cycles to $\pm 1.0\%$ (1.04%, -0.90%) drift saw no real change. A section of the beam cover spalled at 1.0% (250mm long and 20mm deep). This can be seen in Figure 5-14. Two of the cracks already present within the topping extended around 30-50mm.

Figure 5-14. Spalling of the beam cover concrete (Drift=1.0%).

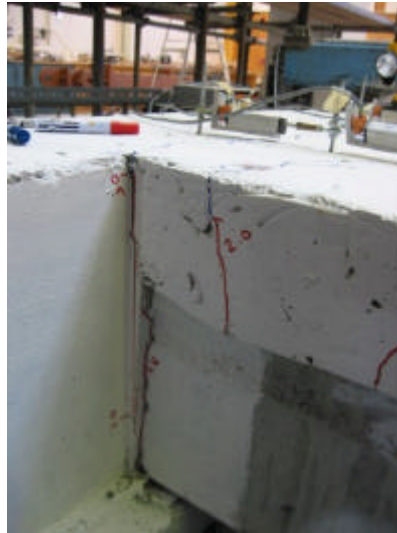
hollowcore unit had closed while the bottom crack was 2-3mm. It was unclear as to whether the bottom crack width was due to the rotation of the unit or whether the compressible material had remained partially compressed. This residual crack width is shown in Figure 5-15.

Figure 5-15. Photo showing the residual crack width at -2.0% (-1.85%) drift.

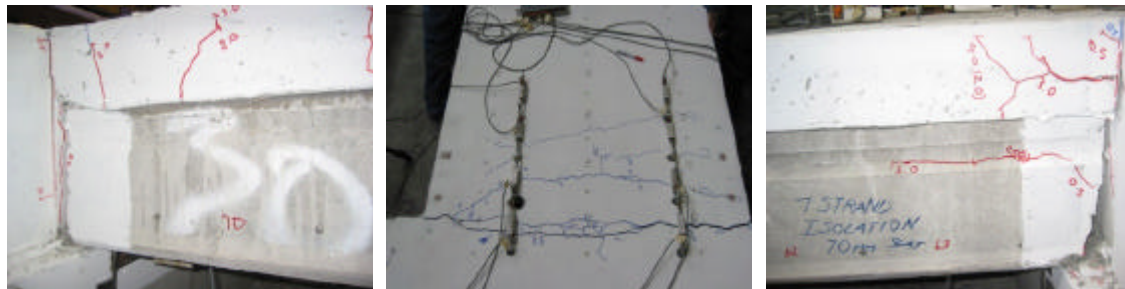
Figure 5-16. Damage at the end of the test.

hollowcore unit and the supporting beam. More cracks formed in the topping. The delamination of the topping at the end of the test varied across the unit between 200mm on the south edge to 500mm on the north edge. Figure 5-16 shows the damage at the end of testing. Note that damage to the bottom edge of the hollowcore unit indicates some bearing contact between the unit and the concrete of the supporting beam.

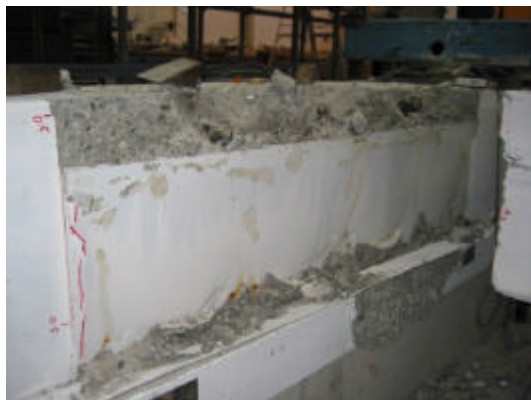
(a) The compressible backing board still attached to the beam.

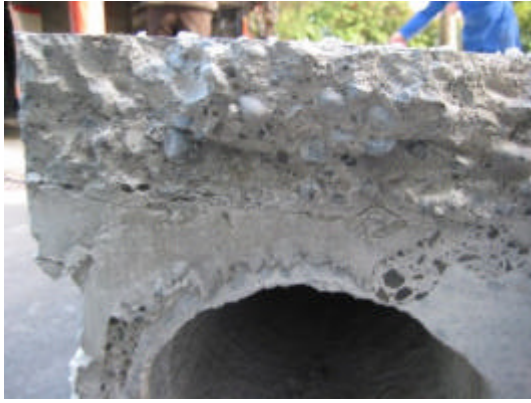
(c) Hairline crack showing some delamination of the topping.

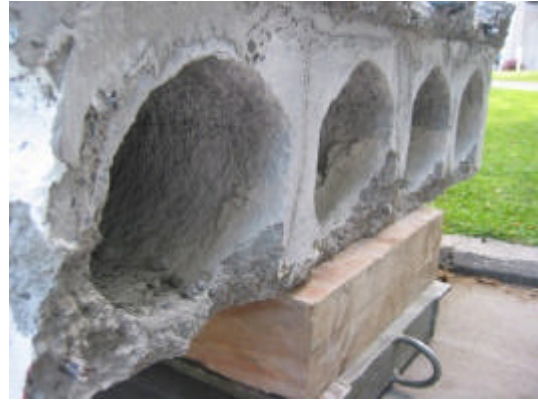
(d) The very bottom of the hollowcore unit fractured.

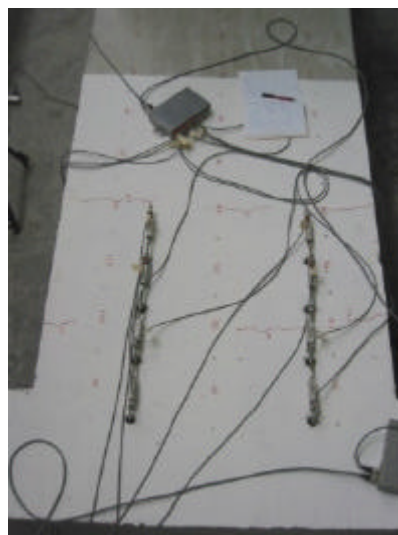
At -0.5% (-0.40%) drift two series of cracks formed in the topping. The first coincided with the end of the zone where the slots were cut into the hollowcore unit to allow the paperclips to be placed. The second crack appeared half way between the first crack and the supporting beam. These cracks can be seen in Figure 5-18.

Figure 5-18. Topping cracks at -0.5% (-0.40%) drift.

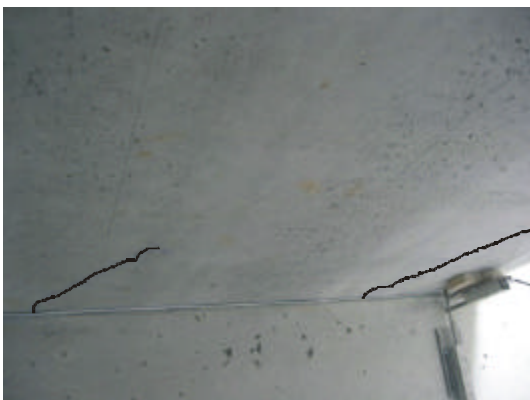
At 1.0% (0.58%) drift two longitudinal cracks formed in the bottom of the hollowcore unit. These cracks were in the soffit of the cores that were not filled with concrete (i.e. the second and fourth cores). The cracks were approximately 300mm long (Figure 5-19). There was no crack at the end of the hollowcore unit next to the supporting beam. It appeared that the low friction bearing strip was allowing the bottom of the unit to slide.

(a) Longitudinal cracks in the bottom of the hollowcore unit (Drift= 1.0% (0.58%))

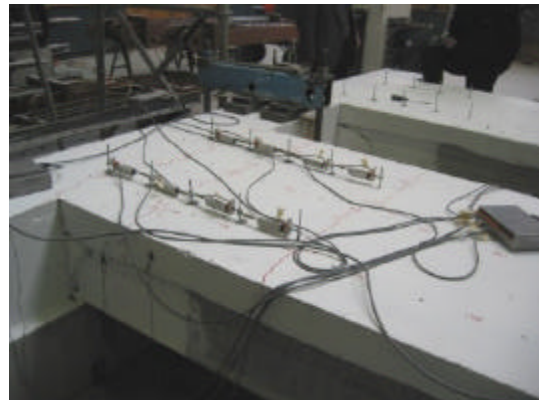
(b) Topping cracks at -1.0% (-0.82%) drift.

At -1.0% (-0.82%) the continuity crack in the topping formed at the end of the hollowcore unit. This crack was approximately 0.2mm wide. The initial two cracks that had formed at -0.5% had now propagated across the entire width of the unit. Figure 5-19(b) shows the topping cracks.

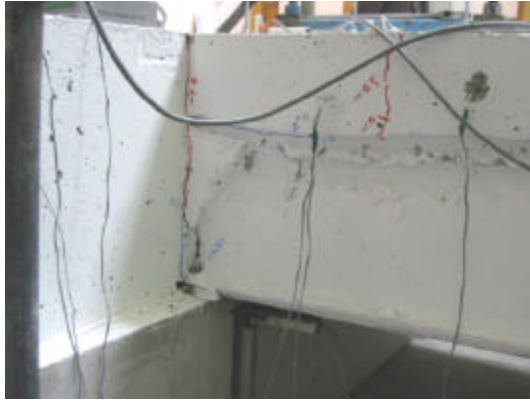
At 2.0% (1.62%) drift the crack at the vertical interface between the hollowcore unit and the beam was 2mm . No other cracks had formed. The damage at this drift can be seen Figure 5-20.

(a) Seat damage at 2.0% (1.62%) drift

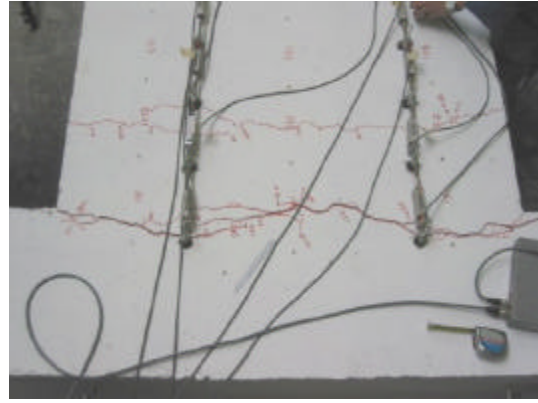
(b) Topping cracks at -2.0% (-1.71%) drift

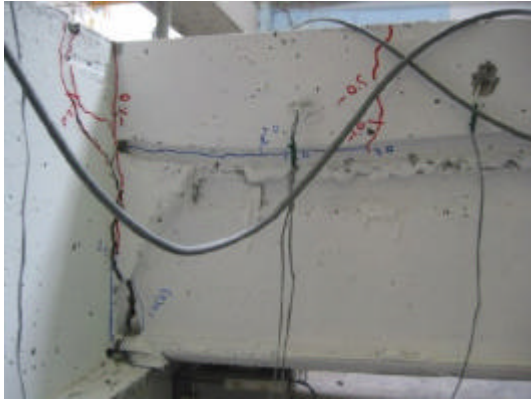
(a) North side

No major new cracks formed on the way to 3.0% (2.69%) drift. The crack at the interface between the hollowcore unit and the beam was now 8mm wide at the base of the crack. A small hairline crack was observed to have formed between the hollowcore unit and the cast in-situ topping. This can be seen in Figure 5-21.

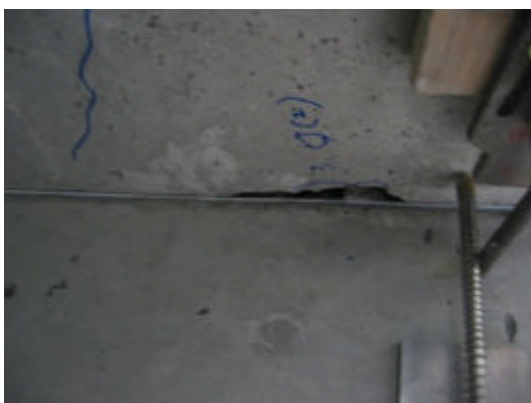
The second cycle to 3.0% (2.93%) drift saw the unit being pried off the beam. It became evident that the edge of the hollowcore unit had been broken off at an earlier stage during the test. This was obscured when it first occurred. The regions where the fracture could be seen corresponded to the unfilled cores. The damage can be seen in Figure 5-22.

(a) The fractured unit

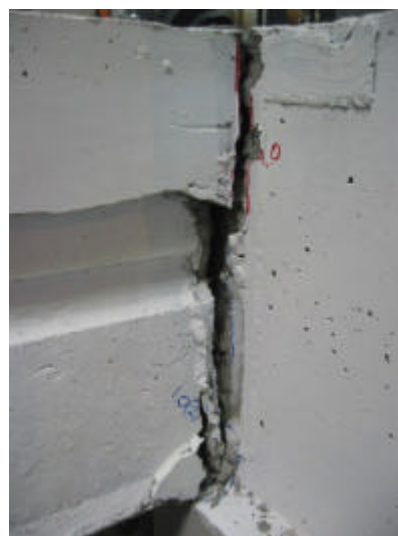
(b) Side elevation of the fracture

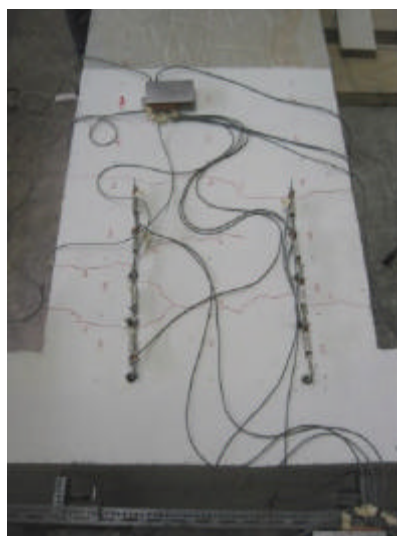
At -0.5% (-0.40%) drift there were several cracks over the topping. The number of cracks seen at this drift level is significantly more than seen in any of the other tests as shown in Figure 5-23.

Figure 5-23. Cracks within the topping at -0.5% (-0.40%) drift.

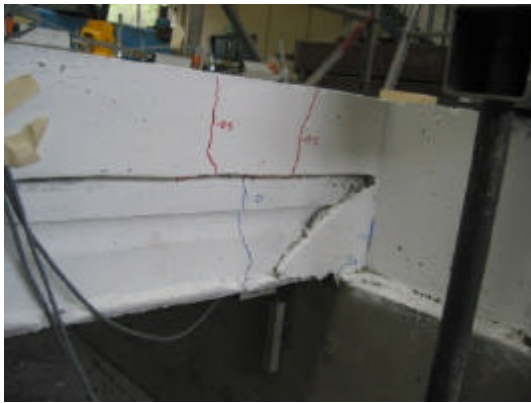
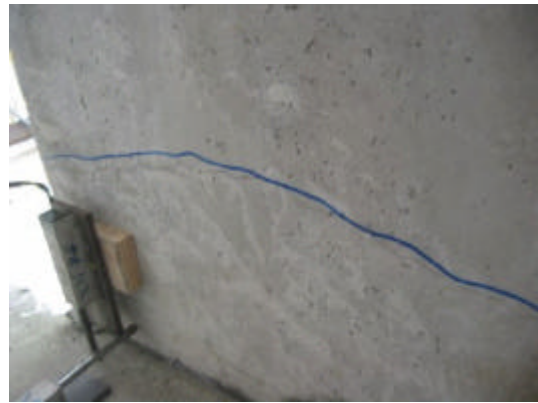
At 1.0% (0.51%) drift a thud was heard (this is associated with some load drop off). Upon inspection it was found that the hollowcore unit had fractured approximately 300mm off the beam face (Figure 5-24). The crack between the topping and the unit had extended. A small crack also formed at the interface between the beam and the hollowcore unit.

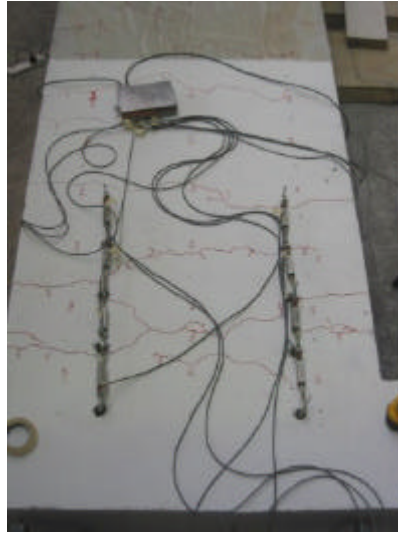
Figure 5-25. Cracks that had formed within the topping at -1.0% (-0.76%) drift.

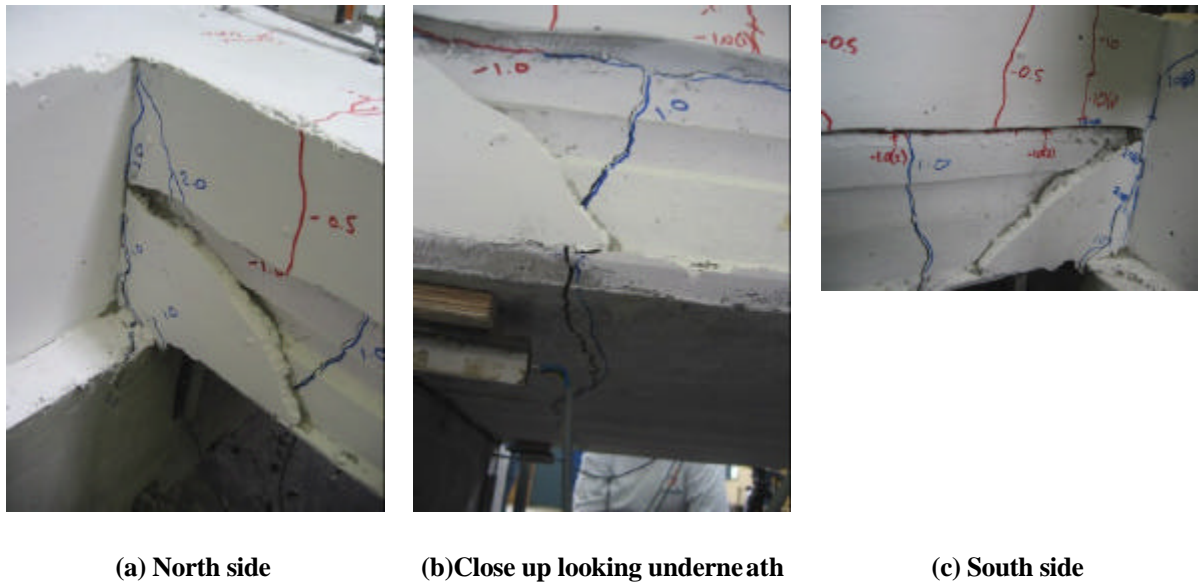
(a) North side

At 2.0% (1.98%) drift there was another thud, another load drop off occurred. Upon inspection it was found that the end of the hollowcore had fractured at the beam face (similar to what occurred in the control, HC1), the crack was 1.5mm wide at both the top and bottom of the crack. The unit had started to drop, a disparity in height could be felt between the two sides of the unit each side of the continuity crack. Figure 5-26 shows the fractured unit.

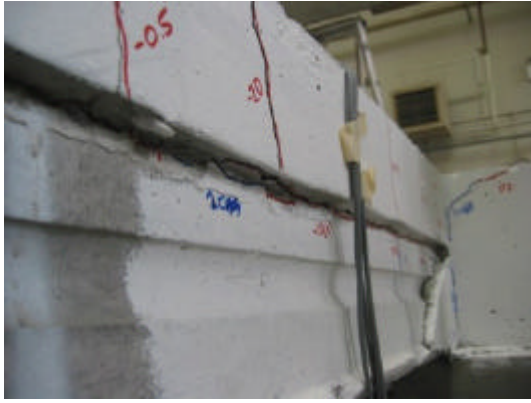
At -1.8% (-1.6%) drift on the way to -2.0% (1.74%) strands of the HRC mesh could be heard to fracture. As the specimen was being loaded it was possible to see the crack open at the end of the starter bars. This is point where the mesh fractured. Once -2.0% drift was reached this crack width was 3-3.5mm. At this point the entire topping up to the end of the starter bars had delaminated. The continuity crack at the end of the hollowcore unit was 1.5mm wide. The hollowcore unit was now 1mm higher than the beam. Figure 5-27 shows the delaminated topping and topping crack.

(a) Delamination of the topping concrete

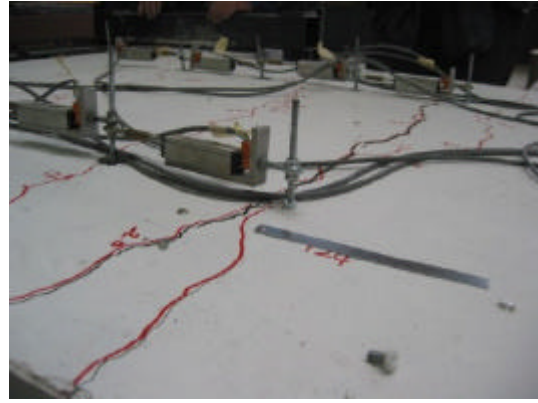
(b) The large crack at the end of the starters that caused the mesh to fracture.

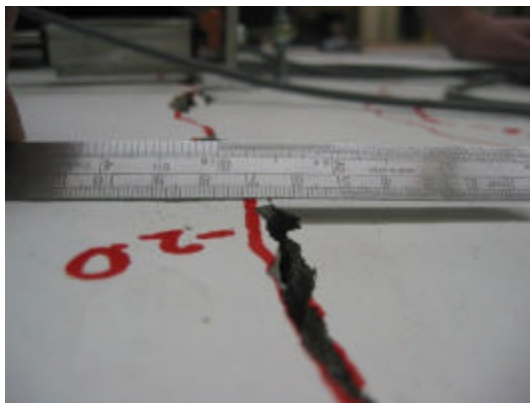
More mesh fractured during the loading out to the second cycle to -2.0% (-1.79%). The crack width at the end of the starters was now 7mm wide. There was also a 6mm vertical separation in the topping on either side of that crack. At the end of the hollowcore a 4mm vertical displacement could be measured between the underside of the topping concrete and the top of the hollowcore unit (Figure 5-28(a)).

(a) Difference in height each side of the continuity crack.

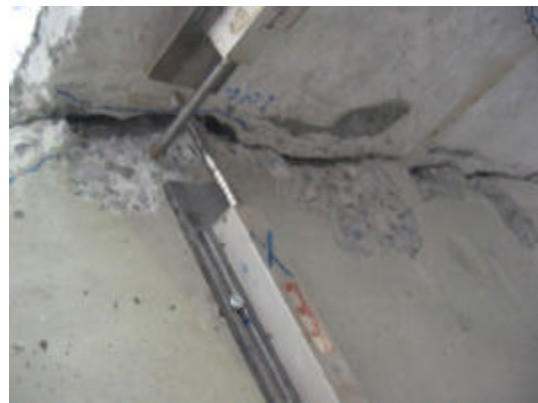
(b) Damage to the underside of the hollowcore unit

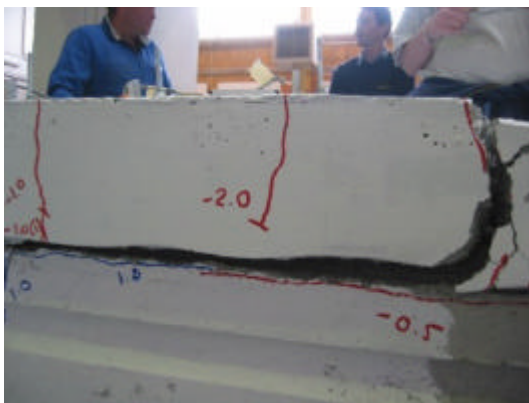
At -3.0% (-2.76%) drift there was a 24mm vertical separation across the crack at the end of the starter bars. The width of crack was 20mm. The unit was rotating about the bottom of the hollowcore unit at this crack location (Figure 5-29).

(a) Close up looking at the end of the starter bars

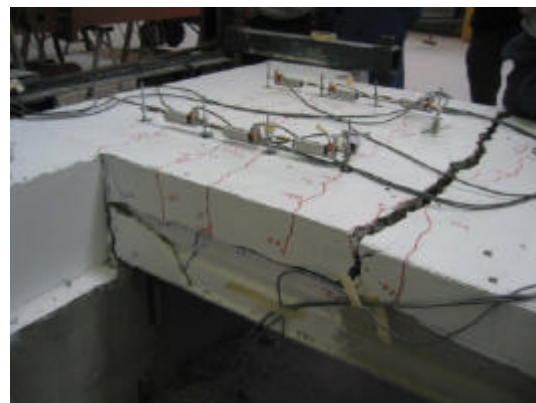
(b) Overall photo of topping failure

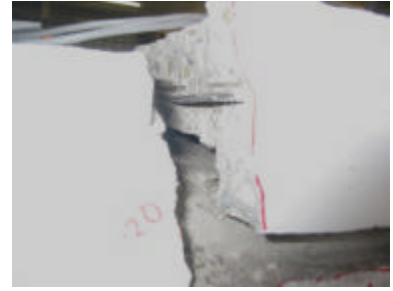
(c) Close up showing the topping separation

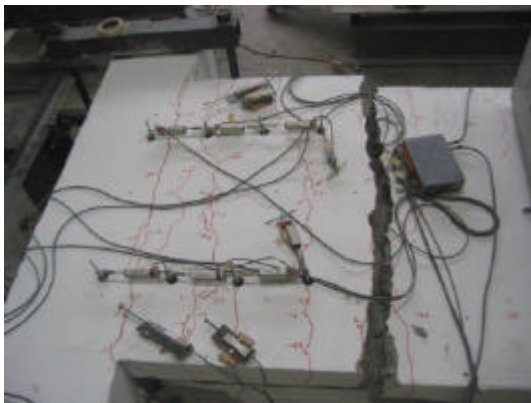
(a) Plan of the HC4 at the end of test.

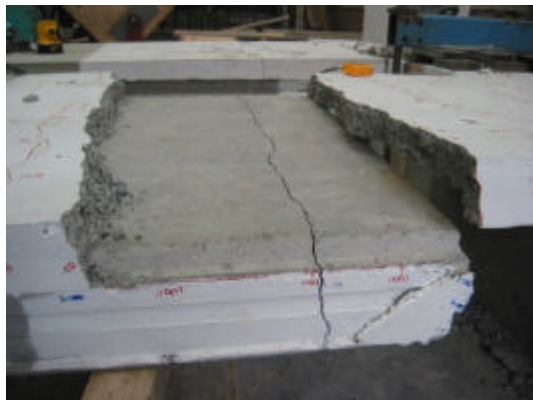
(a) Crack in the end of the hollowcore unit

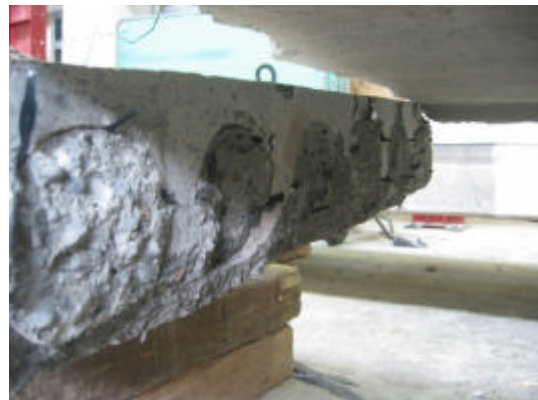
(b) Damaged end of hollowcore unit

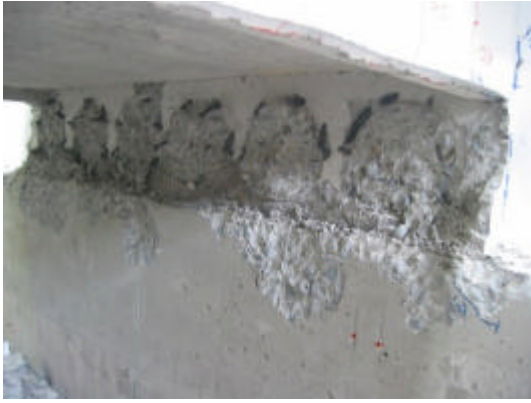
(c) Damaged seat.

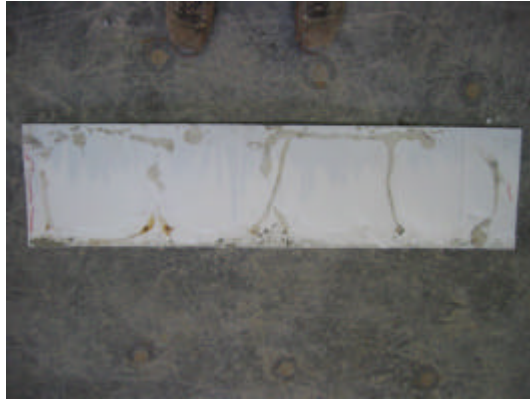
Figure 7-1. Grout seepage into the compressible backing board.
