# Strengthening of Grinding Building Slab at Batu Hijau Copper-Gold Mine

Nusa Tenggara Barat, Indonesia

Submitted by Vector Corrosion Technologies

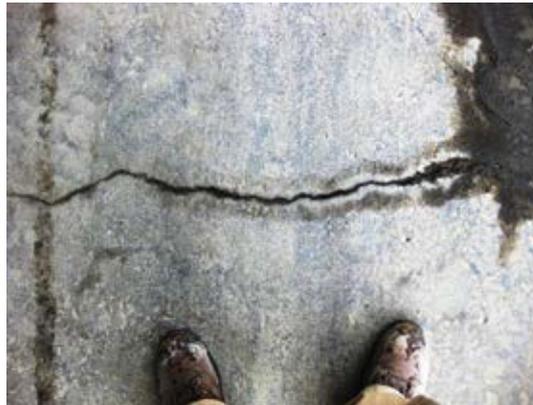
The condition of the 14-year-old slab clearly showed signs of a lack of tensile reinforcement, whereby large structural cracks could be seen over the top of many of the steel support beams. However, prior to designing the repair, a field investigation was completed to confirm the existing condition of the slab.

Several cores were taken in cracked areas and revealed that most of the cracks extended the full depth of the concrete slab.

The strength reduction was confirmed through a structural analysis comparing the factored loads felt by the slab to its factored strength. The two main problems were that there was insufficient positive moment reinforcement provided, and there was no negative moment reinforcement called for in the design.

*Typical negative moment crack over beams*

The proposed repair procedure would be to epoxy-inject the cracks and upgrade the slab using advanced composites. Because the design live load in this case is significantly more than the dead load, it was possible to remove all live load and provide negative-moment carbon fiber-reinforced polymer (CFRP) reinforcing strips in the top of the slab. By removing all except the dead load and waiting for proper bonding time, the newly installed CFRP repair is able to contribute to the slab's ability to carry additional live loads. The intent of the repair was to shift the bending moment diagram from that of a series of adjacent simple spans to one continuous span, carrying both positive and negative moment and by doing so increase the live load capacity to conform to the intended design live load.

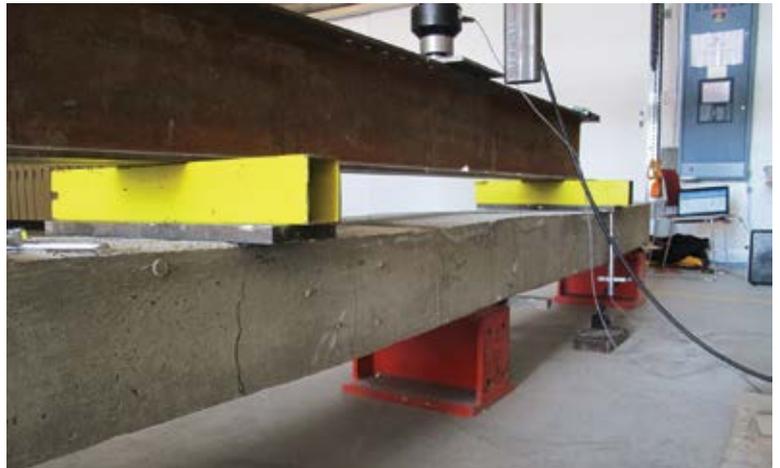
*Slab modeled after existing condition*

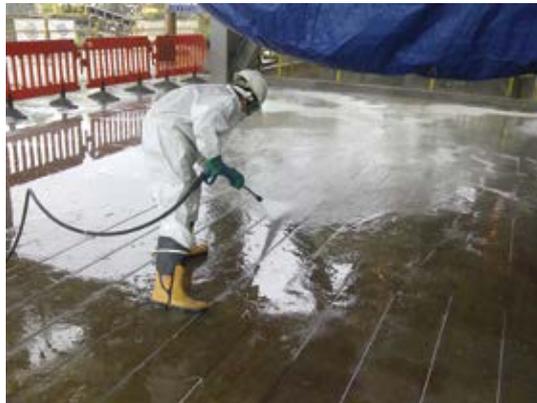
Water blasting CFRP slots

- Blast slots with high-pressure water and degreaser solution;
- Vacuum standing water and blow the slots dry with compressed air;
- Wipe clean the CFRP strips with acetone;
- Place the CFRP strips in the slots using spacers as required to ensure the correct position;
- Flood the slots using low-viscosity resin mixed by an epoxy injection pump; and
- After the bonding epoxy is cured, install a 0.12 x 1.97 in. (3 x 50 mm) wide epoxy seal on the top surface of the slot to prevent process water seeping in and disturbing the bond over time.

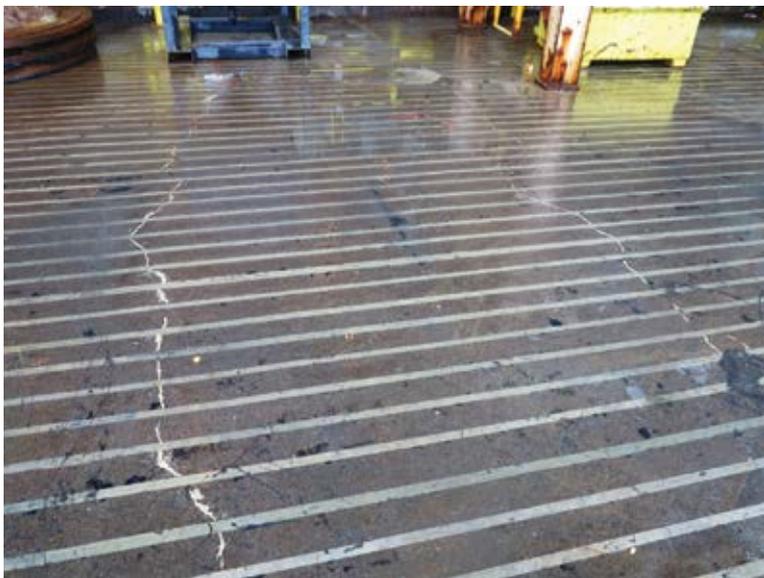
Slab strengthening and repairs completed

After the slab was repaired and strengthened, it was successfully placed in service. A total of 19,685 ft (6000 m) of CRFP was installed, in conjunction with approximately 9843 ft (300 m) of crack injection. Since then, the slab has been visually inspected several times and no additional cracking or distress has been noted.
