Hydrogen Embrittlement In Titanium Steam Surface Condenser Tubing *Truths, Myths & Misnomers*

Dennis J. Schumerth
Titanium Tubular Consultants
4811 E. La Palma Ave
Anaheim, CA 92886 USA
E-mail schumert@AOL.com
dennisschumerth@Gmail.com

Thomas Demers
System Specialist, NB Power
Point Lepreau Generating Station
122 County Line Road
Maces Bay, New Brunswick Canada E5J1W1
TDemers@nbpower.com

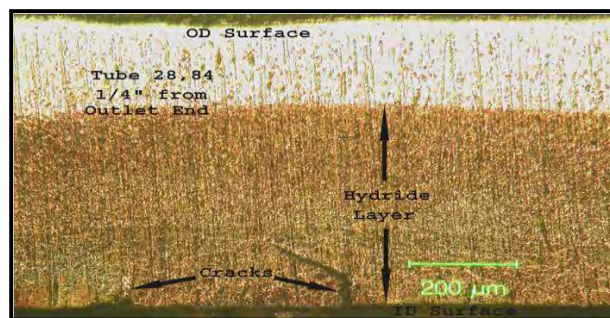
Figure 5
Tube Hydride Layer

At the direction of the utility, an extensive research study was undertaken in 2008 by among others, DNV [7] following reported suspicious calcareous (calcium and magnesium salts) deposits on unprotected tubesheet areas and suspected hydriding of peripheral titanium tube ends. Further examination determined that several of these tubes had hydride formations up to and in some cases, exceeding 80% of the tube wall thickness (Figure 5).

As a cautionary note, do not be confused when eddy current (EC) testing hydrided tubing. Typically, wall loss is not a product of hydriding and EC signals, which resemble wall loss, are actually a change in electrical resistivity in the hydrided layer. Further to this point, the EPRI Charlotte NDE Group [9] will be examining hydrided tube samples from the Pt. Lepreau station to determine if there is a meaningful method of determining hydriding in titanium tubing. Results of this investigation should be available in 2013 or 2014.

Localized tube cracking was also observed. It was suggested that excessive applied cathodic potential could have caused the hydriding. Subsequent computer simulations identified voltages in the range of -1.345 V_{SCE} to -1.36 V_{SCE} were applied to the titanium outlet tubesheet tube ends – the area of highest concentration of wall hydriding.

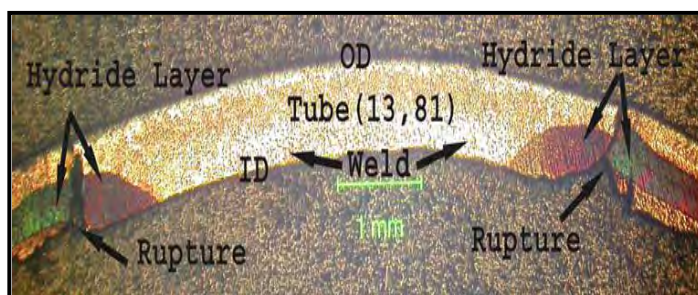
Figure 6
Hydride Layer and Rupture

It is well understood that titanium hydrides generally exhibit very low ductility and are highly susceptible to brittle fracture under the influence of high internal stress. The suspect tubing showed numerous small cracks or fissures in the relatively thick hydride layers. These cracks can act as a notch (stress riser) in the initiation of a tube rupture (Figure 6).

An additional rhetorical sidebar to the investigation is an analysis of the tube weld itself which appears immune to hydrogen absorption (Figure 6) [1]. Hydriding appears to congregate on either side of the weld where ultimately, the rupture occurs.

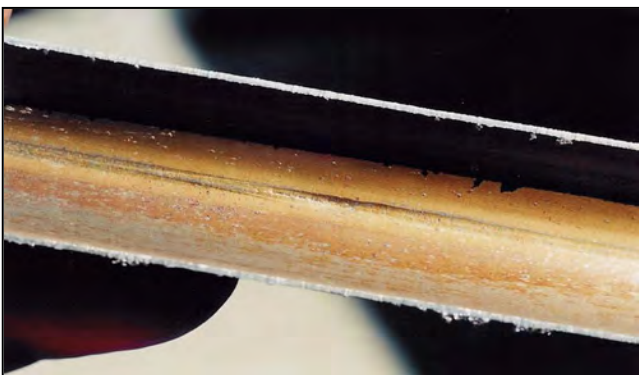
Figure 8
Tube Section Suspect Weld Deformity

Several issues come into play here. The first relates to the suspect tube welds that were discovered during EC testing.

The original tube manufacturer was contacted directly relative to these anomalies and while it was confirmed all tubing passed ASTM-required tests at the time of manufacture (EC and pressure test), an ultrasonic test (UT) was not performed (Figure 8 and Figure 9).

ASTM did not require a UT at the time and indeed, had this test been performed, weld deformities may have been discovered. It is notable however that no leaks were directly attributable to the weld anomalies. Second, the circumferential cracking attributable to hydriding exhibited classic characteristics including high stress concentrations presumably from an over roll conditions during the first retube and an overactive IC system. It would appear that there are similarities between the Kahe and Pt. Lepreau units in terms of a highly stressed environment acting in concert with an overactive IC system. It was further reported that neglect of the IC system and selection and use of an improper anode material compounded the problem.
