CITY OF PHOENIX EMBRACES FIVE YEAR REHABILITATION PROGRAM FOR THE VAL VISTA TRANSMISSION MAIN

*By Brandy A. Kelso, P.E. (City of Phoenix),
Bethany A. Williams, P.E. (Brown and Caldwell),
and Gary Schult (Kiewit Western)*

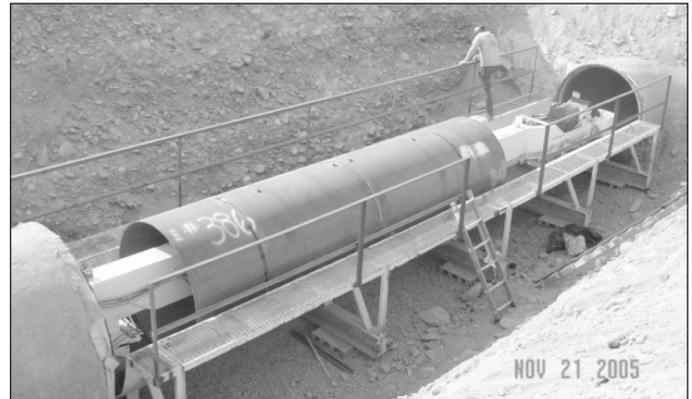
A cradle, as shown in Figure 2, was installed between the PCCP sections at each access pit. Liners were individually lifted into the cradle. A cart was used to lift each pipe section and transport it to the correct position within the host PCCP. Figure 3 shows the cart prior to installation in the cradle. The wheels on each end of the cart straddle the liner section. Lifts installed at intervals along the cart lift the liner section for transport through the pipe.

Figure 2 – Cradle with Collapsed Liner Ready for Installation

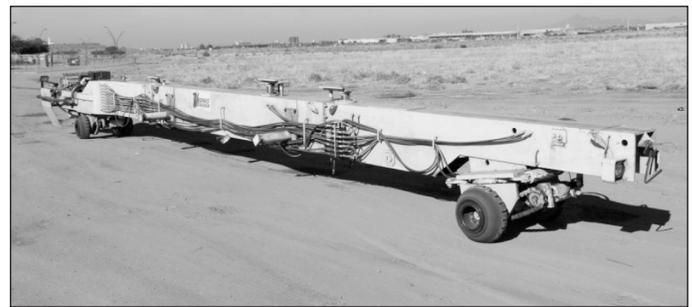
Figure 3 – Pipe Cart

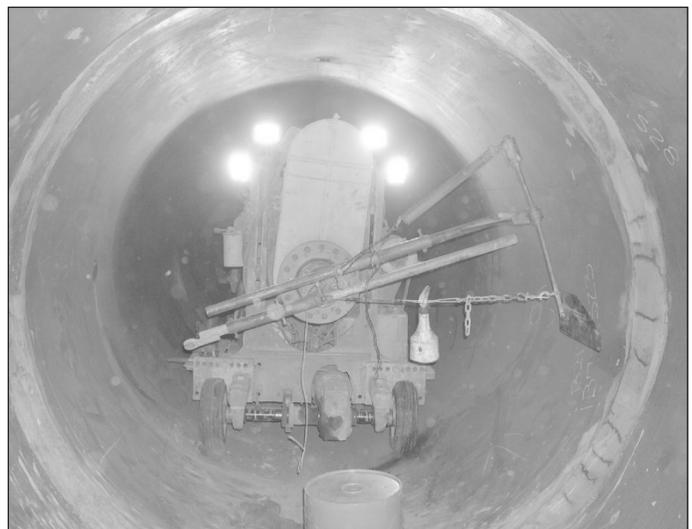
located in the pipe. This machine, as shown in Figure 4, sprayed the mortar on the pipe interior and used double spring-loaded trowels to bring the mortar to a thickness of 0.5 inch.

Figure 4 – Mortar Troweling
