# “When History Needs a Helping Hand from the Present”

## An Overview of the Preservation of a Historic Façade in London

By Graeme Jones and George Ballard

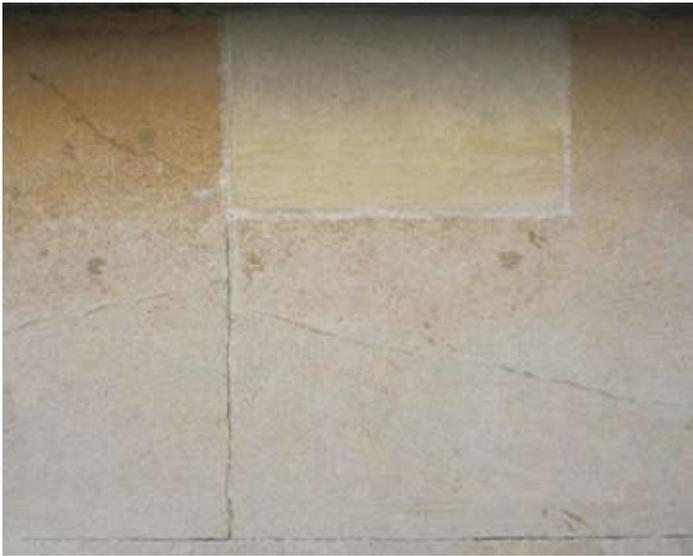
The visual effect of the expansion of the iron component is to cause cracking of the stone with eventual fragmentation of the cover to the iron and loss of stone cover. This will continue to allow the environment to perpetuate the corrosion problem until the iron has corroded completely.

*Fig. 2: Aesthetic deterioration caused by the unsightliness of cracking of the stonework. Note the crack developing from a previous repair where all the iron was not removed*

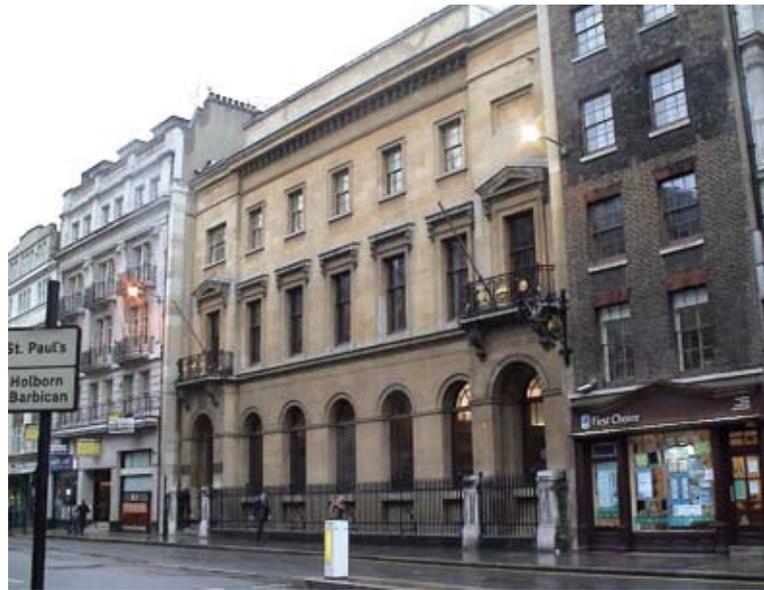
*Fig. 3: Hoare's Bank in 2006 prior to the remediation work commencing*

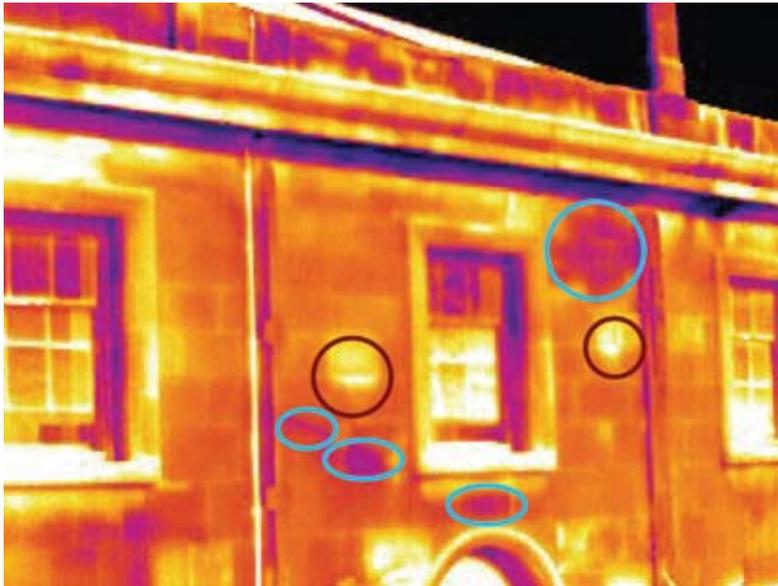
Fig. 5: Thermography output showing areas of moisture retention, circled in blue, and previous spalls and repairs, circled in brown

inextricably linked to the vulnerability pattern of the iron within the stone. Where moisture is retained, it is likely that the ironwork in that location would be prone to corrosion initiating and propagating. It also identified areas of damage where corrosion had already corrupted the stone.

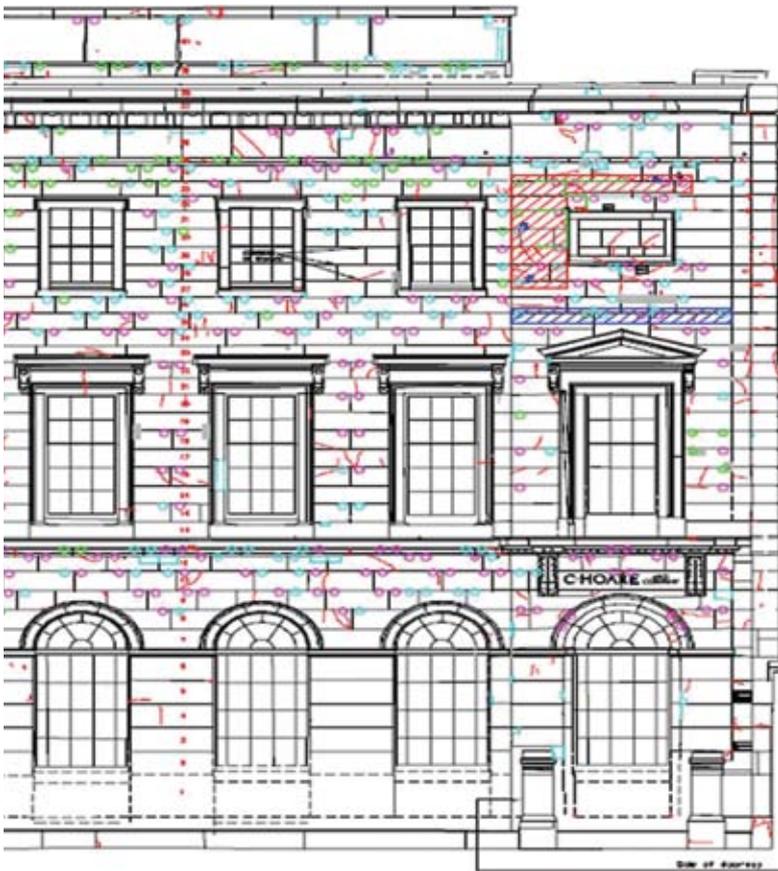
Fig. 6: CAD representation of iron component positions including color-coding of corrosion risk assessment. Note that the red-shaded area was the location chosen for the ICCP preview study. The blue-shaded area was to test surface-applied corrosion inhibitors that did not take place

Magnetic mass probe is an evolution of pulse induction techniques developed by GB Geotechnics Ltd. to work in parallel with radar assessment of stone damage to identify the departure of any cramp relative to an assumed healthy condition and dimension. Iron components were graded as low, medium, and high risk, depending on the combined results of the survey techniques. A CAD drawing was produced that showed the precise location and apparent condition of all detectable iron components.

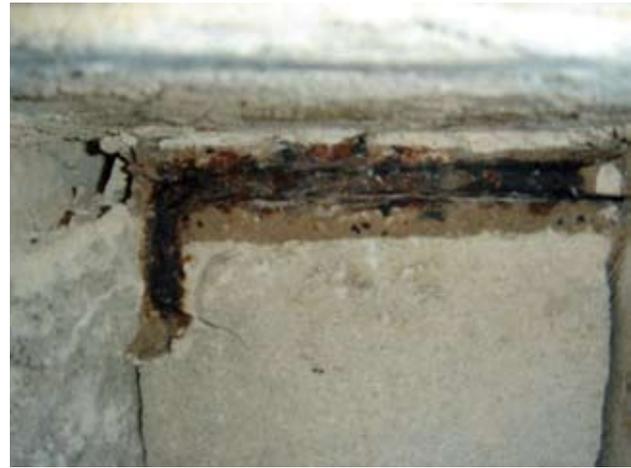
Fig. 7: Iron cramp exposed during preview to show condition; this agreed with a position that was deemed high risk by the condition survey. Note the end of the dog cramp to the left shows the emergence of a crack developing from the tip

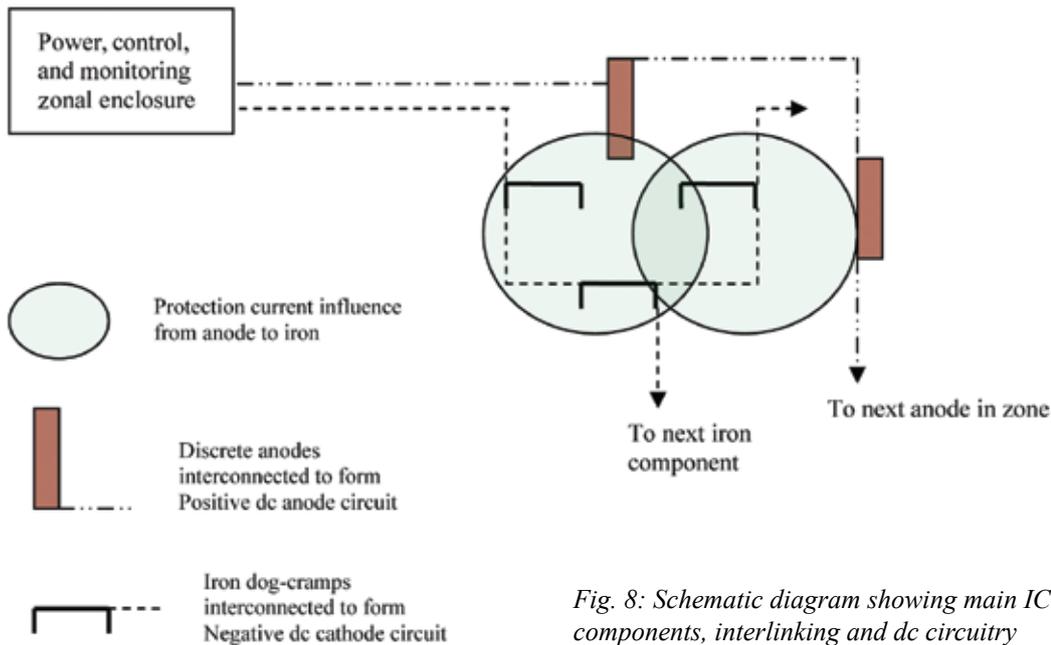
Fig. 8: Schematic diagram showing main ICCP components, interlinking and dc circuitry

The principle is simple: all the iron objects to be protected are connected together and held at potential at which they are cathodic to a distributed anodic zone by passing a current between the two. The current supplied is remotely controlled from a network management system.

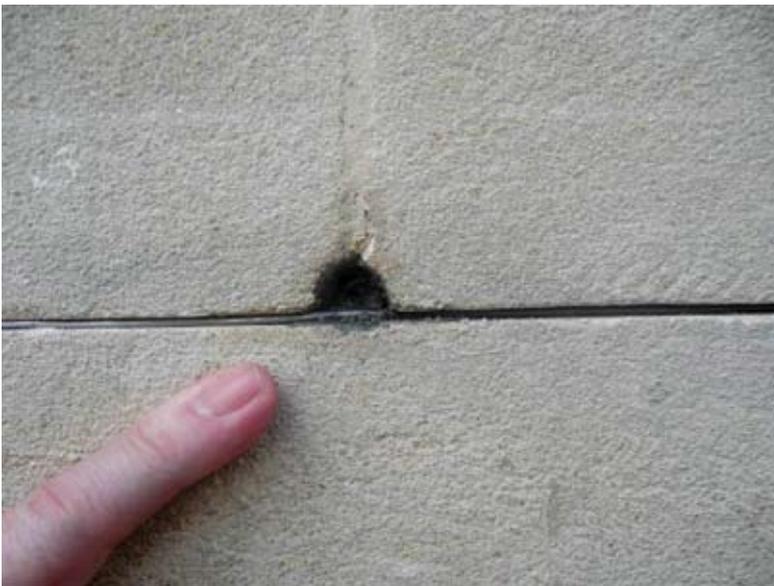
*Fig. 9: Anode drilled and grouted into position with interconnection wire ready for retucking*

A discrete anode was chosen that had the physical dimensions to minimally disturb the bed joints (these were only 0.04 in. [1 mm] in width but a 0.31 in. [8 mm] anode was viewed as acceptable). The interconnecting wire was 0.05 in. (1.2 mm) in diameter and therefore the amount of over-widening of the joints was constrained to very small discrete hole positions and only slight along the length of the bed joints.

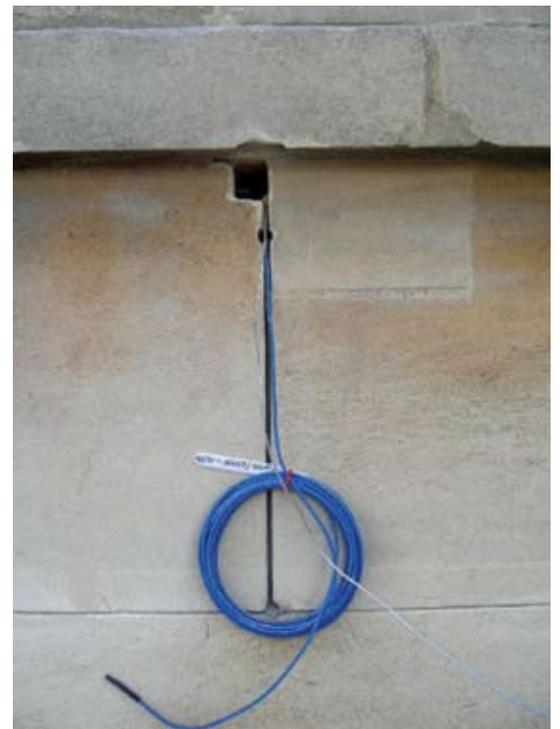
*Fig. 10: Position showing discrete breakout for drill and tap steel connections and reference electrode monitoring installation*

The cathode interconnections were made using 0.05 in. (1.2 mm) steel wire and formed in joints on the opposite side (where possible) to the anode wire. Where crossover was a problem, the titanium anode wire was sleeved with a low diameter tubing to insulate the two wires.
