BUILDING ENVELOPE FAILURE CASE STUDIES IN HIGH-RISE CONSTRUCTION

Pierre-Michel Busque, P.Eng.¹

ABSTRACT

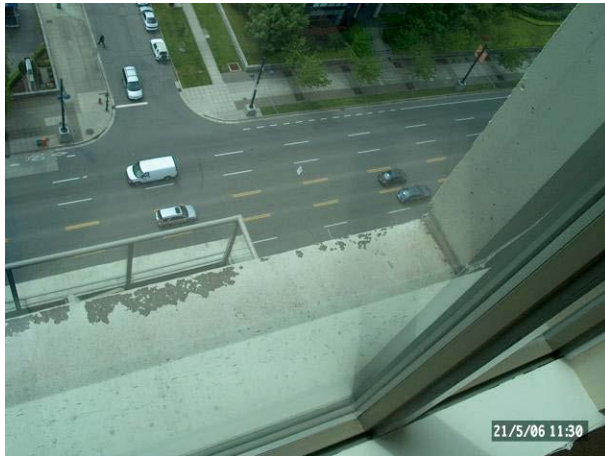
PHOTOGRAPH 2: View of the outward projection of a floor slab from the interior of the building. Note the spalling paint on the surface of the slab.

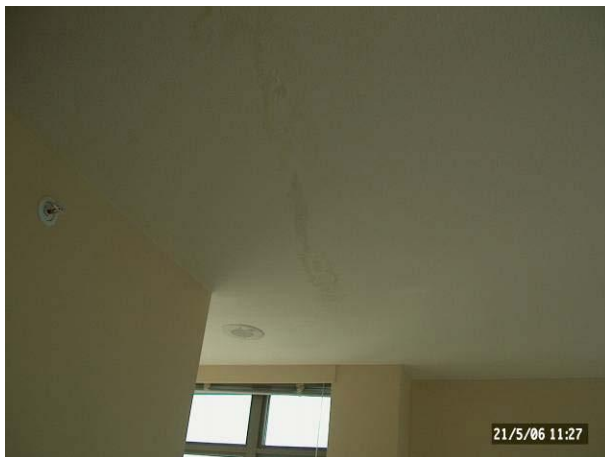
The Eyebrows of the one building reviewed by the author were sloped approximately 2% towards the exterior and coated with acrylic paint. A leak had developed at the ceiling of a unit approximately 10 feet inwards from the exterior wall. Multiple tests were performed on the building and no evidence of leakage was observed. Finally, water was directed over the eyebrow of the floor above where the leak was reported. A spray of water was allowed to continue for a period of approximately two hours. After two hours, a steady drip of water was noticed at the bedroom ceiling where the leak had been reported.

PHOTOGRAPH 4: The ellipse denotes a crack in the ceiling where water was dripping.

The author was surprised to observe that water was able to travel a distance of approximately 10 feet through a slab to finally escape at a crack in the concrete.

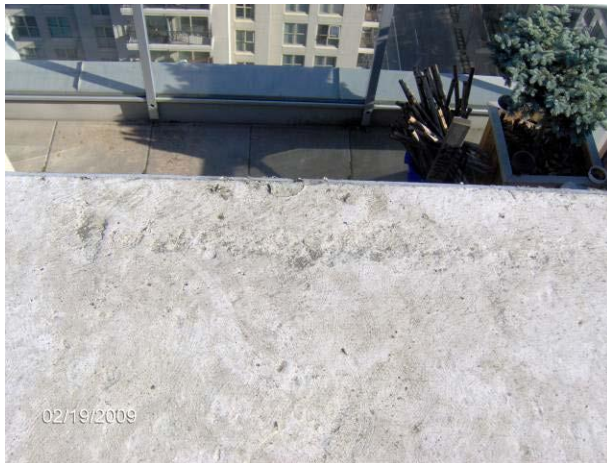
In a recently constructed building, silicone elastomeric paint had been utilized to waterproof the eyebrow projection. After approximately 3 years, the silicone paint was frayed and was delaminating from the concrete substrate. In the author's opinion, silicone paint is unlikely to provide a durable waterproofing membrane in (near) horizontal applications. This is due to the fact that unreinforced coatings are unlikely to effectively span cracks that develop during the service life of the concrete, even if the coating has a high elongation capacity. Where cracks develop in the concrete after the coating has been applied to the Eyebrow, the coatings will be stretched beyond its ability to bridge the crack. Unfortunately, Eyebrows are nearly never waterproofed with a waterproofing membrane and covered with flashings because of architectural considerations.

PHOTOGRAPH 5: The ellipse denotes an area where the silicone paint has delaminated from the concrete slab.

The Standard of Care required of a reasonable and prudent building envelope designer is to design a building envelope assembly that is tolerant to incidental moisture (and not leak). Based on several buildings, it is the opinion of the author, that a waterproofing membrane should be utilized on horizontal and near horizontal building surfaces. This said, it is also the experience of the Author that it is not always possible to convince a Developer that the extra cost involved in providing a waterproofing membrane in this location is worthwhile.

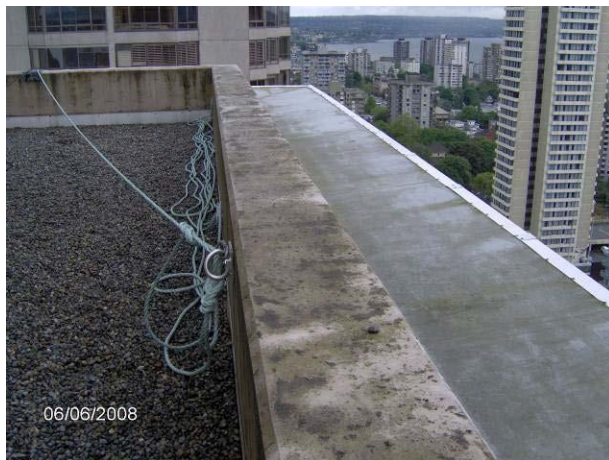
It is a preferred detail of the architectural community to design concrete walls that extend above the surface of the roof. These walls are referred to as parapet walls. Frequently, architects will require that the top of the concrete walls remain unprotected from the elements in order to create the aesthetic effect that they desire. This was an architectural feature favored by the late architect Arthur Erikson. At times, the resistance to installing a waterproofing membrane on top of a parapet wall can be obstinate. Convincing the architect that concrete cracks and that water can travel into the cracks down the parapet wall height to accumulate beneath the roofing and into the occupied space below is usually not difficult. Convincing the architect that he has to modify the appearance of the building usually is.

PHOTOGRAPH 6: The parapet wall of this building is unprotected by a waterproofing.

The Standard of Care required of a reasonable and prudent professional is to minimize the likelihood of building leakage. Leaving the top of a concrete parapet wall uncapped is not

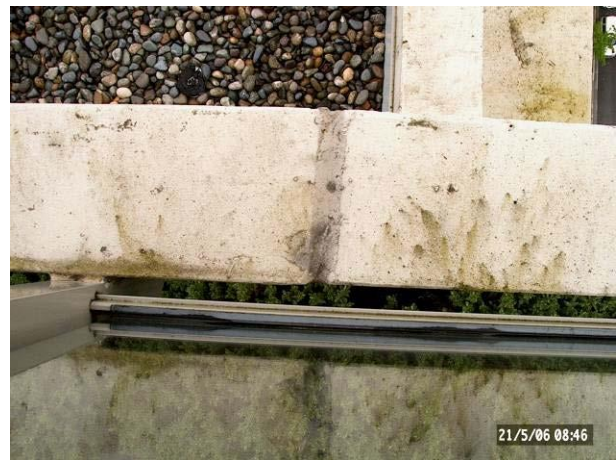
PHOTOGRAPH 7: The top of this parapet wall, on a building located approximately 10 blocks away from the building shown on Photograph 5. In this case, a joint in the parapet wall is waterproofed with sealant, thus increasing the likelihood of leakage.

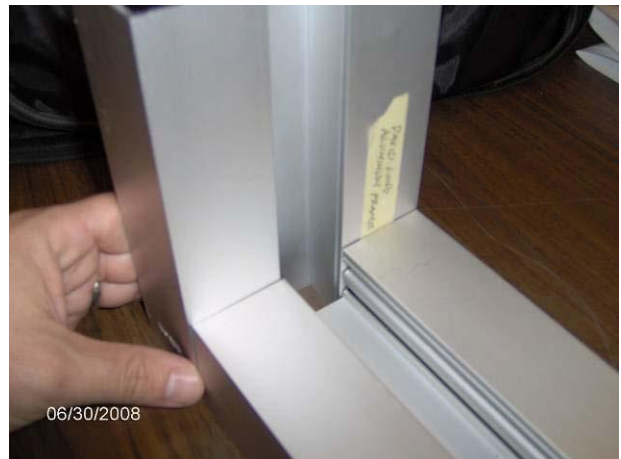
PHOTOGRAPH 9: With the sealed unit remove discontinuity of the glazing pocket at junction of the jamb and the sill shown by the red arrow.

Storefront windows rely on dry gaskets to secure the glass within the extrusion. Dry gaskets are more likely to allow water into the glazing rabbet of the window frame. Due to the discontinuity of the glazing pocket at the junction of the jamb and the sill, the water performance

resistance of this type of glazing system is reliant on a sill membrane or flashing with back and end dams. If the sill flashing is imperfect or missing, leakage may result.

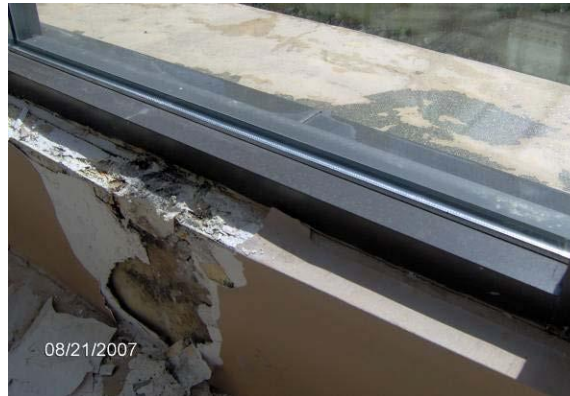
PHOTOGRAPH 10: Shows the consequence of utilizing a storefront window system in a location exposed to wind-driven rain without adequate sub-sill waterproofing. The sub-sill flashing in this photograph had a joint at the point of the leak.

The Standard of Care of a reasonable and prudent building envelope consultant would be to demonstrate that the storefront glazing system could provide comparable performance to that of another glazing system. It may be possible to do so, if the installation details are designed and constructed adequately.

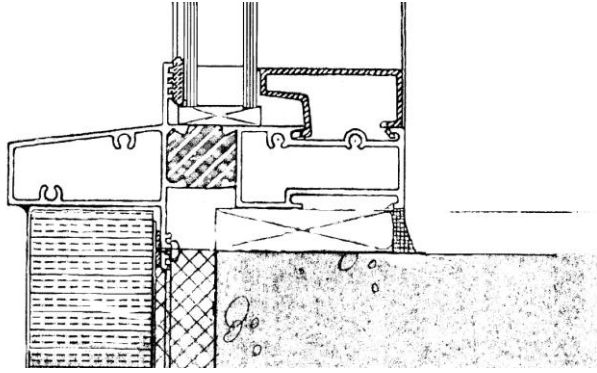
To achieve the desired level of performance, face sealed windows employ wet (or sticky) glazing tapes that join the window frame to the glass. In time, these tapes break down and water may penetrate into the glazing rabbet causing the sealed unit to fail.

FIGURE 2: Face-Sealed Window. In a face-sealed window, the area denoted by the ellipse, is the glazing rabbet. The sealed unit sits on a setting block in the glazing rabbet. In a face-sealed window, this area is not drained to the exterior. Water penetration the exterior wet gasket will penetrate to the interior as shown by the blue arrows.

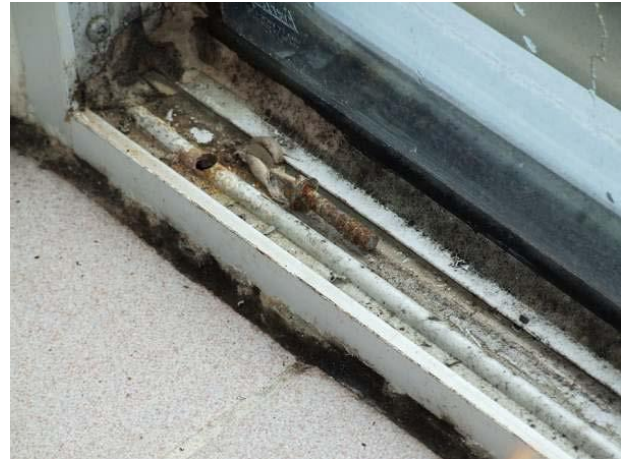
PHOTOGRAPH 11: The window shown on Figure 2 was utilized on a building and leaked. The windows were converted to a rainscreen water management approach by drilling weep holes through the extrusion and installing a fillet bead of sealant (heel bead) at the location marked by the red arrow.

When face-sealed windows leak, the fasteners at the sill may be exposed to water. These fasteners may not be resistant to corrosion because they were designed to be in a “dry” section of the building envelope. The head of the fasteners shown in Photograph 10 was not corroded. Yet this fastener’s shaft was so corroded that it could easily be broken with little torque. This window system was installed on a 30 floor tower above a busy sidewalk in a downtown location.

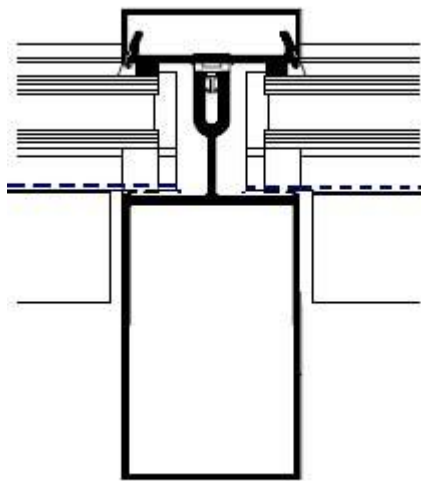
FIGURE 3: Raised Leg, no Overlap Skylight

Skylights traditionally relied on a perfectly sealed exterior face in order to control water penetration. Over time, the design of skylights has evolved. An internal drainage system was incorporated to deal with moisture that could penetrate beyond the exterior seals of the skylight. Such a system is represented in Figure 3. The raised leg skylight features an internal drainage gutter at the level of the

rafters and of the purlins. The dashed blue line represents the drainage path from the purlins of the skylight into the rafters. Unfortunately, because the drainage gutters of the purlin and of the rafter are at the same elevation, sealants and glazing tapes must be relied upon in order to ensure water tightness.

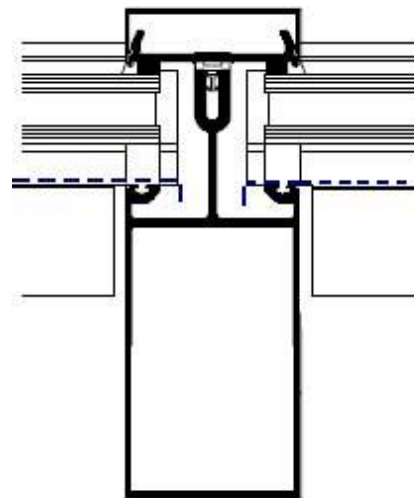
FIGURE 4: Raised Leg, Overlap Skylight

A vast improvement to the design of the skylight in Figure 4 is to raise the level of the bottom of the drainage gutter of the purlin. Thus the joint between the purlin and the rafter is not exposed to water for long periods of time.

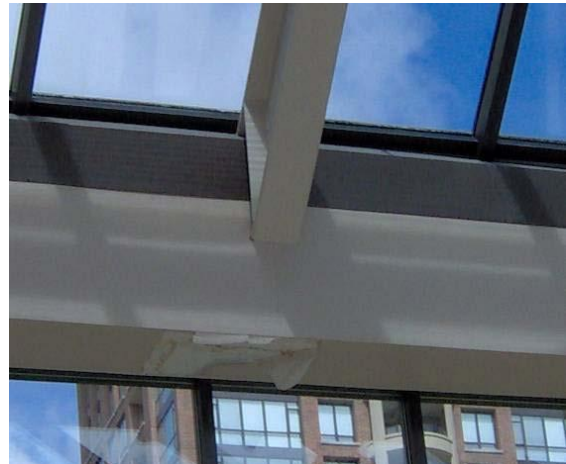
PHOTOGRAPH 13: Damage to the ceiling caused by the leaking of a very large skylight without the raised leg overlapped drainage gutters.

Building designer and Developers should select building components that are likely to perform with reasonable maintenance, for the expected service life of the building component. As skylights are also roofs of sort, it could be argued that the expected service life of a skylight should not be shorter than that of a roof. The skylight shown on Photograph 13 leaked profusely as soon as the sealants and glazing tapes employed failed, after approximately 5 years of service.
