**2020 ISSA Preservation Performance Award  
Nomination – Cape Seal Benalla Victoria**

## Project Overview;

## Treatment undertaken;

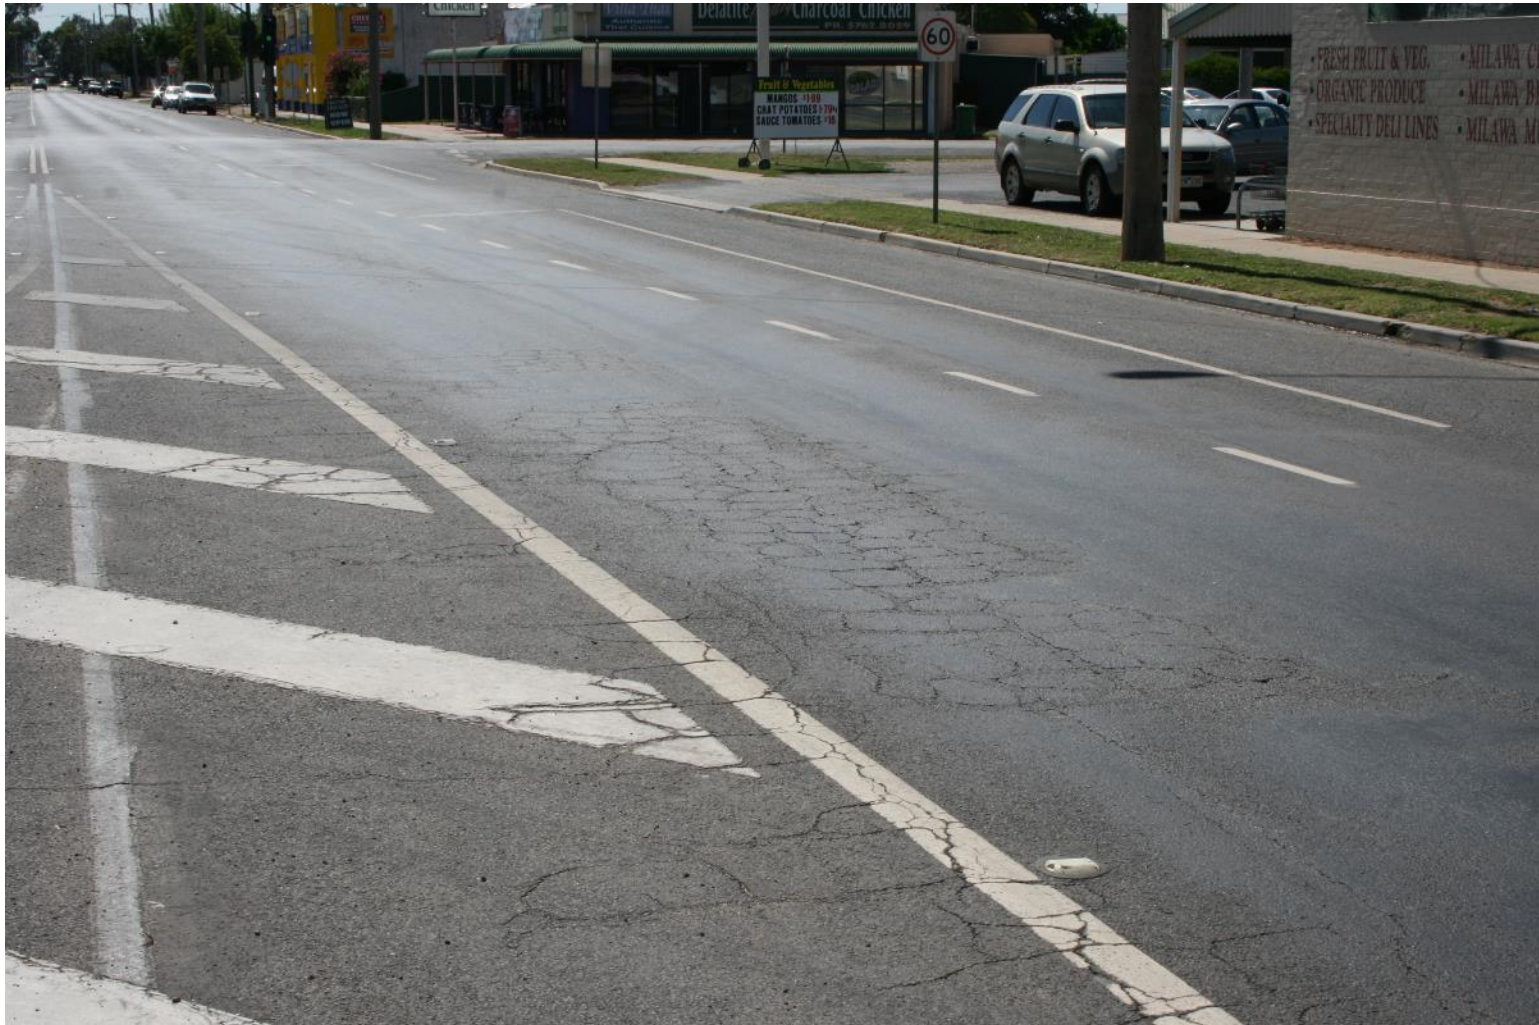
Pre-existing condition – January 2014

- This site exhibited extensive surface cracking but with the pavement is still in good to high condition for its shape and drainage. The site had displayed surface cracking defects for many years but recently the cracking had become more prevalent.

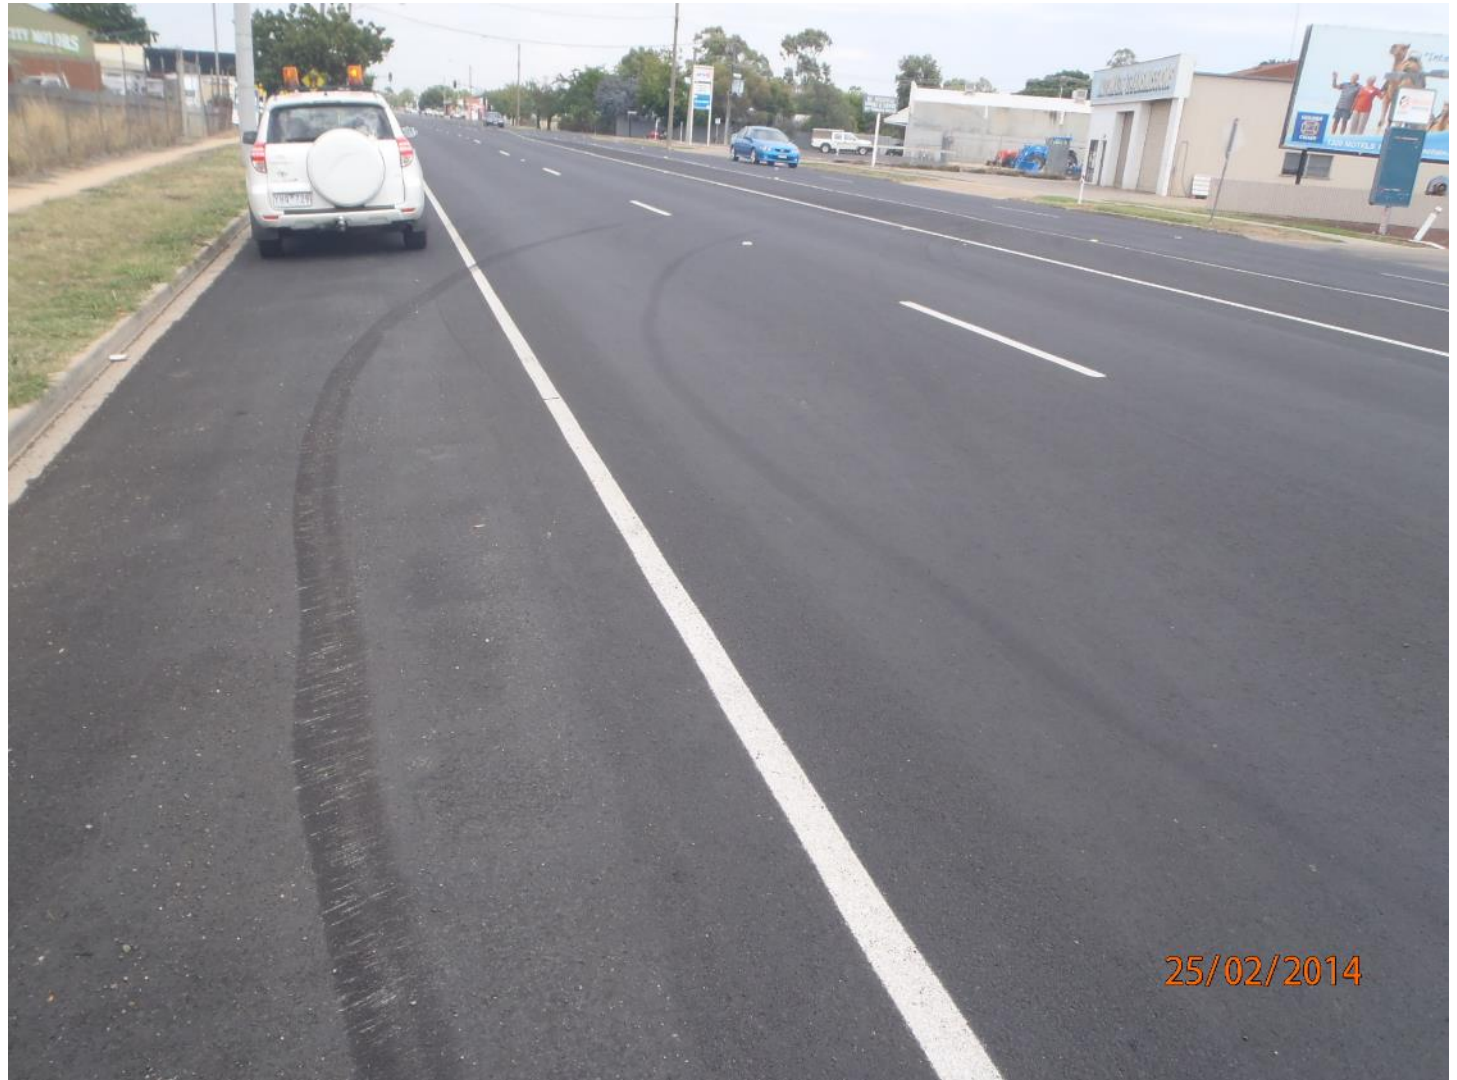
### Completed Surface 2014

*Works included replacement of all pavement line markings and pavement markers plus post surfacing sweeping. This photograph taken three weeks post completion of surfacing works showing resistance achieved to high toque actions on the new surfacing.*

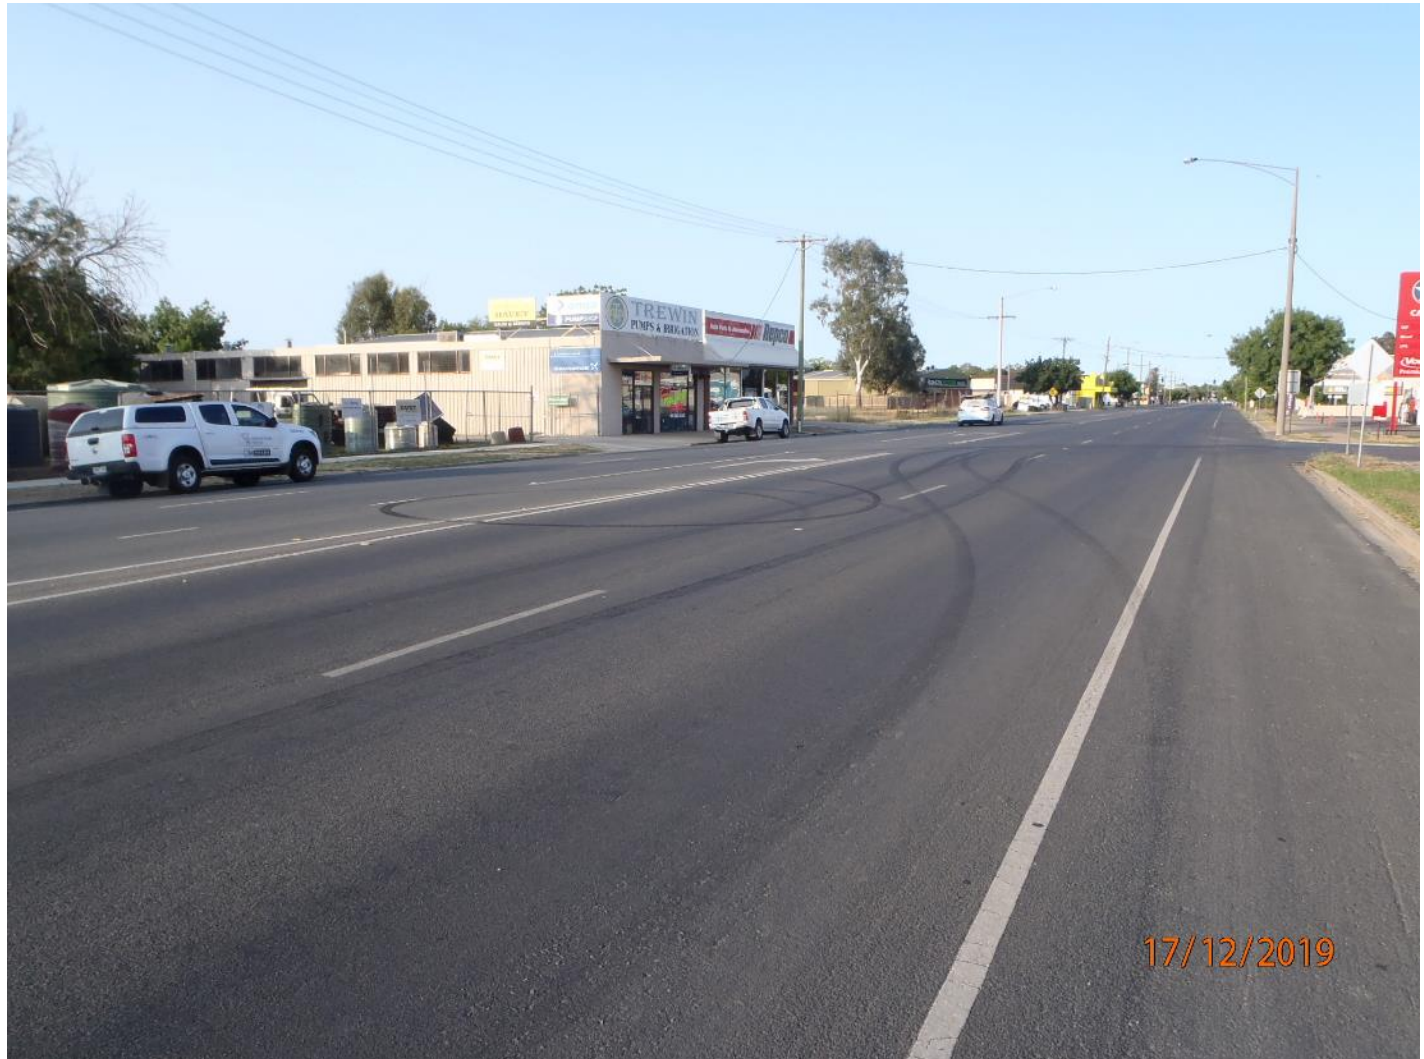
## Performance Review December 2019

*Aesthetic review of the site undertaken in Dec 2019 shows the pavement in good condition.*

*Some areas exhibit minor reflective cracking and there is some binder flushing, however turning and screwing action of traffic have been resisted and the surface texture has been maintained. The site has been scheduled for a further flexible spray seal treatment this season to continue to maintain waterproofing of the pavement.*
