## **PUKETE BRIDGE FOUR LANING – MODIFICATIONS FOR CONSTRUCTION OF PEDESTRIAN/CYCLEWAY CLIP-ON STRUCTURE**

M J FORD

Downer NZ

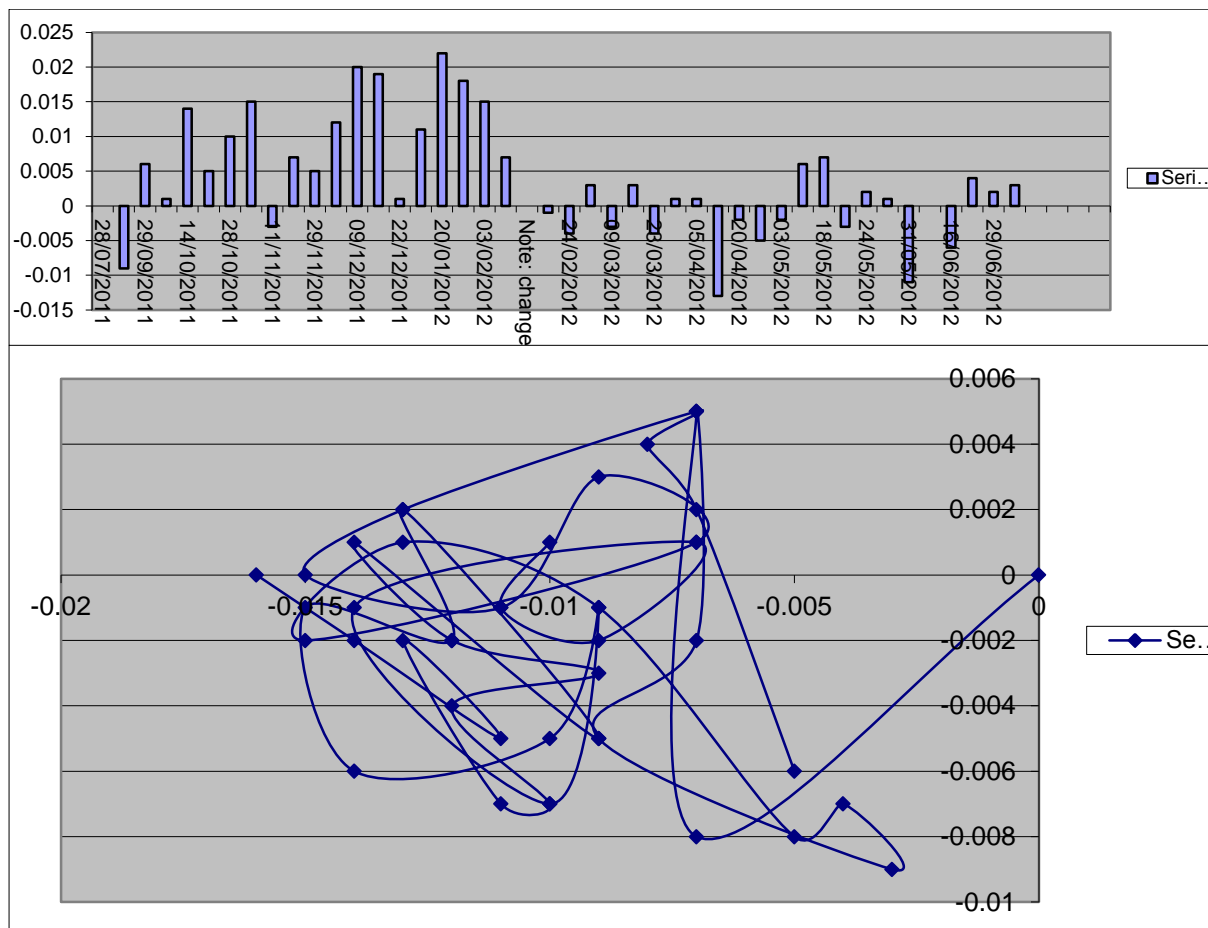
Monitoring points were established at 10 metre intervals along each side of the bridge to provide early warnings of potential issues. At each monitoring point, measurements recorded vertical deflections and lateral movements on a weekly basis. This increased to daily recordings during critical work activities such as hanging scaffold erection, frame connection drilling, frame erection, central kerb removal, deck milling and asphalt overlay. The recordings also provided observation of any rotational (twist) movements imposed on the bridge. Temperature readings of both ambient and structural mass were also recorded. An example of these recordings can be seen below in Figure 1.

Figure 1. Vertical and horizontal monitoring records for a typical location

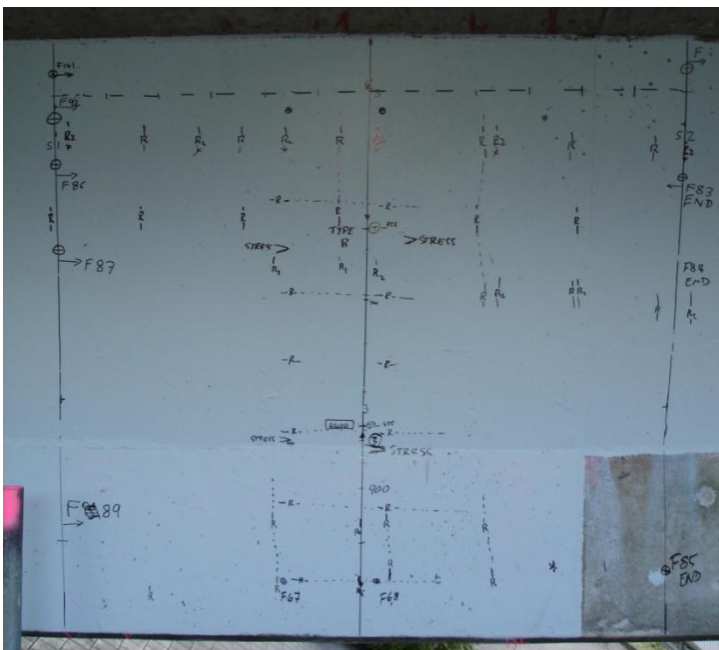
The outer scan results were plotted directly on the concrete surface along with the frame centreline positions and theoretical draped cable locations. Please see Figure 5 below for an example of this.

Figure 5. Typical external scan mark-up at frame position

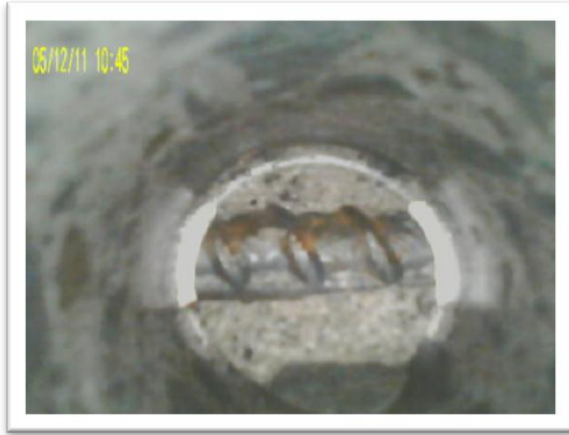
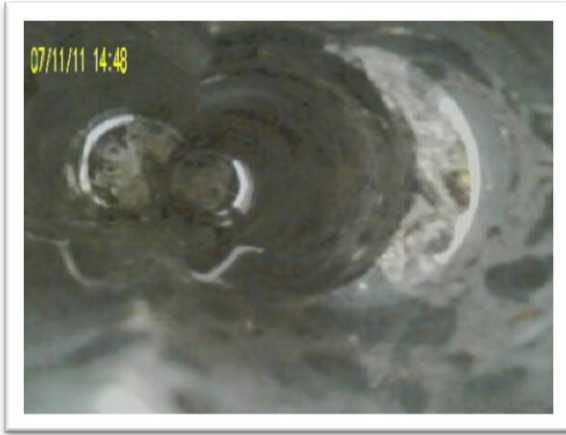
Figures 7 and 8. Borescope Images showing reinforcing bar encounters

Where offset constraints could not be overcome, permission was requested to cut (partially or fully) intersected bars. Figure 8 above is a typical example of where permission was requested to cut intersected bars. The outcome was that very few vertical bars were severed, and a number of horizontal bars encountered were cut where they had not been included in the MWH back-analysis calculations. This was due to not being indicated on the as-built drawings.

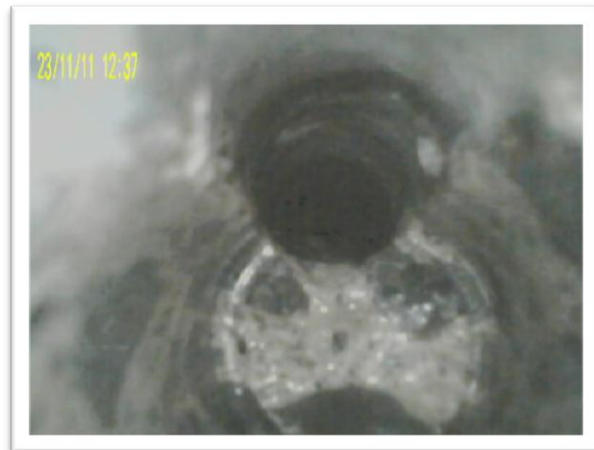
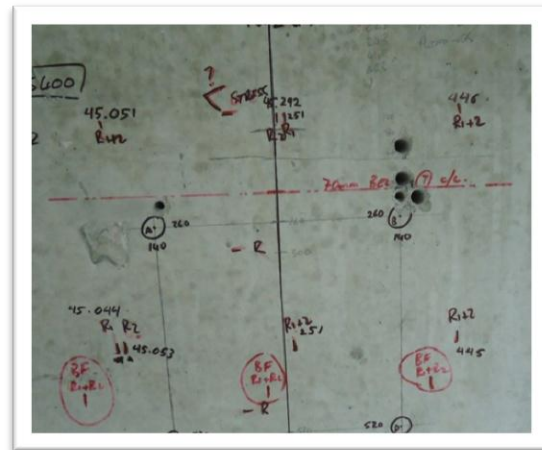
Awareness levels were at their highest when drilling in close proximity to the tendons, where zero tolerance of any form of damage existed. A methodology of percussion drilling 12mm diameter pilot holes to confirm tendon duct locations and/or clearance was employed. Yet even with clearances confirmed, the core drilling was executed in 10mm drill depth increments while in the zone of the stressing duct. Each 10mm increment involved core material removal and borescope camera inspections, until the core drill had successfully passed by the tendon duct zone. Figures 9 and 10 below show images from the borescope camera and percussion drilling pilot holes at stressing strand duct locations.

Figures 9 and 10. Pilot hole drilling at stressing strand duct locations

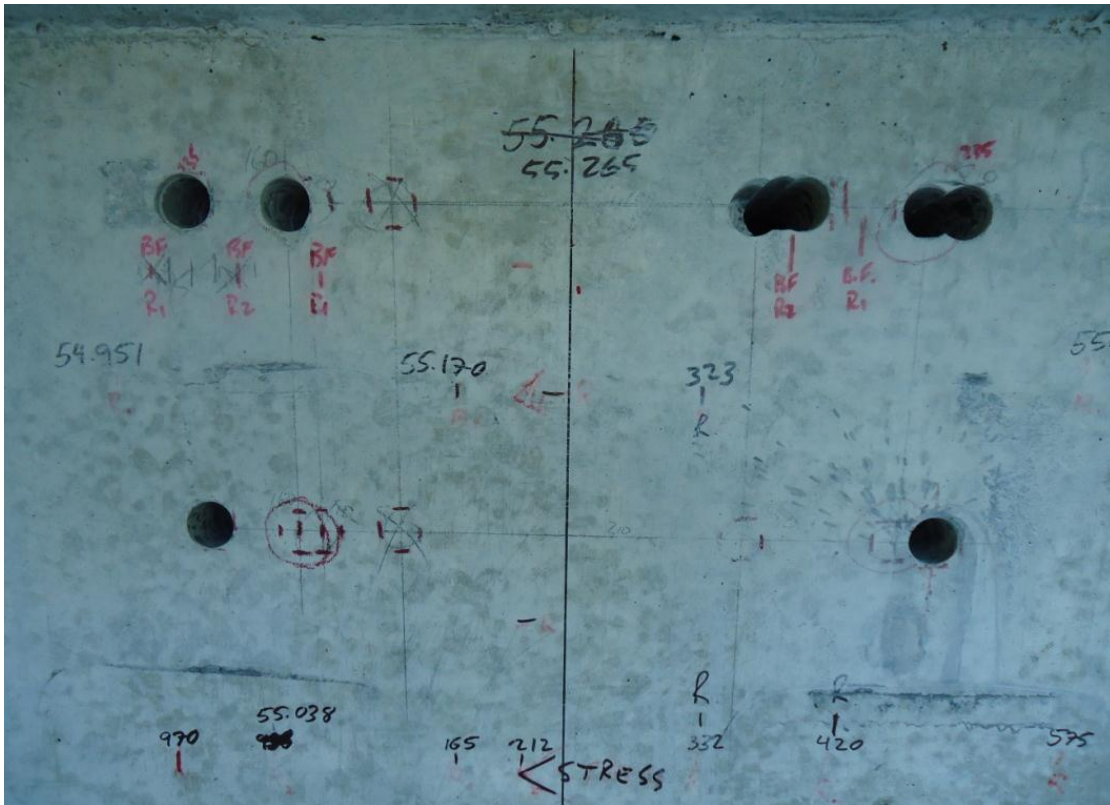
In a perfect world, all of the reinforcing would be located at regular intervals and in locations as per the construction plans. However, as expected, anomalies often occurred due to the non-verticality and/or non-planar orientation of stirrups which occasionally tested our faith in the scan data. Figure 11 below demonstrates this.

Figure 11. Four successful holes – from ten attempts
