# Case Study 9

T. Bob Davis, DMD

**CASE REPORT – INSTALLMENT #9: ANTERIORS**

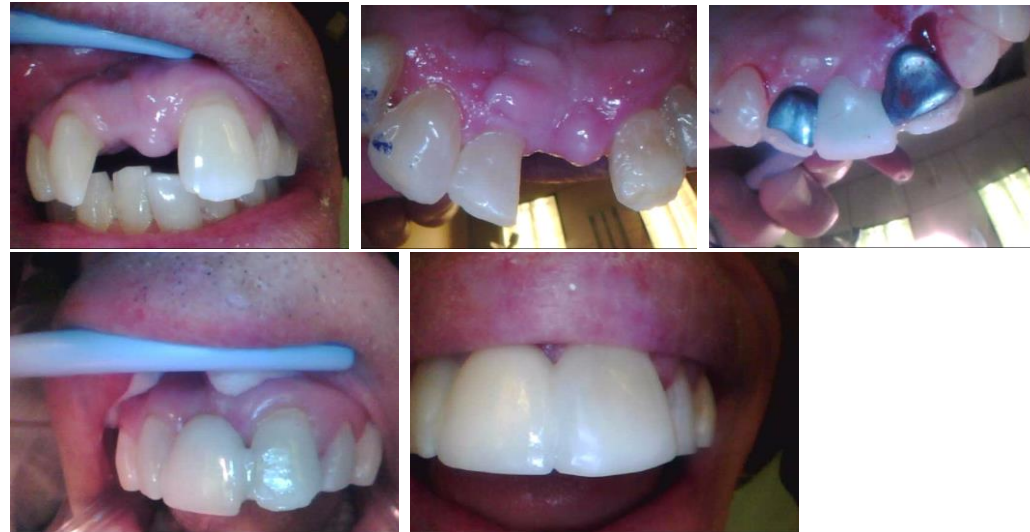
**Glen G.**

This 67 year old male had worn a flipper partial for all his adult life. It broke finally and a MB was fabricated as a standard design between #7 and 9, which had been chipped over the years. Composite buildup was used to match the finished look of the porcelain #8 pontic. Note the nice grip on the lingual of #7. At the same time a MB replacing missing tooth # 30 was placed after years of being empty. See Installment #5.

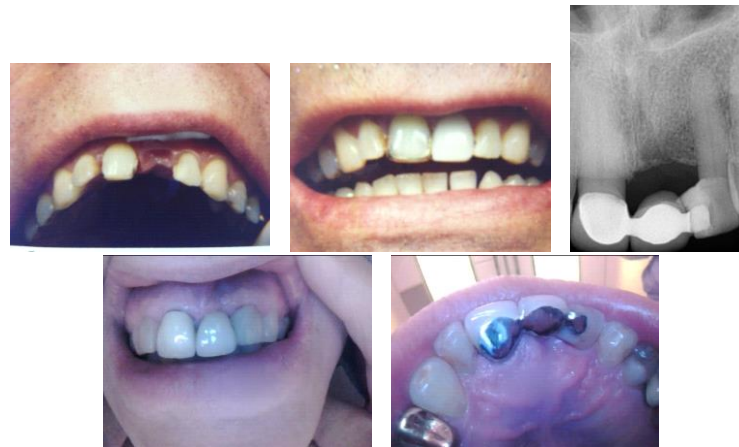
**Calvin J.**

This 56 year old gentleman had a severely broken down old bridge that was replaced by a combination bridge that is now past 24 years in service. It has had three repairs to the wing attachment on #10 with composite in that period of time, but there have been no changes to the cemented crown on #8. This is an excellent non - invasive restorative option which is easily maintained. Note how small an attachment wing I used on the lateral- probably too small, but consider its longevity.

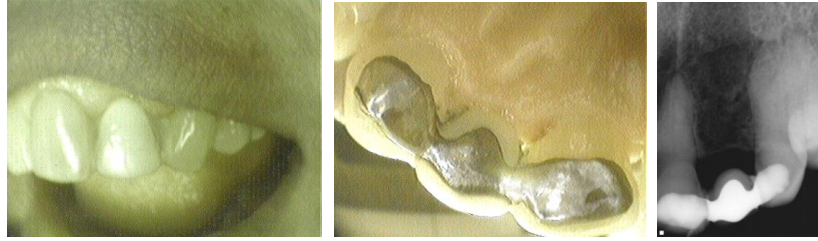
**Erma T.**

88 years old when tooth #10 extracted and replaced by Maryland Bridge. Quick, esthetic, cost effective, and non-invasive replacement.

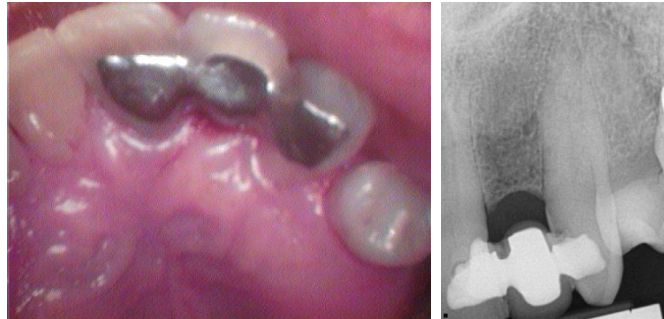
**AI M.**

Metal chain hit him in the mouth while hooking up a car to his truck to tow, just a few months after it was placed. Seven years later he was in his garage and stepped on a metal tool and metal handle hit the bridge and knocked it out again. Each time the bridge was re-etched and rebonded, now having served the patient for over 14 years and running.

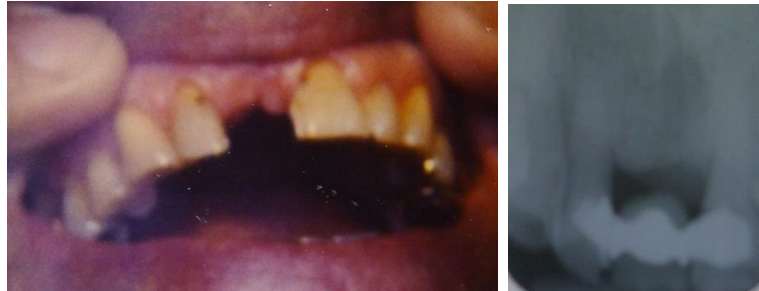
**AJ**

70 year old patient – drilling in concrete and big chunk hit mouth and broke abutment tooth #7 off. He's put stadium seats in many of the stadiums in North America! The MB from #7-9 had served him well for only six years and had to be replaced with a standard bridge from #6-9. The moral to this story is accidents cut short the life of any of our excellent work.

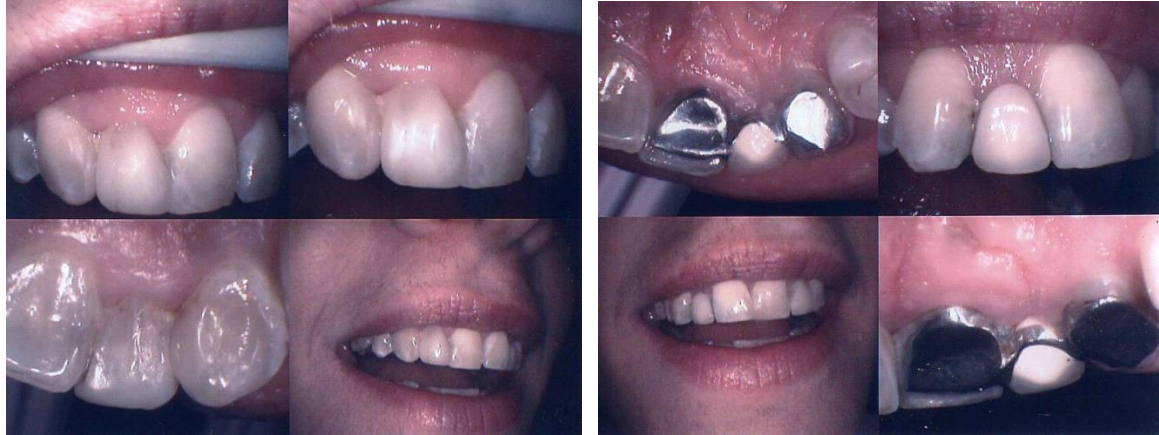
### LeeAnne

Congenitally missing tooth #7 had been temporarily with a single tooth flipper for many years. For her graduation from high school at age 18, her parents chose the Maryland Bridge as a gift. Placed on September 13, 1982, with Comspan resin cement after acid bath electroetch, this bridge is still in service after 32 years with no debond.

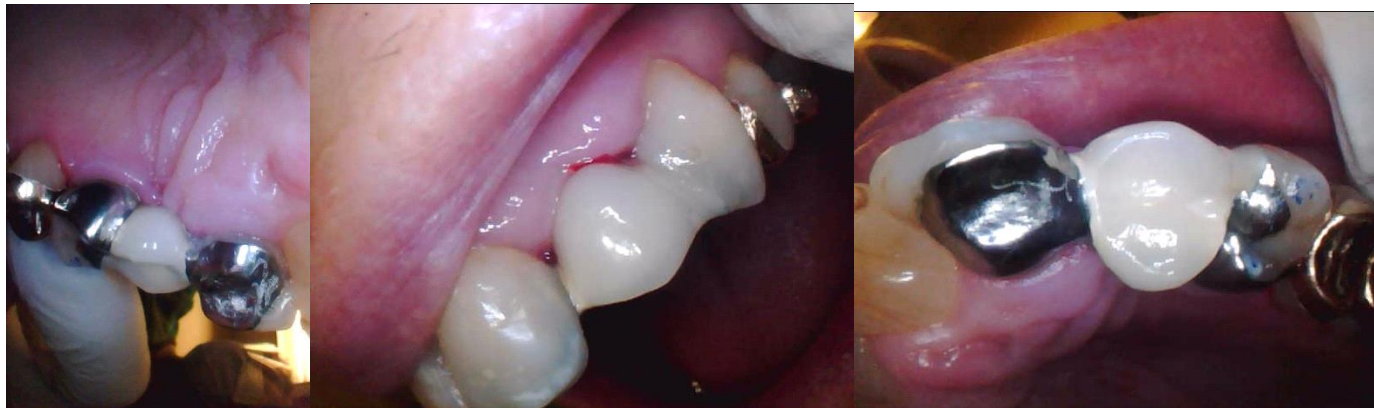
### Jessica H.

This patient had a cuspid, #11, moved into the congenitally missing, #10, lateral's place while young. Gap was actually space for #11 and we had to make it more a bicuspid look. This sort of altered positioning leads to compromise but is a quick fix if patient rejects ortho or desires conservative care. No need to grind down perfectly healthy teeth #11 and #12! Perfect treatment plan for such a situation. It has been 7 years so far with great maintenance.
