AUCKLAND INTERNATIONAL AIRPORT - R3 RUNWAY RECONSTRUCTION

This paper describes the background and design of the R3 runway reconstruction, and the logistics of construction within this tight time frame.

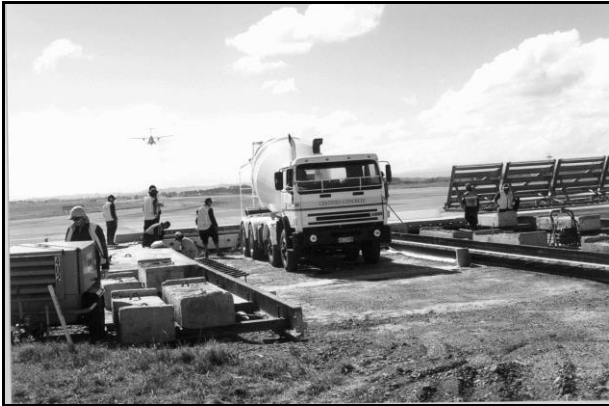
Two teams split into a day and a night shift, prepared and placed concrete 24 hours a day. Concrete was poured directly from the trucks into place and compacted with powerful pneumatic spud vibrators.

It was levelled using a rotating screed and bull floating, and then given a broom finish and a spray-on curing membrane. A spray-on antivap was used whenever conditions suggested there was a risk of plastic shrinkage cracking.

Concrete Construction in Progress

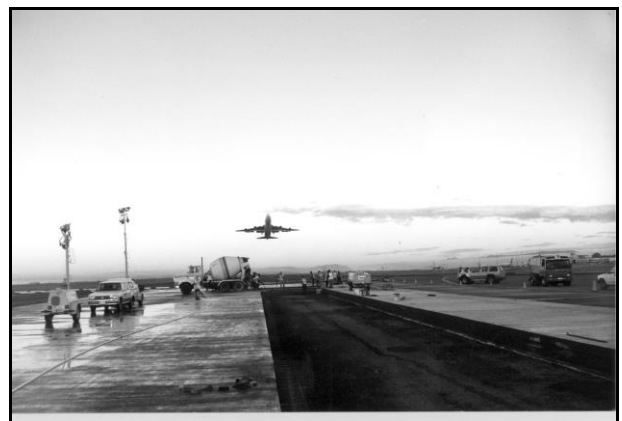
Concrete Construction in Progress

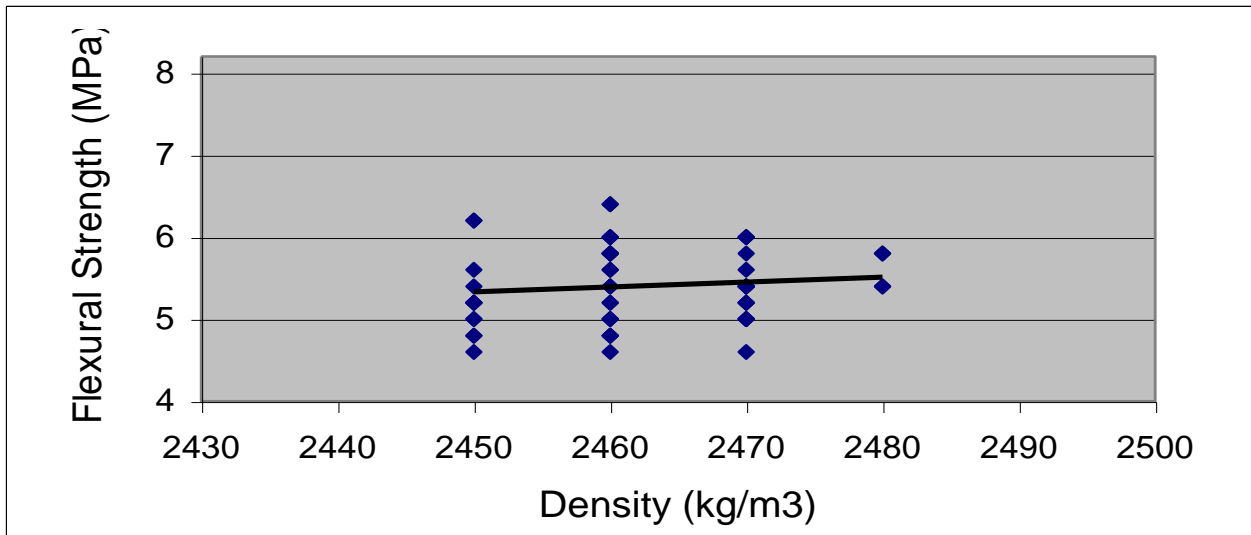
The flexural results are shown graphically in Figures 2 and 3, showing the variation in flexural strengths at 4 and 28 days with density.

Figure 2 – Variation in Flexural Strength at 4 Days with Density

At 4 days the average flexural strength was 5.5 MPa and the average compressive strength was 42 MPa. This rose to an average flexural strength of 6.3MPa a compressive strength of 56 MPa at 28 days.

The average strengths achieved are well in excess of the specifications even at the early four day strength requirement, and of the 132 test measurements only three dropped below the minimum values and in each case repeat tests showed that for the other samples the minimum strengths had been met as well as the average strength required.

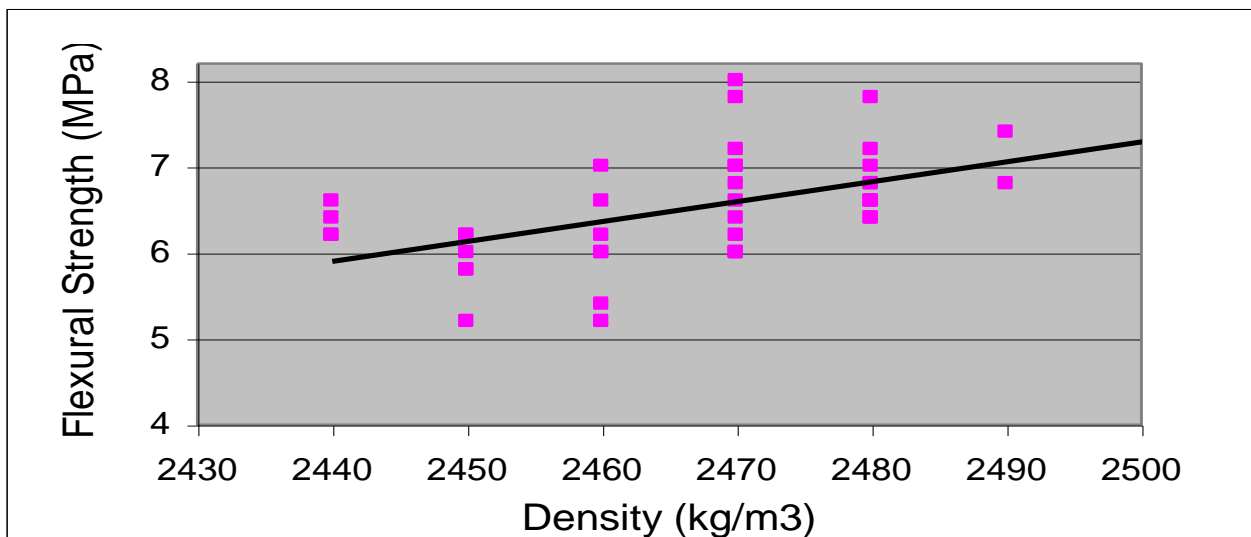
Figure 3 – Variation in Flexural Strength at 28 Days with Density

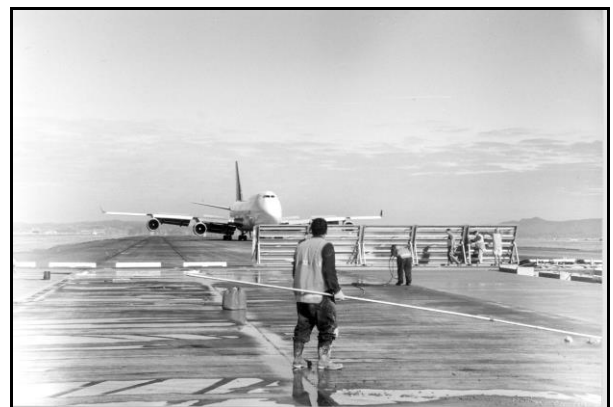
A blast fence was designed and installed on the runway to protect the workers from the effects of jet blast from taxiing aircraft nearby. Part of this blast fence could be hydraulically raised and lowered at a moment's notice to provide the required clearances to aircraft. The use of this blast fence minimised the disruption to the workers from aircraft and hence improved the work programme and flow.

Blast Fence in Operation

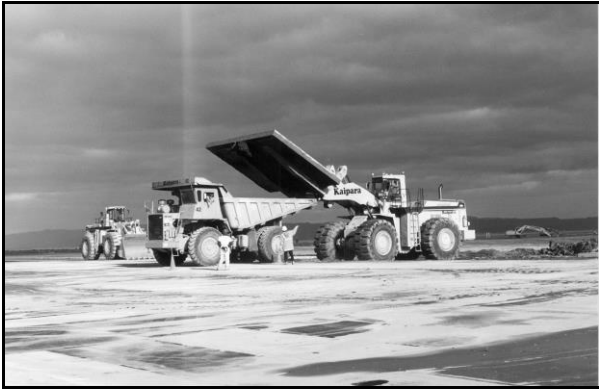
The use of the large front end loaders fitted with forks to remove concrete slabs in one piece to the waiting dump trucks was also an innovation put forward by the earthworks contractor, Kaipara Earthworks Limited. This replaced the previous method of rock breakers and excavators to remove the concrete slabs in smaller pieces and greatly sped up the removal phase of the project.

Front End Loaders Lifting a Slab

The first activity is saw cutting of the existing old runway slabs into small enough pieces for large loaders equipped with forklift arms to lift each slab in one piece and deposit it on a waiting dump truck. The old concrete is stored adjacent to the
