SHAKE TABLE TESTING OF POST-TENSIONED CONCRETE MASONRY WALLS

Gavin D. Wight¹, Jason M. Ingham² and Mervyn J. Kowalsky³

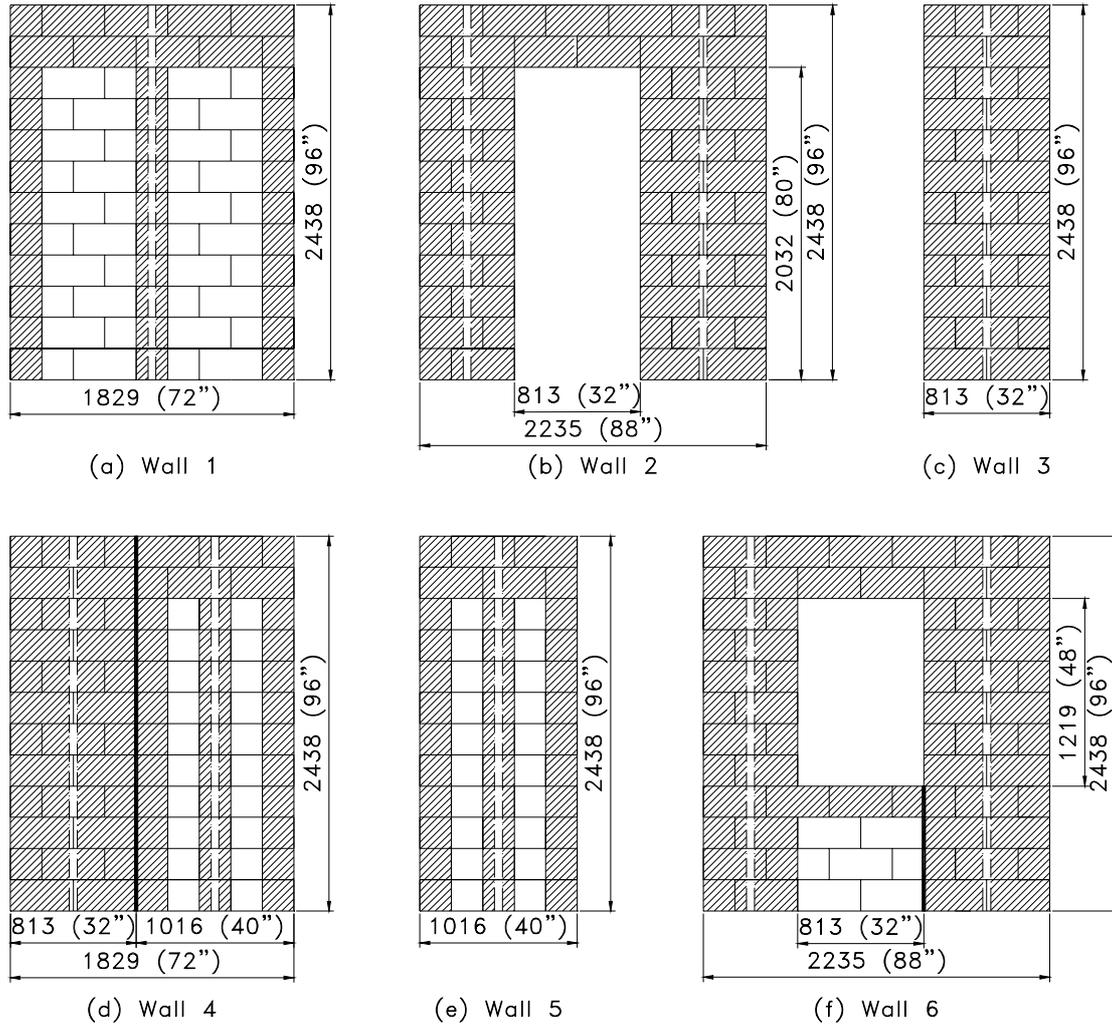
Figure 1 Wall dimensions

Wall dimensions are listed in Table 1 and shown in Fig. 1, where the hatched area indicates cells that were grouted and the prestressing ducts are depicted as a clear space inside a hatched cell. This system requires the cell containing the tendon and the two end cells to be grouted. Due to dimension limitations caused by the size of the shake table, this resulted in some walls being fully grouted. Wall 3 was derived from wall 2 after completion of earlier testing. Upon completion of testing wall 4, the 800 mm wide panel was removed and the remaining panel tested as wall 5.

The bond beam in all walls consisted of 2×16 mm (No. 5) bars, with one bar located in each of the top two block courses on opposite sides of the centrally located post-tension duct. Stirrups were spaced at 600 mm centres except when the bond beam formed a lintel as was the case for wall 2

and wall 6, where they were spaced at 165 mm on centre over the opening. Wall 4 contained two dowel bars crossing the control joint with a total length of 800 mm. One half of the bar was greased and coated with a plastic sleeve to ensure bond was not formed with the surrounding grout. ASTM-706 mild reinforcing longitudinal steel, which is the seismic grade mild reinforcing steel in the USA, having a specified yield stress of 414 MPa (60 ksi), was used in all walls tested. The stirrups used in the bond beam were ASTM-615, 6 mm round wire stirrups, with the same specified yield stress.

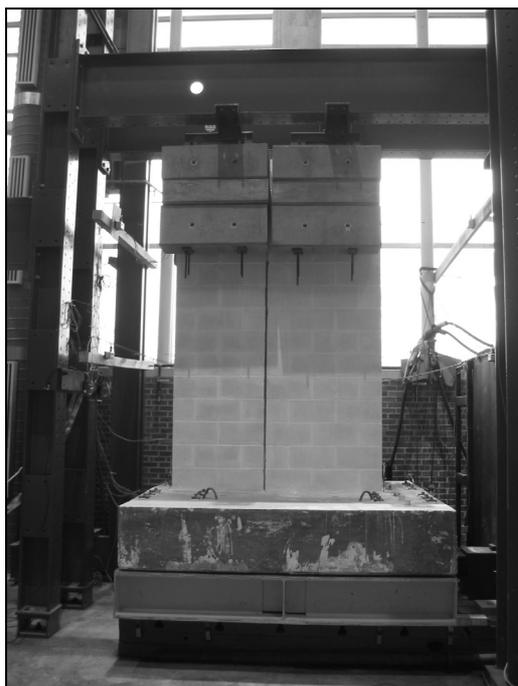
Figure 2 Wall 4 ready for testing

Fig. 2 shows wall 4 ready for testing. The shake table has surface dimensions of 2438 mm × 2438 mm (8 ft × 8 ft) and a displacement capacity of ±127 mm (±5 in.). It provides an acceleration of up to 1G to a mass of 18,143 kg (40,000 lbs). The walls were built on reusable concrete foundations then moved onto the shake table using an overhead crane. The foundations contained the lower prestress anchorages and were bolted down to the table using a series of 16 mm (5/8 in.)

threaded rods. The additional seismic mass blocks were placed on the wall top with a layer of high strength mortar placed in between to provide an even bearing surface. The top prestress anchorage was installed on top of the mass blocks, to hold the structure together. The additional seismic mass applied to the wall top on walls 1, 2, 4 and 6 was 2880 kg, which represented a loading of 3 kPa over an area of 9 m². The remaining walls had an additional seismic mass of 1440 kg installed.

Support frames were erected to provide out-of-plane support to the walls, with a number of rollers used to allow for the table and wall displacements. Instrumentation was installed to record accelerations and displacements at key locations, such as the wall top. The data acquisition system recorded 200 scans per channel per second to provide accurate time history data. The walls were post-tensioned using a hollow core jack and hand pump, and the prestress force was measured using load cells.

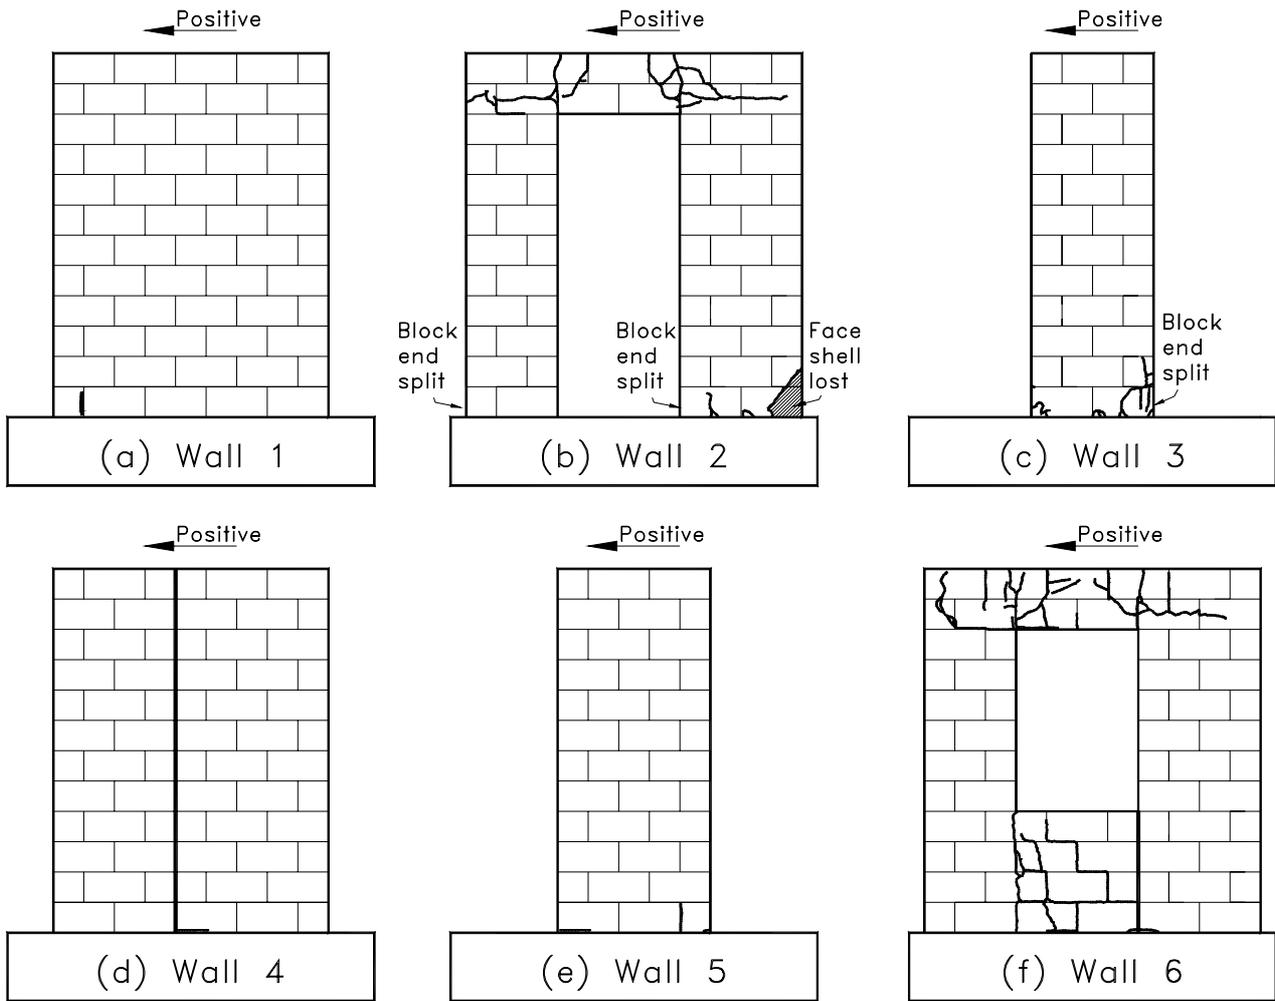
Figure 3 Wall crack patterns at end of testing

Fig. 3 depicts the crack patterns and wall damage for each specimen at the conclusion of testing. Fig. 4 shows the force-displacement backbone curves for the six walls, which were derived using the equation of motion for a SDOF system subjected to an external force. Recognising that the velocity at the peak displacement must be zero, the force at peak displacement is simply the seismic mass multiplied by the total acceleration. By plotting the force at the peak displacement of each wall oscillation throughout the duration of an earthquake record, a backbone curve can be fitted which encompasses all these points. Fig. 4 contains backbone curves for a number of ground accelerations run for each wall. It should be noted that any base sliding was subtracted from the top of wall displacements prior to plotting, and this was seen to be small compared with the top of wall displacements for all dynamic tests. The backbone curves captured for the three rectangular walls are compared with the analytical predictions of Laursen and Ingham [12] showing an acceptable match for all three walls.

For wall 2, the seismic mass was installed in two equal amounts of 1440 kg, one on top of each of the two wall panels, ensuring that the mass block did not stiffen the door lintel. The wall was subject to eleven records before testing was ceased due to considerable crushing of the wall panel lower corners, as shown in Fig. 3(b). Fig. 4(b) shows that the wall stiffness reduced throughout all the runs as a result of the accumulation of lintel cracking, but that there was no significant loss of strength until the final run in the negative direction when the lower corner was crushed.

During the third run at the lower prestress level, significant cracking of the wall occurred, resulting in the masonry below the opening breaking away from the left hand rectangular panel, as shown in Fig. 3(f). A maximum displacement of 31.6 mm (1.32% drift) was achieved and testing ceased due to substantial wall damage.

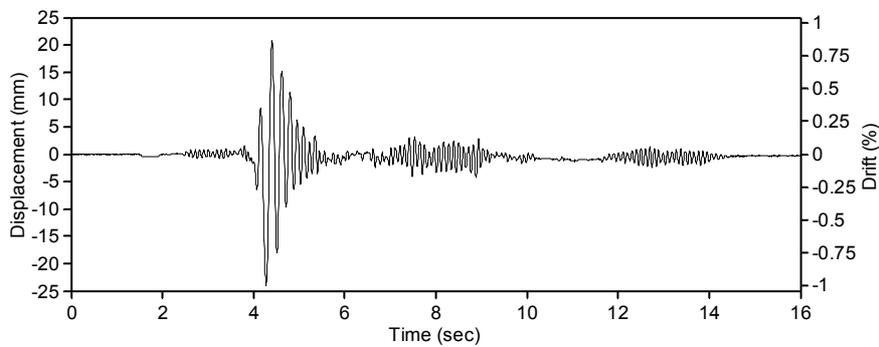
Figure 5 Wall 5 Top of Wall Displacement History (Sylmar)

Initially wall 5 was subjected to ten ground excitations with a prestress level of approximately $0.46f_{py}$. Fig. 4(e) shows that the wall achieved a maximum lateral displacement of 35.9 mm or 1.50% drift, resulting in minor masonry cracking in the compression toe zones and no loss in wall lateral strength. Fig. 5 shows the relative top of wall displacement history for the Sylmar ground excitation, demonstrating the large displacement capacity and lack of residual displacements. Fig. 6 shows the prestress history, indicating that the tendon remained within the elastic range throughout the entire run and there was no loss in prestress.

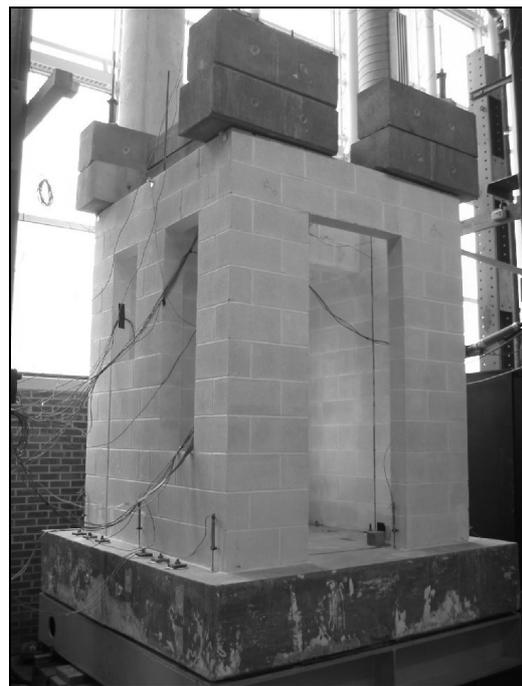
Figure 7 Simple structure ready for testing

Following the series of shake table tests reported here, a single storey simple PCM structure was built and tested on the shake table at NCSU, as shown in Fig. 7. The 2 m square building, made up of four external walls and one internal wall, consisted of two door and four window openings and two shrinkage control joints. The test objective was to investigate the performance of L and T corners and further investigate opening and wall connection performance. The structure was subjected to a series of ground motions at different prestress levels then rotated 90 degrees and the testing procedure repeated. Preliminary data analysis indicates that the structural elements performed as expected based on results from the tests presented in this paper. A more comprehensive account of the experimental results will be published in the near future.

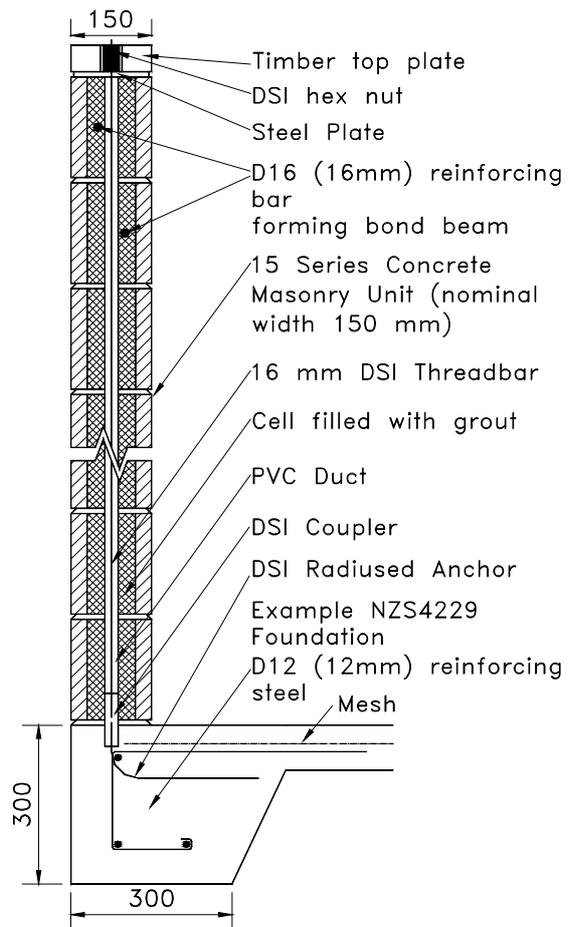
Figure 8 Proposed example wall cross-section

The final phase of this research program involves the design and construction of New Zealand's first PCM house. Design of the structure has not yet begun, however Fig. 8 shows the proposed example wall cross-section for a single storey PCM wall. In this situation standard 150 mm nominal width masonry units are used, placed upon an external reinforced concrete foundation beam. The steel layout in the foundation is as per NZS 4229 except for the addition of the post-tension anchorage, which consists of a Dywidag (DSI) Radiused Anchor and a coupler embedded in the floor slab to a depth of half the coupler height. The anchorage needs to be located accurately in the floor slab to ensure the tendon is located in the centre of the wall width, which is possible by tying the anchor bar on the mild reinforcing in the foundation, and by providing a means of holding the top of the coupler at the correct location. Upon completion of the floor, the wall can be constructed by stacking the blocks and ensuring that washouts are provided at the bottom of each cell that contains a tendon, to provide access to the coupler when installing the tendon. The top two courses require the installation of the bond beam reinforcement, and then upon completion of the blockwork, the PVC duct and tendon can be installed. It is recommended to provide a small amount of prestress to the wall, by way of tightening the nut using a wrench, to provide some out-of-plane bracing for the wall during the grouting process. Preliminary trials indicate that it is difficult to provide more than approximately 20 kN of prestress using a standard adjustable wrench due to the course threads. The wall is then partially grouted, filling the cells that contain tendons, around openings, at corners and in the block courses that contain the bond beam.

The wall is prestressed using a small hollow-core jack and hand pump with a calibrated in-line pressure gauge, to ensure that the required prestress force is obtained. After prestressing the additional threadbar beyond the nut can be cut off, the timber top plate installed and the subsequent construction of the remaining structure started.
