# WELLINGTON RAILWAY STATION REFURBISHMENT

## SUMMARY

The Wellington Railway Station was sold to the Crown who in turn secured a lease with Victoria University to create a central city education campus, whilst maintaining the existing services of Tranz Metro, Tranz Scenic and Tranz Rail. This change of use required an extensive building upgrade coupled with a building-wide earthquake strengthening to modern seismic standards. Structural modifications included the construction of new shear walls and installation of uplift anchors. During the conceptual stages of the project, the anchors were recognised as being an important part of the seismic upgrade and this paper provides an overview of the design and construction processes used to ensure the successful performance of the uplift anchors.

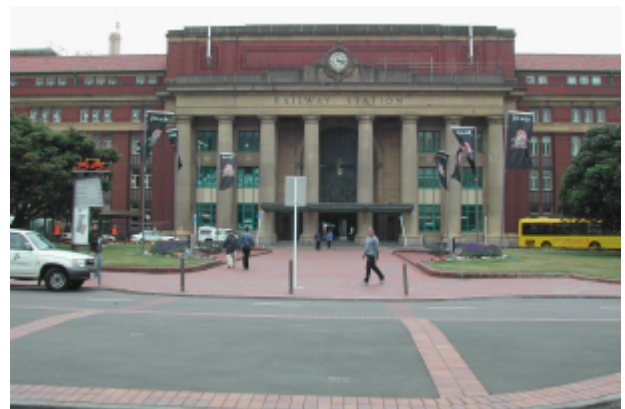
Figure 1: Wellington Railway Station

The building is a dignified and largely undated structure with impressive architecture as illustrated in Figure 1. It is listed by the NZ Historic Places Trust.

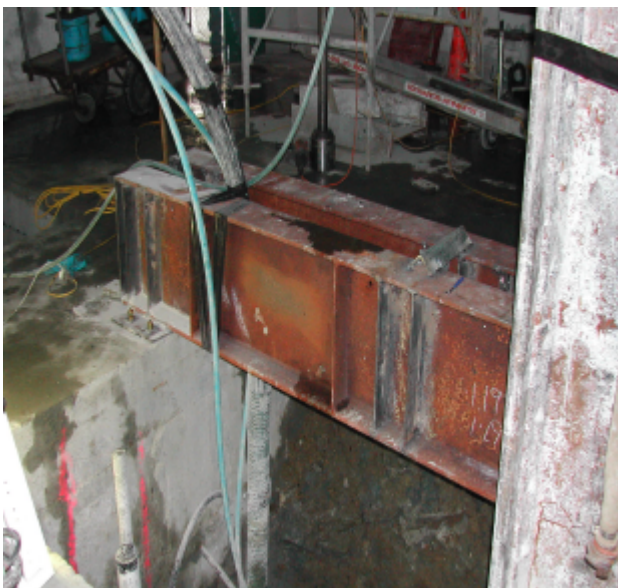
Following a 7 day curing period, the anchor was successfully proof load tested off a steel beam supported on the existing railway station foundations (Figure 3) to 1700kN (76% UTS) which verified the post-grouted anchorage system.

Figure 3: Reaction frame for 1700kN proof test

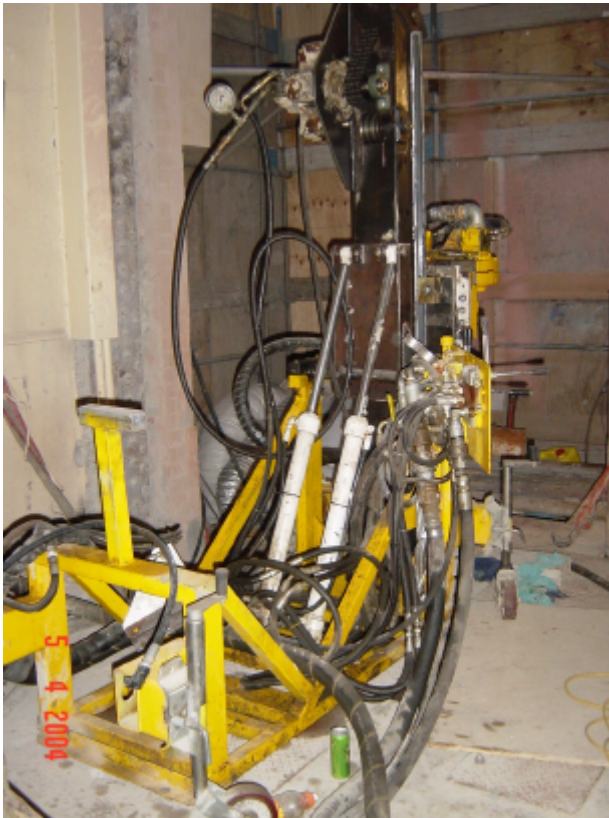
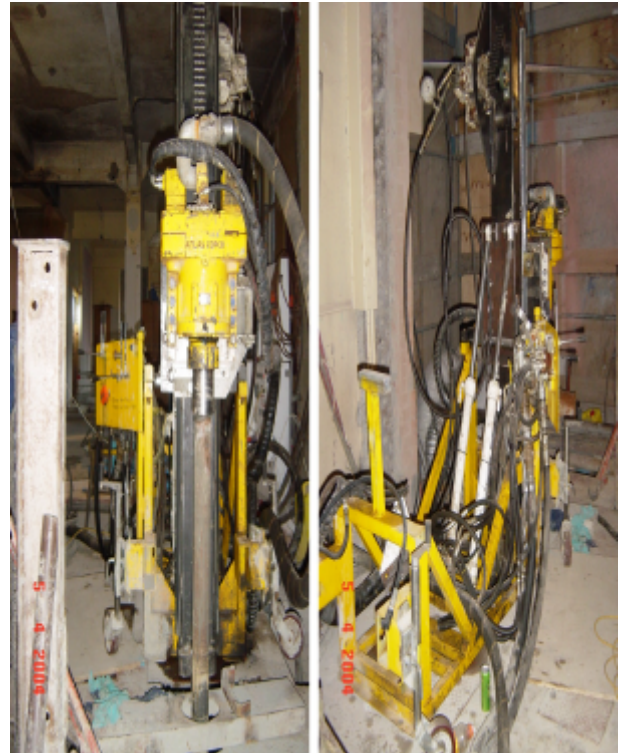
The drilling rig selected for this project was an Atlas THR 48, hydraulic top drive rig (Figures 5 and 6). A special stub mast was fabricated to deal with local height restrictions and the rig was mounted on wheels for ease of movement around the site.

Figure 5: Drilling rig

Figure 6: Drilling rig

With limited access at each shear wall location, coupled with the requirement to minimise noise, the hydraulic power pack and compressor were located outside the railway station building and connected to the rig via umbilical hydraulic power lines up to 45 metres long.

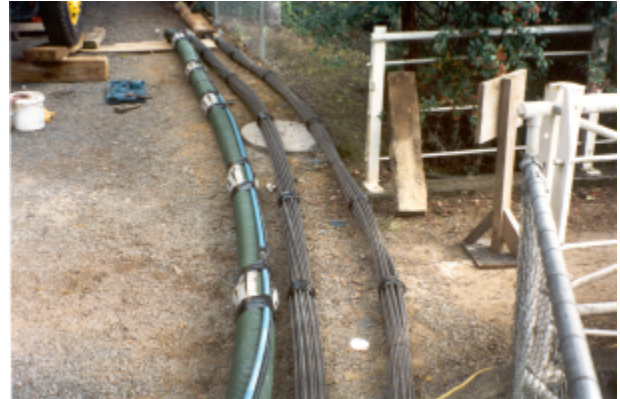
bare bond length to create a basket weave (Figure 8) and fitting the internal grout tube and steel nose guide (Figure 9). The end of the corrugated duct was sealed and water tested to verify its intactness prior to inserting the tendon.

Figure 8: Strand anchor arrangement

For the strand tendons, each individual strand was run through a greasing and sheathing machine to provide protection of the strands over the free length, and allow the strands to elongate during tensioning. The individual greased and sheathed strands were then configured into the 12 strand arrangement by installing plastic spacers over the

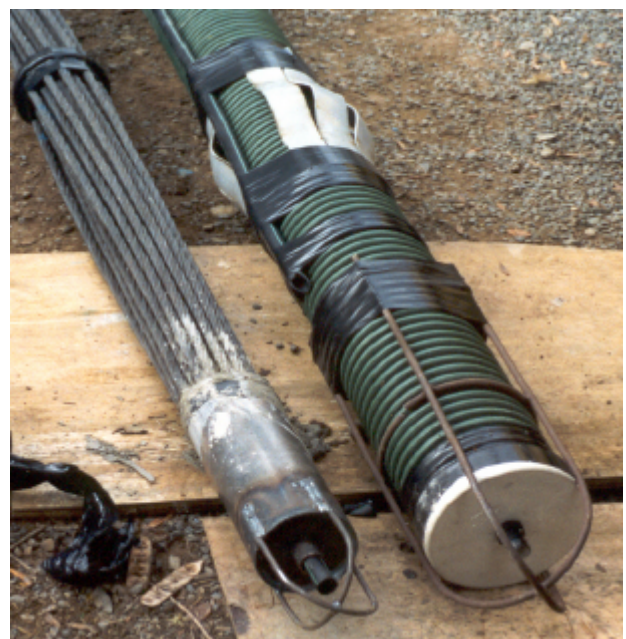
Figure 9: Internal nose guide

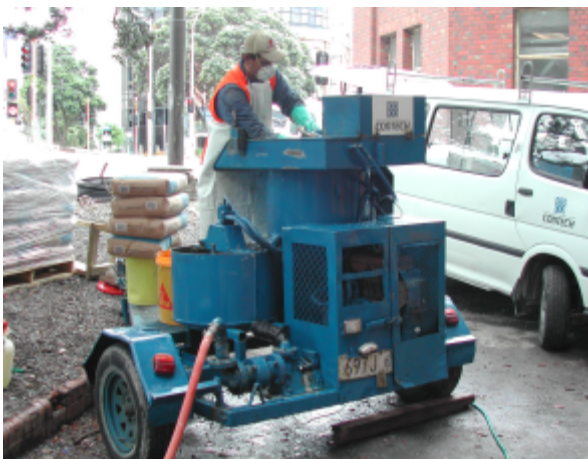
Once the anchors had been installed, they were secured in place and held off the bottom of the drill hole. Grouting was carried out using a high speed, high shear mixer (Figure 10) with grout delivered to the bottom of the drill hole / anchor via the primary grout lines.

*Figure 10: Grouting equipment*

For the strand anchors, the grouting took place simultaneously on the inside and outside of the corrugated duct to maintain an equal pressure and minimise the risk of damage / collapse to the corrugated duct. As the bar anchors were pre-

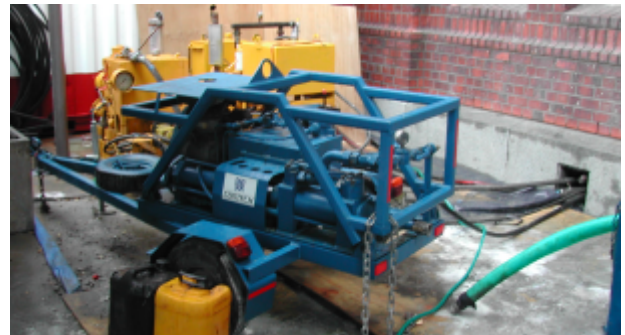
Within 24-hours of the primary grouting operation, the post-grouting process commenced. The high pressure pump (Figure 11) is capable of pumping at a pressure of 4000psi. Neat cement grout was injected until either a constant target pump pressure was maintained, or a target volume had been injected. If the target volume was reached prior to attaining the target pump pressure, another stage of post-grouting was scheduled for the next day and the process repeated. The target pump pressure was adopted from the results gathered during grouting of the proof anchor.

*Figure 11: High pressure grout pump*

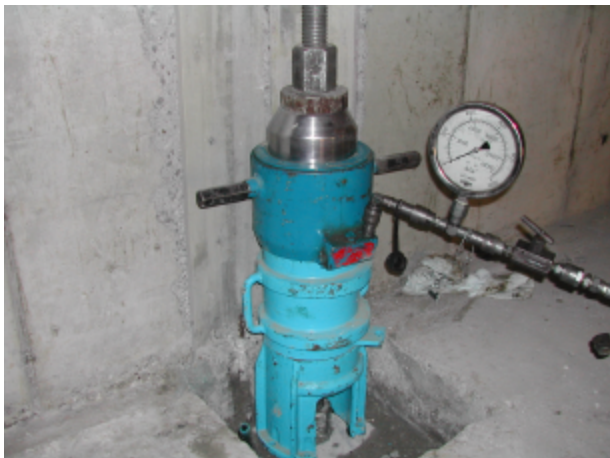
Stressing was carried out against the newly constructed anchor foundation beams using a 200 tonne centre hole jack and trestle as shown in Figure 12. The strand anchors were proof tested to 1700kN and the bar anchors were proof tested to

1379kN in a single load cycle in increments of 20% UTS. Creep tests were not required.

Figure 12: Centre hole jack and trestle

A levelling device located remote from the anchor was used to record extensions off a graduated scale rule attached to the end of the bar or strand tendon. Displacements of the new concrete foundation beams were also recorded but were negligible.

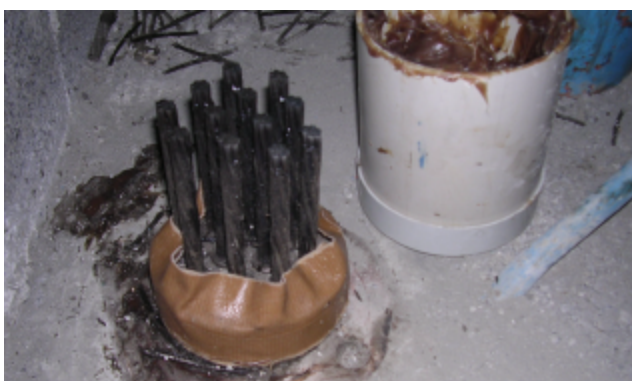
The documents required that the anchors were able to load tested in the future. For the strand anchors, excess strand was cropped to within 150mm above the anchor head and the head protected with denso tape prior to fitting a grease filled PVC cap (Figure 13). The bar anchors were cut to leave sufficient bar protruding above the anchor nut to allow future coupling for testing and protected as per the strand anchors.

Figure 13: Strand anchor head prepared for protection
