RAISING THE “TANGIWAI” BRIDGE

Graeme Jamieson¹, Tony Mans²

The existing bridge carrying SH49 traffic over the Whangaehu River at Tangiwai was recently raised by 2m to allow freeboard for anticipated lahar flows down the river valley.

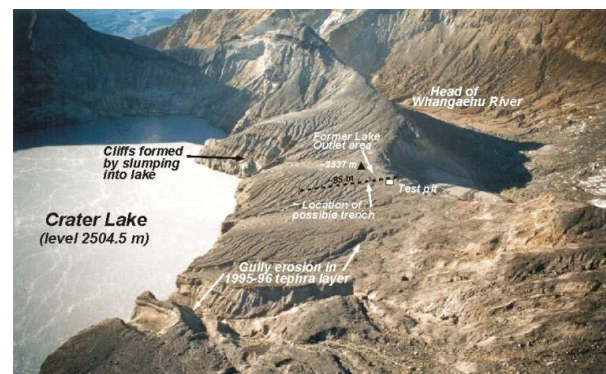
Photo of Tephra dam – Crater Lake

The road and rail bridges built since 1953 have allowed increased freeboard, which has proven adequate for subsequent lahar flows. However the latest round of Ruapehu eruptions during 1995 and 1996 changed the characteristics of the catchment. In particular they deposited a tephra dam some 7.5m high over the historic outlet in the rock rim of the crater lake.

The unconsolidated airfall materials which make up the tephra are not robust, but they are sufficiently strong to increase crater lake level beyond levels which have launched recent lahars. The tephra dam also provides an additional and immediate source of flow solids when the lake breaks through the new dam. In consequence significantly greater lahar flows are predicted (in the order of 2-3 times that of the 1953 event) for the next lahar. The date of this next lahar is contingent on weather patterns, but lake levels are being monitored with appropriate care.

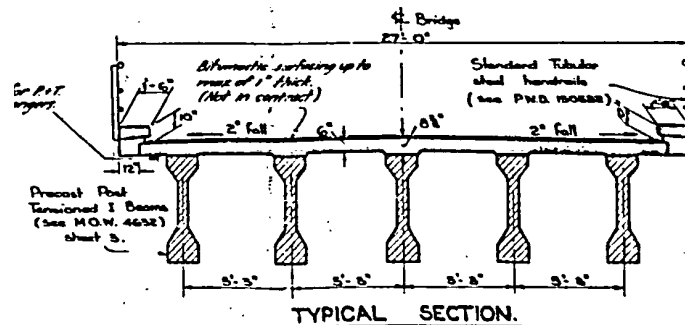
TYPICAL SECTION.

The general arrangement of the existing bridge remains unchanged. Three equal 31m spans of simply-supported pretensioned concrete I-beams support a composite in situ concrete slab, and are linked by in situ concrete diaphragms.

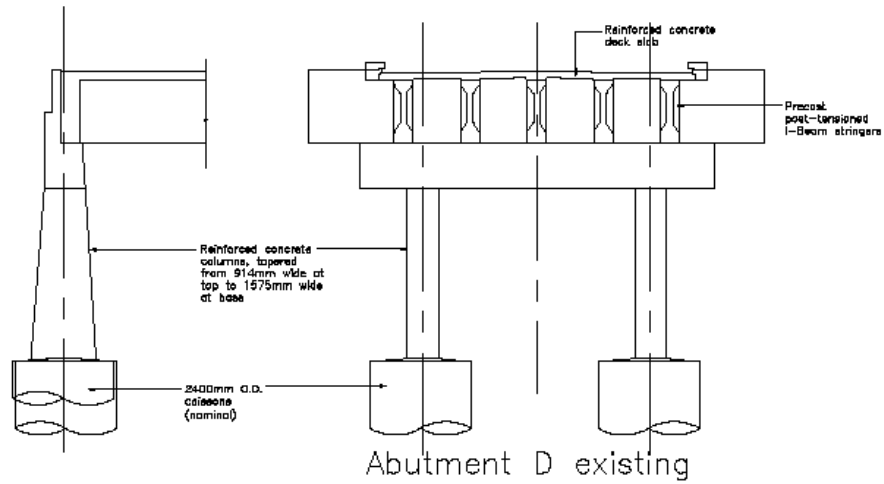
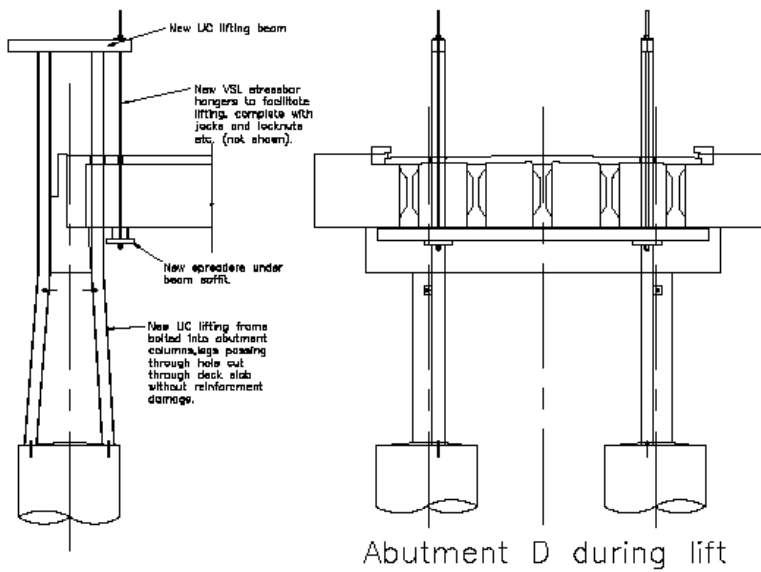
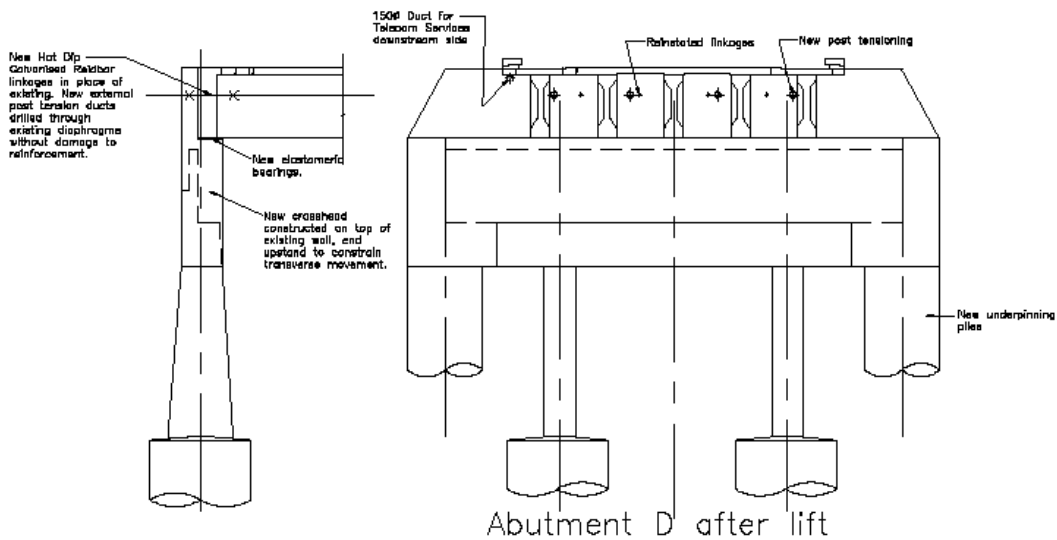
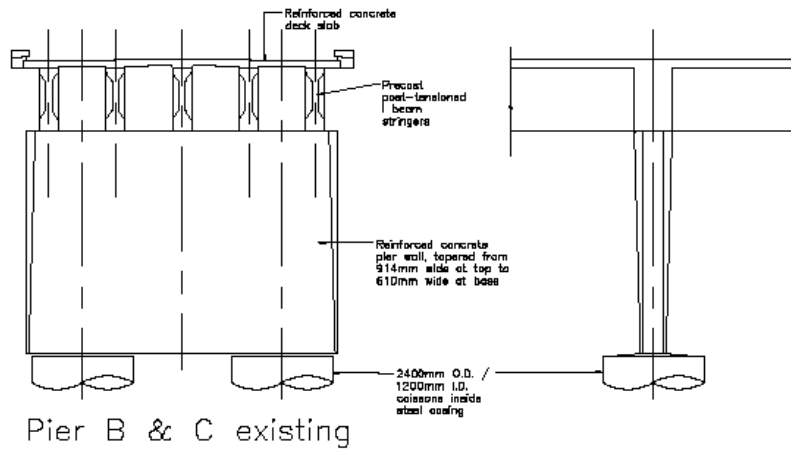
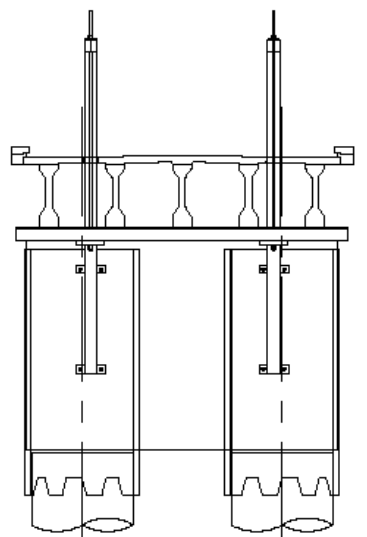
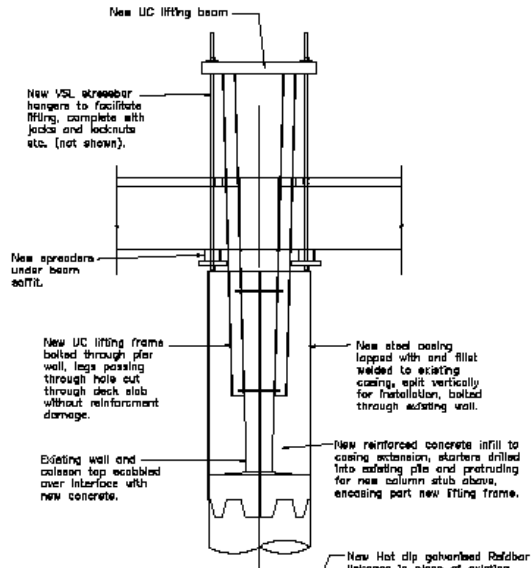
Drawings on the following 2 pages show sections through abutment D and piers prior to lifting, during the lift, and at completion of the process.

Lifting the bridge was accomplished on a span-by-span basis. Each span weighs about 350 Tonne. The end diaphragms are brittle, and relatively feeble compared to loads of this magnitude. The horizontal linkage bolts passing between spans and the vertical holding down bolts in the pier diaphragms had to be removed or cut prior to lifting.

For this reason the conceptual design opted not to push the bridge span from below. Instead the concept was based on pulling the bridge up using prestress jacks supported by steel frames springing from the abutments and piers, passing through the deck slab. Prestress tendons passed through the deck to temporary steel bearers sitting under the precast concrete girders. The proximity of the steel frames to the deck concrete was capable of providing some stability in the event of construction-stage earthquake.

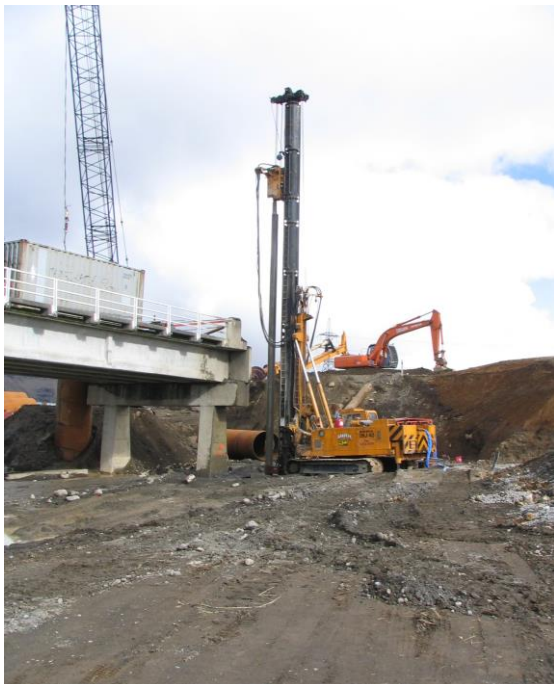
Pre-drilling

The most difficult aspect of the construction phase of the main contract was the sinking of the 1.80m diameter abutment piles. Due to the bouldery nature of the subsoils. Smithbridge had elected to pre-drill the piles on the line of the casing with a small diameter (0.2m) downhole rotary hammer drill to cut through any boulders that may have been in the path of the casing. On the first pile a limited number of cores were made in the interior zone of the pile, this was later found to be inadequate and the entire pile cross section was cored on the remaining three piles. The small diameter holes were backfilled with gravel, to prevent collapse, upon withdrawal of the down hole hammer.

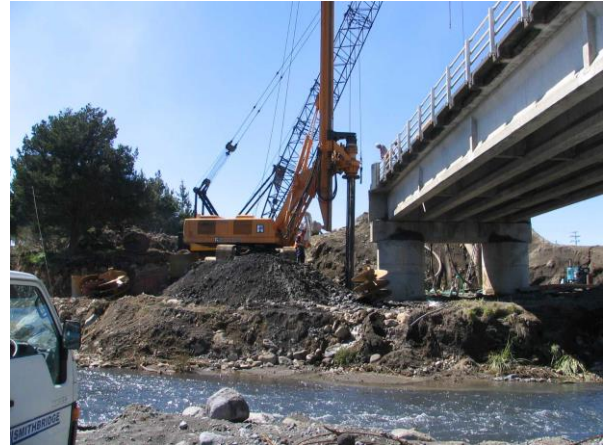
Clearing out casing

Fulton Hogan was subcontracted to auger out the broken up material and to bore the socket into the

underlying papa material. There were problems with the auger heads skipping on buried boulders not completely broken up by the pre-drilling and more traditional methods of chiselling and clam bucketing were necessary at times to progress the piling.

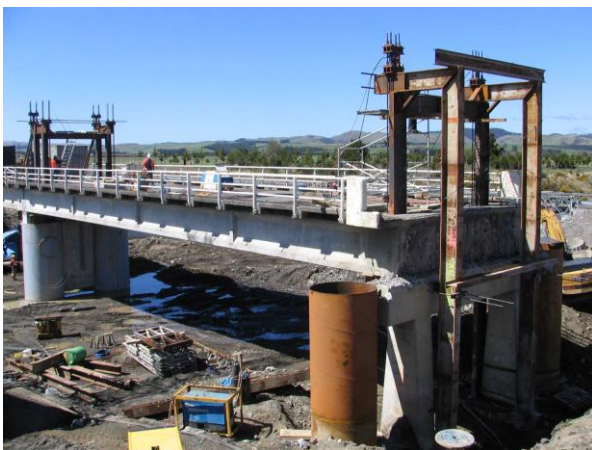
Abutment lifting arrangement

Smithbridge elected to follow in principle the concept methodology for lifting as set out in the tender documentation. The final design was prepared by Ocel Consultants of Christchurch. The design utilised 4 – 36mm diameter dywidag bars in each corner as the hanger rods to a 610 UB underslung beam which supported the bridge beams during the lift. Initially a single 100 tonne capacity hydraulic jack was used on each corner but this arrangement was found to only just handle the span weight and the number of jacks was doubled for subsequent lifts to 2x100 tonne jacks on each corner which easily handled the applied loads. The spans were lifted to 2.5m above their initial position to allow for working space beneath the beams. Once in their lifted position, the dywidag bars were locked off and the jacks removed to the next span to be lifted. In the lifted state the lifting frame over the piers was braced back via props to the adjacent deck span which was still in its original position. Further longitudinal bracing was provided in the form of anchored stressing tendon from the new piles or pier extension passing through an anchorage in the midspan diaphragm. Lateral stability relied on portal frame action of the lifting frame.

A maximum of two spans were lifted at any one time with the abutment lifting frame needing to be shifted from one abutment to the other before the opposite end span could be lifted.

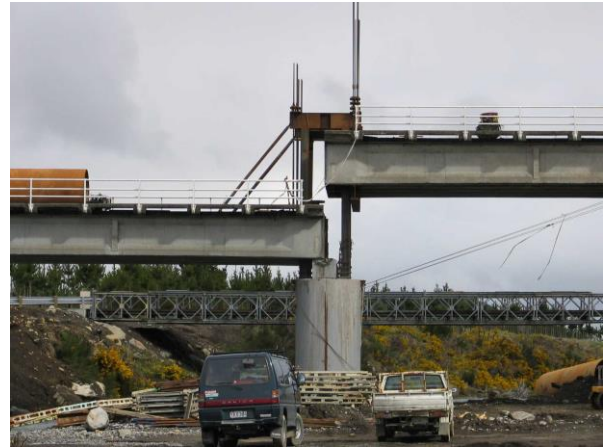
Central span in lifted position

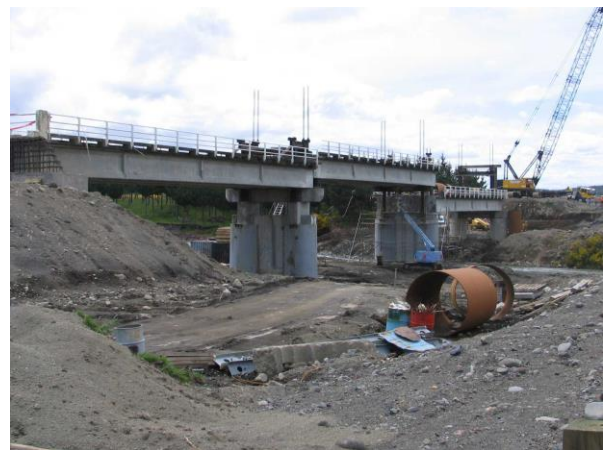
Bridge deck at 3 Different levels
