NEW ZEALAND'S FIRST POST-TENSIONED CONCRETE MASONRY HOUSE

SUMMARY

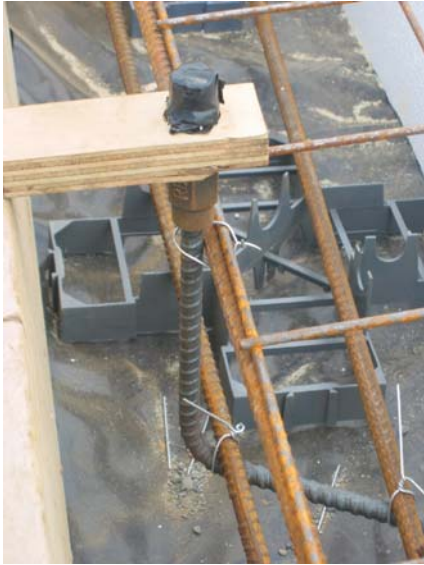
(a) Tendon anchorage in exterior beam

Although complicated by the required pipe bridging and foundation retaining, construction of the raft floor was conducted following standard New Zealand practices. A photo showing the integration of a bottom tendon anchorage in the standard exterior beam is shown in Figure 8(a). Figure 8(b) shows the first course of blocks for the PCM walls being laid using traditional methods, with a tendon coupler shown protruding from the floor. Above this masonry course, wall erection speed was greatly enhanced through the use of mortarless blocks. The tendons were installed after the walls had reached their full height and following the installation of the mild reinforcing steel around the openings and in the bond beam. Washouts were provided in the first course of masonry at each tendon location to assist when screwing the tendons into the couplers, as illustrated in Figure 8(c). PVC ducting was then installed to ensure the tendon remained unbonded. A temporary top tendon anchorage was installed, enabling a small prestressing force to be applied to the tendon using a spanner. This small force was estimated to be only a few kilonewtons, and helped provide additional stability to the mortarless block walls prior to grouting.

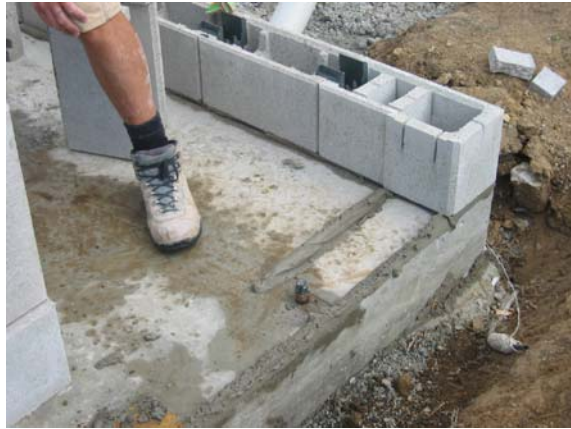
(b) Laying the first course of blocks

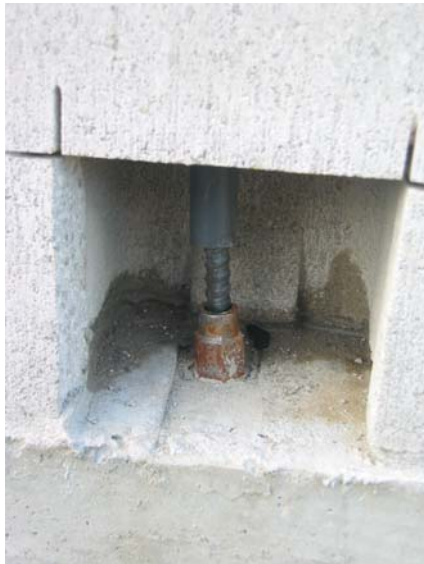
(c) Tendon coupler at floor height prior to grouting

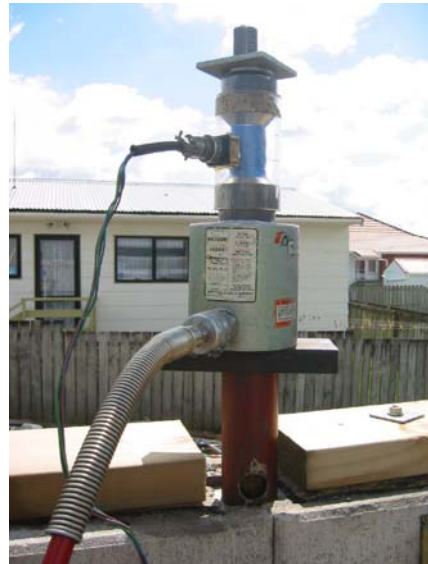
(d) Post-tensioning equipment setup

The walls were prestressed one week after grouting using simple stressing equipment, consisting of a small hollow core jack and jacking chair, and a hand pump, as shown in Figures 8(d) and (e) respectively. The tendons were stressed to the desired level (403 N/mm² or $0.70f_{pu}$), which was determined using the calibrated pressure gauge seen in Figure 8(e). A load cell and digital meter were also used for verification, though it is noted that the use of a load cell is redundant provided the pressure gauge is reliable. Upon reaching the desired level of prestress, the top anchorage nut was hand tightened through access in the jacking chair, and the stressing equipment removed.

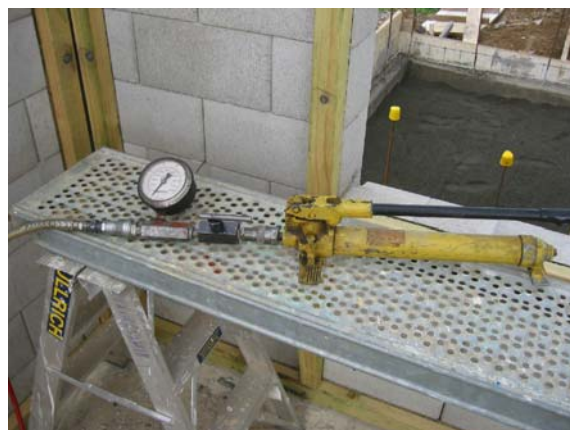
(e) Hand pump and pressure gauge
