Design & Construction of New Zealand's Largest Post-Tensioned Floor/Pavement

Brian Mooney¹, Andrew Dallas², Jeffery Marchant³, Timothy Walker⁴

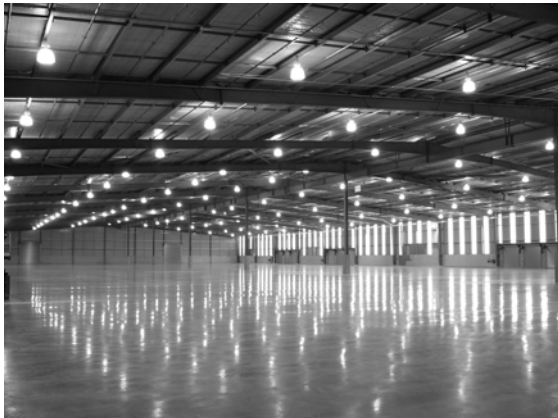
Figure 1 Finished internal storehouse floor

The 75 m by 460 m internal post-tensioned floor, shown in Figures 1 and 4, provides the main storage/ operating surface for the storehouse. The building is divided into three separate storage areas by internal walls. The floor is 165 mm thick, and is designed to cater for forklifts with axle loads of up to 24.6 tonne. It was constructed in 12 pours, with the size of individual pours ranging from 2,300 m² to 3,345 m². The post-tensioning tendons in each pour were crossed over with the adjacent stage across the building, tensioning the pours together and holding the joint between them tightly closed. This resulted in bay sizes of up to 6000 m² that did not contain any joints.

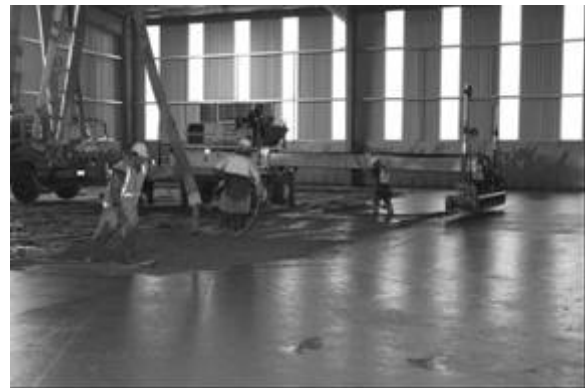
Figure 2 Somero Laser Screed in use for internal storehouse construction

All of the slabs were constructed using Somero Laser Screed's, to allow for the accurate placing of concrete. The Laser Screed is a completely self propelled driver operated vehicle, which uses a high specification laser to guide the strike off of concrete by a vibrating screed head. A laser screed is pictured in use in Figure 2 below. Note that specially designed ramps are used to allow the plant to cross post-tensioning ducts without crushing or damaging them.

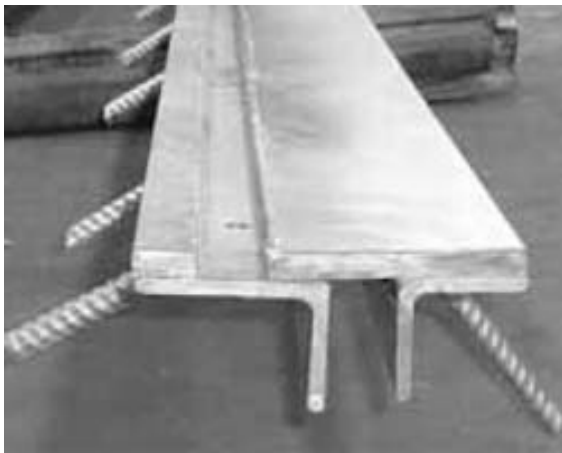
Figure 3 LESA Type G joint. The design ensures that any joint opening is kept covered.

The joints between each 6000 m² bay were armoured using LESA Systems Type G steel joint armour, which incorporates a “sliding plate” type design to keep the joint opening covered after it opened. The armour protects the joint edge from spalling, and reduces fatigue/damage to forklift traffic crossing the joint. It helped to meet the hygiene requirements for the storehouse which required that there were no which would allow rodents or other animals into the building. Figure 3 demonstrate the armour. The joints were doweled to allow load transfer across the joint.

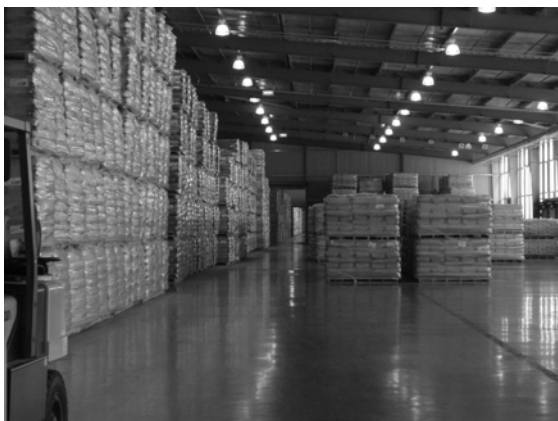
Figure 4 – Finished storehouse in use

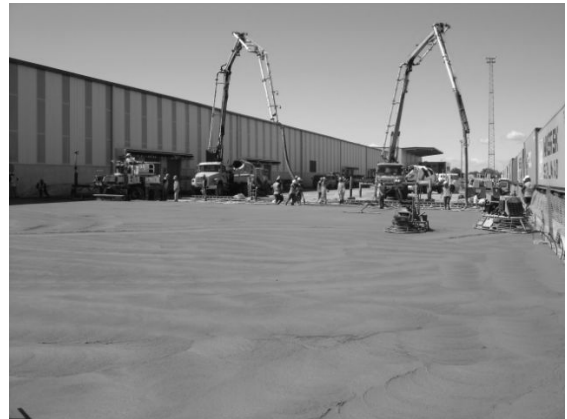
Figure 5 The external pavement during construction.

The external pavement has dimensions of 30 m by 460 m. The pavement is 270 mm thick, designed to carry 84 tonne axle loads

and 40’ containers stacked two high. It was constructed in 6 separate pours, and incorporated 506 post-tensioning tendons. It was constructed only 2 m away from an operational railway track, which presented a real hazard despite being fenced.

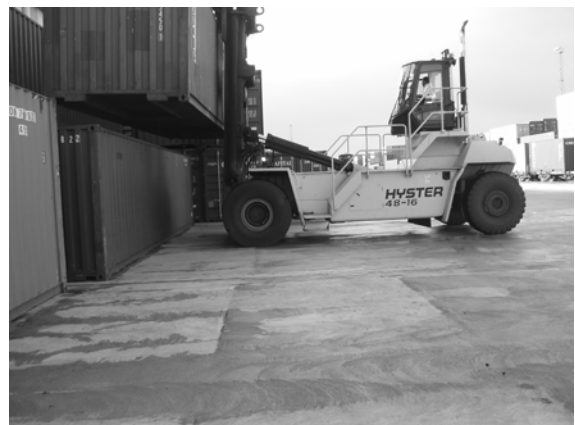
Figure 6 Container lifting equipment with 84 tonne axle loads operate on the post-tensioned concrete pavement

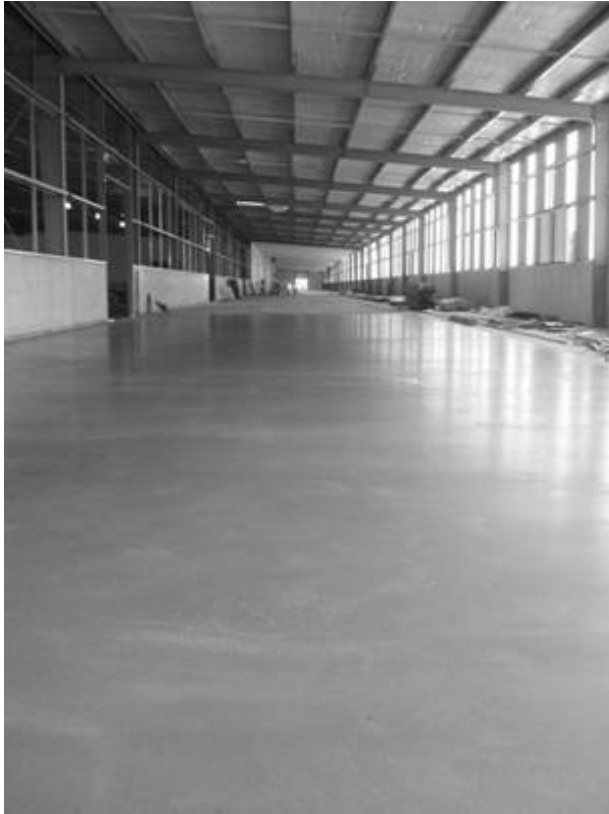
Figure 7 The 460 m railway unloading tunnel.

The rail unloading tunnel sits next to the internal storehouse, allowing material to be directly unloaded from trains under cover. The tunnel incorporates a 4 m wide slab to support the railway, and a 12.5 m wide area for unloading. The tunnel runs the full 460 m length of the storehouse. A dish drain channel was formed along the full length of the slab to collect waste water when the area was washed down.

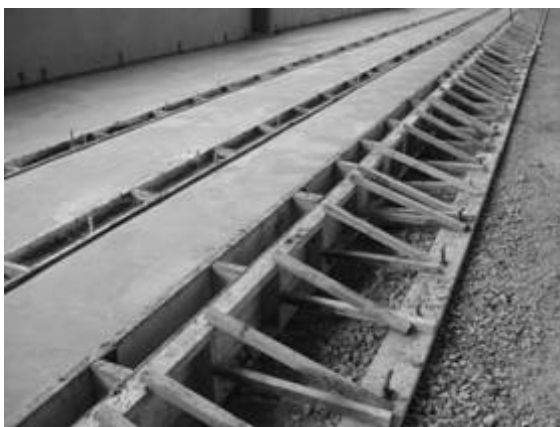
Figure 8 Railway track slab, 4 m wide with rebates for tracks.

The 4 m wide slab that supports the railway tracks was heavily reinforced with continuous deformed bars. The depth of the slab varied from 250 to 350 mm, with the thickest part of the section directly beneath the tracks. Extremely accurate rebates were formed into the slab to allow for track placement. The slab is pictured prior to formwork being stripped in Figure 8.

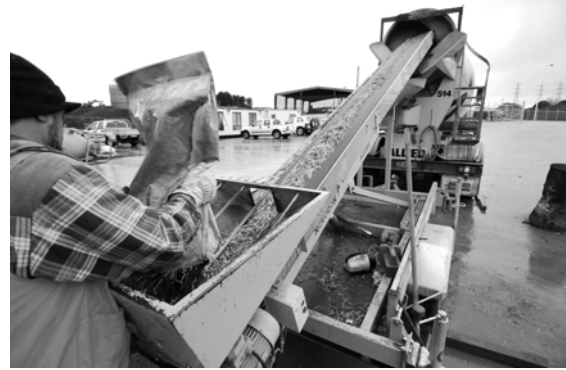
Figure 9 Xorex steel fibre loaded into a ready mixed concrete truck

The remaining 12.5 m of the unloading tunnel was constructed as a “joint free” steel fibre reinforced floor. This was 175 mm thick, and incorporated 35 MPa concrete with 40 kg/m² of Novacon Xorex steel fibre. Figure 9 shows the fibre being loaded into the rear of ready mixed

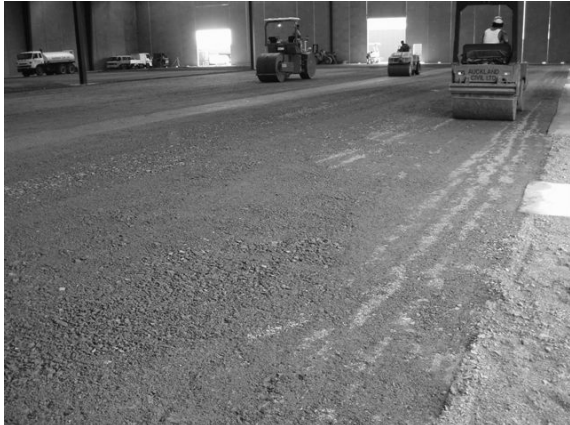
Figure 10 The sub base needed to be finished to tight tolerances to reduce the risk of the floor cracking.

To achieve this the sub base blinding layer was graded to a uniform tolerance of +/- 5 mm from target level. A laser guided machine control grader, which was mounted on a large 4wd tractor, was used to achieve this result. It was necessary to re-grade several areas prior to the first 2-3 sections of floor being poured, however after this the highly skilled machine operator was able to get a handle on what was necessary to achieve the tolerance and the remainder of the blinding layer

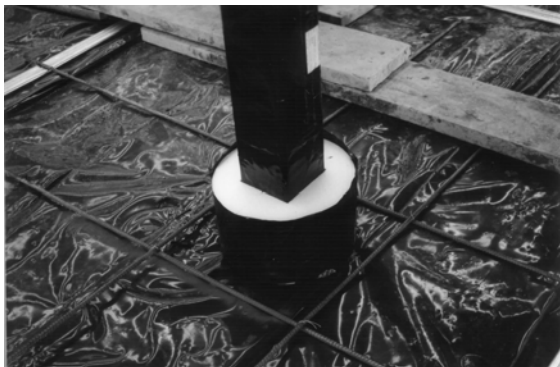
Figure 11 Slab penetrations such as portal legs are isolated using contoured polystyrene block outs. Note that the portal leg has been wrapped in polythene to protect it from concrete splash.

In addition to requiring a smooth sub base to reduce restraint on the slab, penetrations such as portal legs needed to be well isolated. If they were not the floor would “hang up” on them and crack as it underwent its natural shrinkage movement. Slab penetrations were isolated using contoured polystyrene block outs, as shown in Figure 11.

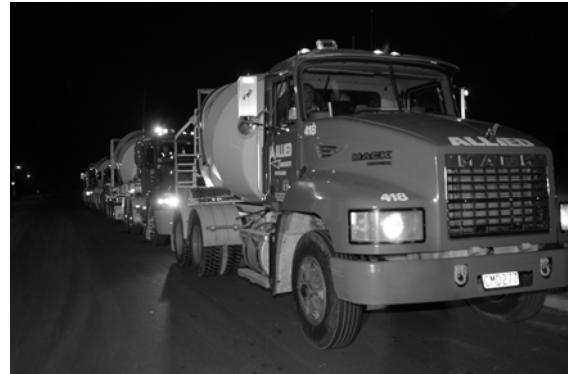
Figure 12 Ready mixed concrete suppliers Allied Concrete and Holcim performed well.

A typical concrete pour for the project required around 550 m³ of concrete to be delivered throughout the day. For each pour this was approximately 235 ton of cement, 570 ton of coarse aggregate, 480 ton of sand and PAP 7, and 1400 Litres of water reducer & retarder. Concrete was supplied by both Allied Concrete and Holcim, who stockpiled material at the plant and also had it continuously delivered during the pour. Clearly, pour dates had to be set well in advanced and adhered to, not only to ensure materials were available, but to make sure concrete supply to other customers was not unduly disrupted during the project.

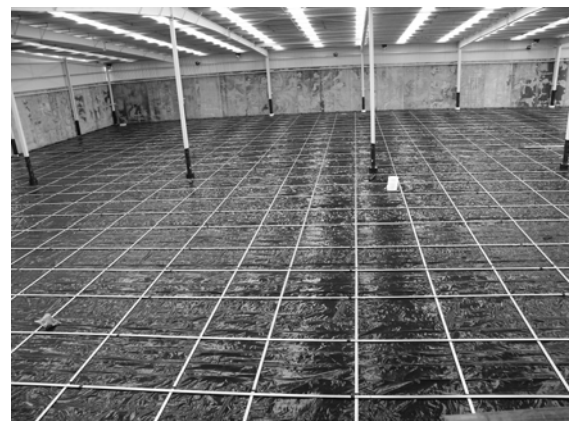
Figure 13 PT ducting makes it impractical to discharge concrete directly from trucks.

It is not practical to discharge concrete directly from trucks when constructing a post-tensioned slab, as the trucks would have to cross a large number of PT ducts, which could be damaged.

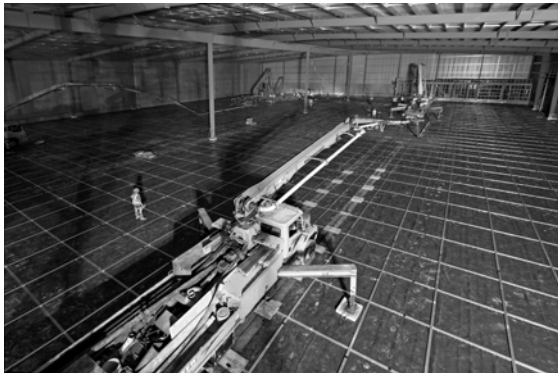
Figure 14 “Feeder” and “Discharge” pumps.

For this reason concrete is pumped for the construction of PT slabs. For this project each pour employed 3-4 boom pumps and/or a telescopic conveyor. A back up pump was available on site in case of any break downs. Generally two “discharge” pumps would be driven across the PT ducts so they are able to discharge into the floor at the furthest point away from the

access points. These would be fed by two “feeder” pumps, situated off the slab on the prepared subbase or in doorways through the internal walls. Often additional line was required to feed the pumps.

The two “discharge” pumps were shifted backwards several times during each pour until they reached the doorways/access point. At this point the “feeder” pumps are no longer required. On average approximately 70 – 80 m³ was pumped per hour. The use of “discharge” and “feeder” pumps is demonstrated in Figures 14 and 15.

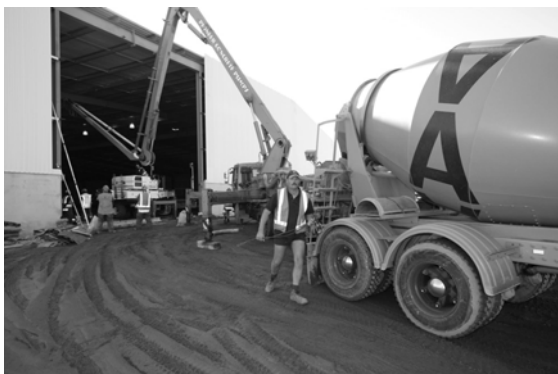
Figure 15 Concrete is discharged into a pump at a doorway

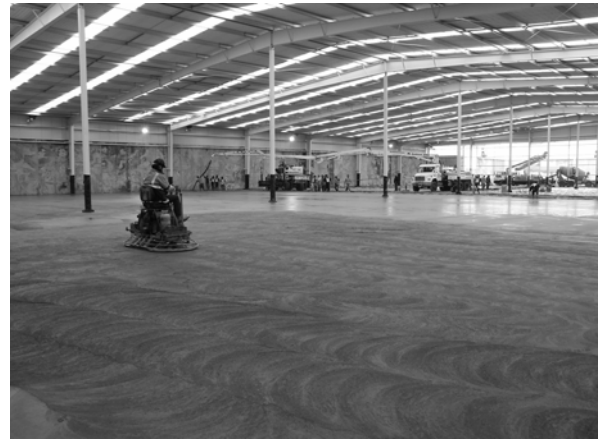
Figure 16 Finishing begins at one end of the building while concrete is still being poured at the other end.

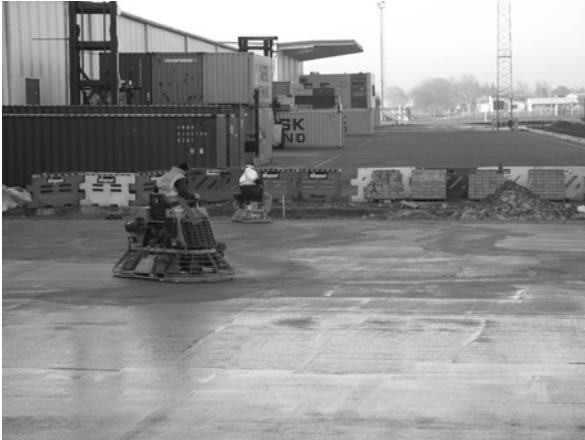
Figure 17 Large container stand pour during finishing.

It proved difficult to achieve a rougher finish and maintain good control of flatness and levelness, particularly on windy days. The slab would be setting up quickly in the drying conditions. Some

tiny areas of plastic cracking were evident despite water blasting an anti-evaporative spray over the slab.

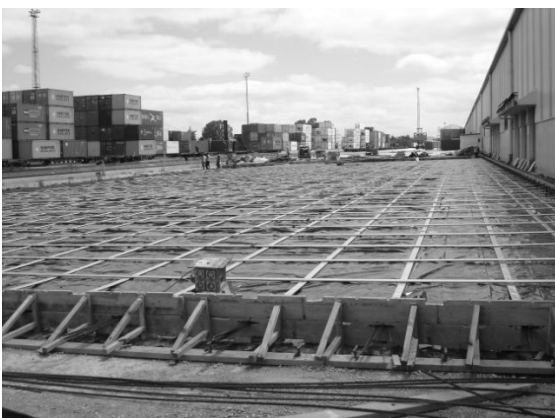
Figure 18 The external pavement is 270 mm thick. This generated a large amount of heat of hydration.

Two layers of polythene were placed over the slab so that the intermediate air gap would provide some insulation. Thermocouples were placed in the slab at about mid depth and near the surface. The ambient air temperature was also measured. It was discovered that the depth of the slab resulted in enough heat being generated that the slab temperature never moved a degree despite going through frosty conditions.
