ORMISTON ROAD CABLE STAYED BRIDGE

This paper provides an overview to the design and construction of the Ormiston Road cable stayed bridge, an iconic cable stayed composite steel and concrete bridge constructed in Manukau City.

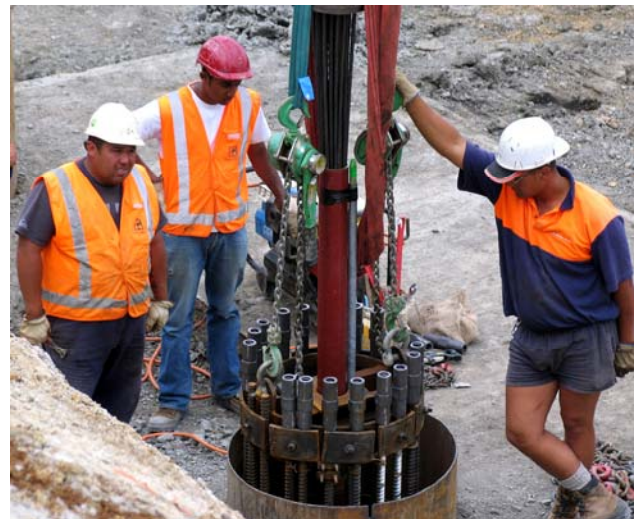
Figure 2. Placing stressing tendons in the western abutment piles

Tendons were assembled on the ground prior to lifting and placing inside the pile reinforcing cage. It took a synchronised effort of 3 cranes using 6 snatch blocks and an excavator to successfully lift the 40m long flexible tendons from horizontal to vertical without kinking the tendon. Pouring of the piles was also difficult as there was only an 83mm void between the tendon anchorage and the reinforcing cage former rings. Each pile was poured using a specially designed 75mm tremie pipe with 10mm aggregate concrete.

The four western abutment piles were designed as 37m long 900mm diameter post tensioned piles. These piles were very difficult to construct due to their length, confined working space inside the pile and high hydrostatic concrete pressures at the base of the pile. Normal drossbach ducting could not be used as the tendon sheathing after research showed that drossbach ducting would collapse at about 12m head of concrete. 100NB steel pressure pipe was used as an alternative, which could cope with the high pressure demands and temporary loads during construction.

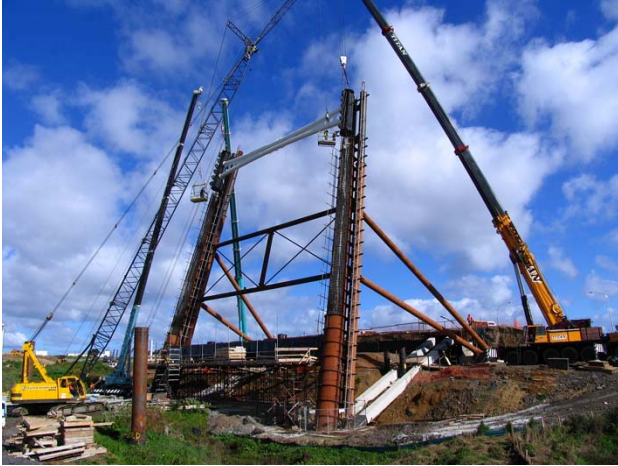
Figure 3. Erection of the steel portal beam and pylon anchorage on top of the column formers prior to pouring

The concrete pylon formers were made from 8mm steel plate, with each 1200mm plate rolled into the tapered section of the pylon. This meant each 1200mm plate was rolled with a 22mm taper. The pylon formers were supported by twin 900mm diameter strong back tubes and four 600mm diameter back stays. To provide the required reaction force to support the pylons the back stays were founded on a pile and pile cap which was laterally stressed to the western abutment and longitudinally to the pylon pile cap using a strut and tie arrangement. Simple pin connections and sliding supports were used in the temporary works to facilitate jacking of the erected pylon forms into a precambered position prior to pouring. The precamber accounted for the anticipated 20mm deflection of the forms during the concrete pour.

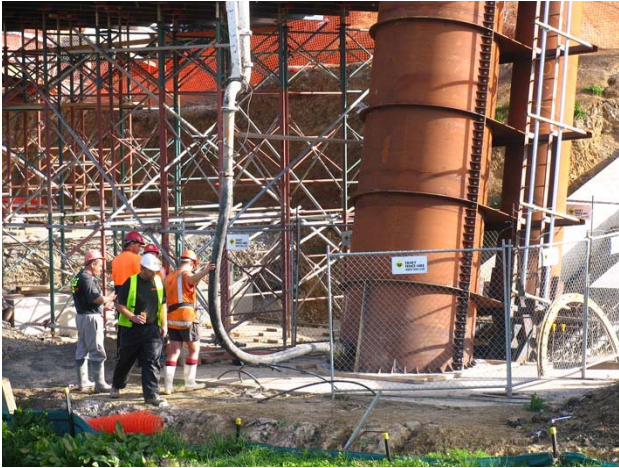
Figure 4. Base pumping self compacting concrete into the 28m high reinforced concrete pylons

A decision was reached to base pump the pylons using self compacting concrete (SCC), as it would provide the best response to deal with segregation and compaction issues as no vibration was required.

There was some risk that this volume of SCC could not be base pumped to this pressure. Measures would also need to be put in place to ensure the finish of the concrete pylons would achieve the specified F5 finish. The back steel pylon forms were also required to be in place for 6 months after the concrete pour, while the deck was constructed prior tensioning stay cables. Rust staining of the concrete pylons from the forms was identified as an issue and were epoxy coated overcome this.

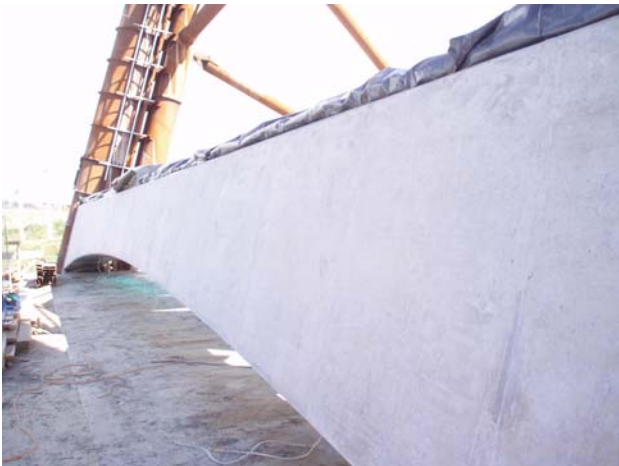
Figure 5. Curved concrete crossbeam which supports the bridge deck at the pylons

The curved concrete cross beam was constructed after the bottom section of the pylons was poured. The crossbeam was difficult to construct from a geometrical point of view with the crossbeam also raked at 15 degrees to follow the pylons and had a curved soffit. The reinforcing connection to the concrete pylons was achieved using Reid Bar and couplers.

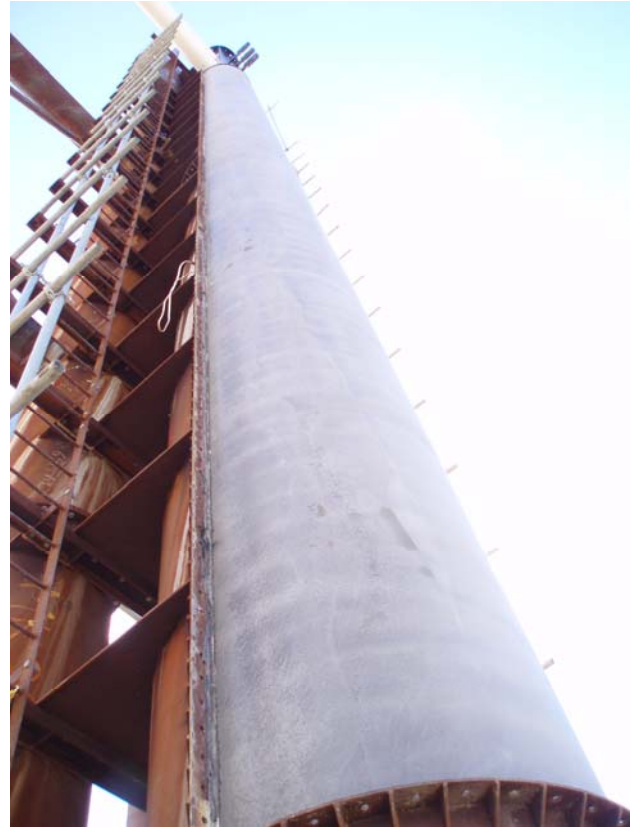
Figure 6. Stripped top section of the pylons

The staged stripping of the forms from the pylons revealed a high quality finish of the base pumped SCC. No segregated concrete or voids were found in the pylons.

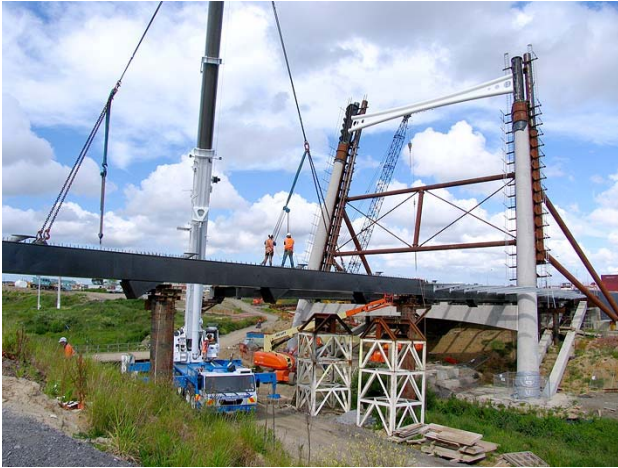
Figure 7. Erection of eastern half of the box girder

Erection of the structural steel was the first task, with the positional placement of the structural steel of primary importance, due to the need for precise alignment between the top stay cable anchorages and the guide pipes and anchorages fixed inside the box girder. An insitu weld splice in the box girder was used to assist transportation and erection.

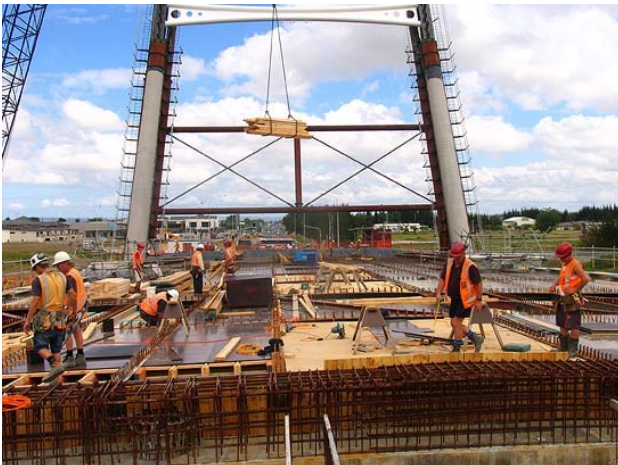
Figure 8. Construction of the insitu concrete deck

Depth control of the concrete deck pour was very important to provide the required cover to the reinforcing without adding additional dead load to the bridge which would effect the cable stressing. A 10mm increase in overall slab depth would result in an additional 350kN of dead load.

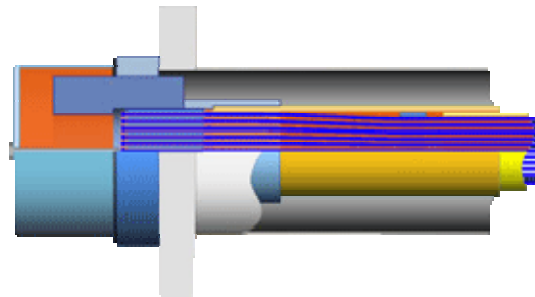
Figure 9. DINA stay cross section at end anchorage

The stays consist of 7 mm diameter wire, arranged in a compact parallel bundle within a thick walled HDPE sheath and filled with a flexible corrosion-inhibiting compound.

The individual wires are terminated at each end with a cold-formed button head which transfers the full load to the anchor heads.

Length adjustment and load transfer to the bridge structure is provided by lock nuts screwed onto the outside of the anchor heads. Grease filled corrosion covers are fitted to enclose the anchor heads following stay tensioning.

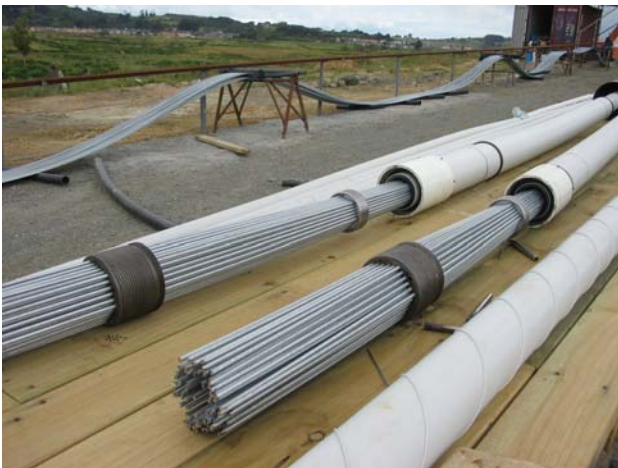
Figure 10. Wire bundles inserted in stays prior to button heading. Note cutting line and pre-cut wires in the background and turbulence inducers on the HDPE duct in foreground.

Once a set of wires for a pair of stays had been cut these were inserted through the various components at the ends of the stays and through the length of the HDPE duct. Each wire had to be inserted through a predetermined location in each component to ensure the wires remained as a parallel bundle, free from twists.

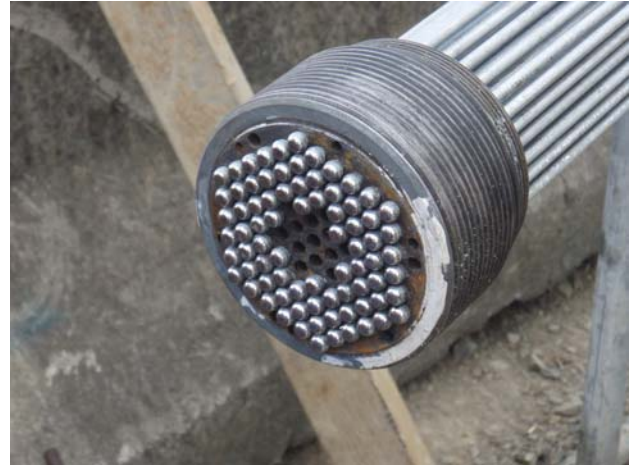
Figure 11. Wires terminated with button heads at an end anchorage

The button heads are formed by gripping the wire and pushing it into a dye. A circular profile is formed of consistent dimensions and which has been found to transfer the full wire capacity to the anchor heads. The process is similar to forming jolt heads on timber nails.

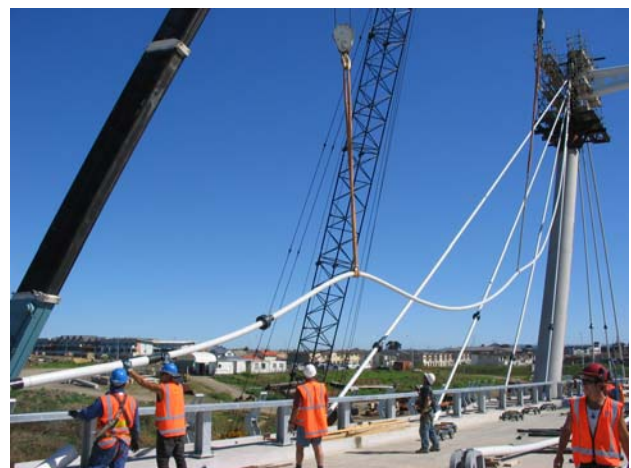
Figure 12. A stay being installed using a three point lift system

A number of options were considered, but it was decided that the stays would be installed complete and with the clevis fitted, using two cranes and a mechanical excavator.

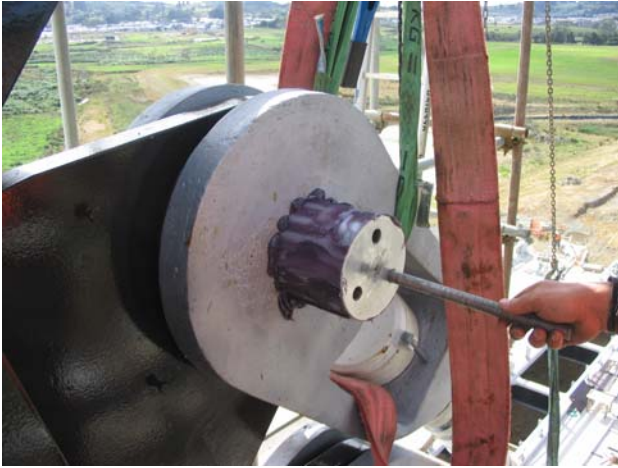
Figure 13. Inserting the clevis pin.

The cables were lifted and connected at the clevis, end first. The lower end was then inserted into the guide pipe through the main girder.

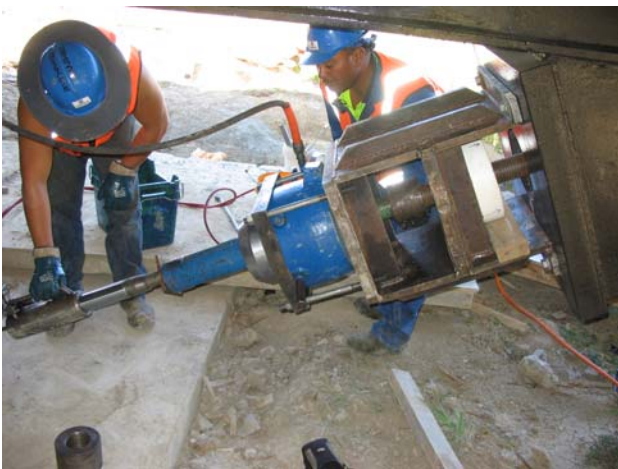
Figure 14. Stay tensioning arrangement. Note the small capacity jack being used to pull the pull rod through the large hydraulic jack.

The tensioning system consisted of 250 tonne centre hole hydraulic jacks tensioning the stays via a re-locatable 75 mm diameter, 450 tonne pull rod.

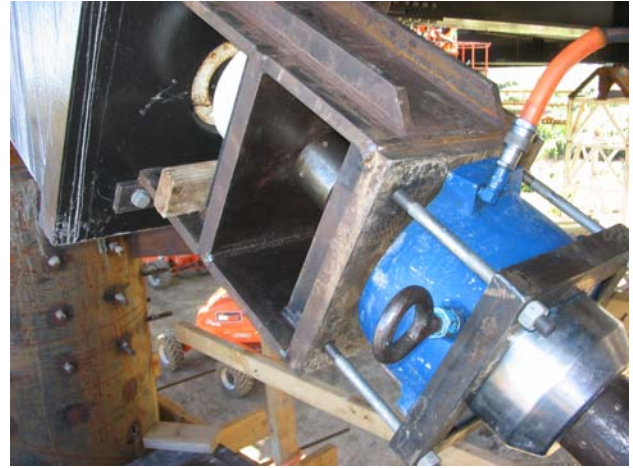
Figure 15. Stay tensioning arrangement. The 2 stage trestle allows the jack to be cycled and retain load in the stay.

As the hydraulic jacks have small stroke compared with the required stay extension a two level trestle was utilised to ensure the stay could be locked at stages during tensioning. This ensured that the jack could be retracted, at the end of each stroke, without losing the force already applied to the stay. The hydraulic jacks were cycled until the required stay force was achieved.
