DAMMING THE DAM

Campbell Robertson
Technical Services Manager
Holcim (New Zealand) Ltd

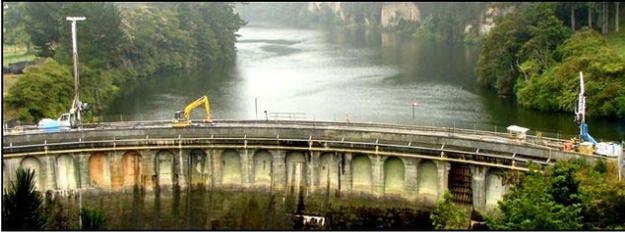
Figure 1: Panorama of Arapuni Dam looking upstream

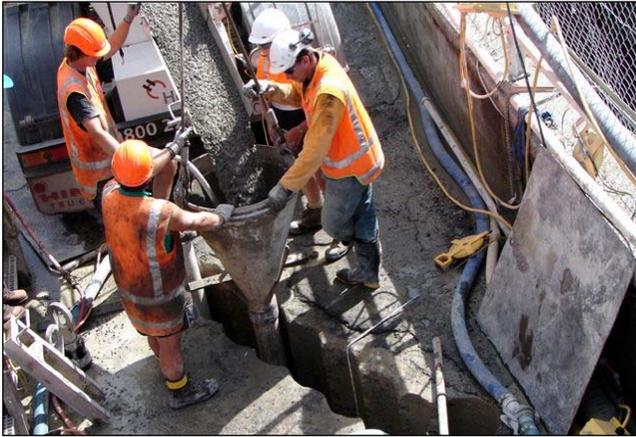
Figure 2: Discharging Concrete into Tremmie Funnel
