Development of Secant Pile Retaining Wall Construction in Urban New Zealand

Nick Wharmby
Brian Perry Civil, Hamilton, Waikato, New Zealand

SYNOPSIS

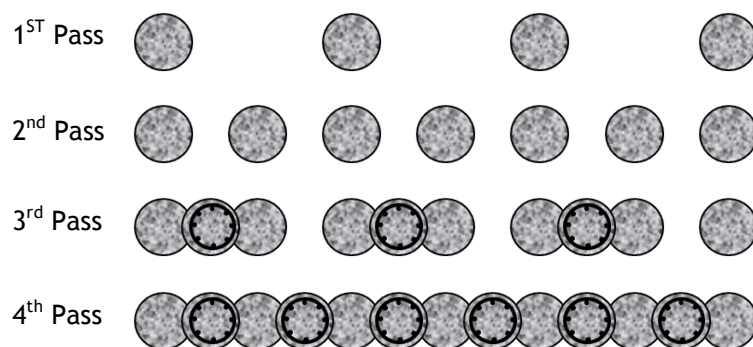
The secant pile methodology comprises the formation of overlapping concrete piles. Typically alternate unreinforced or “female” piles are formed using lower strength concrete. The remaining piles are standard reinforced concrete “male” piles. Figure 1 represents an example of a construction sequence that may be adopted dependant upon the soil strength.

(Figure 1) Pile Construction Sequence

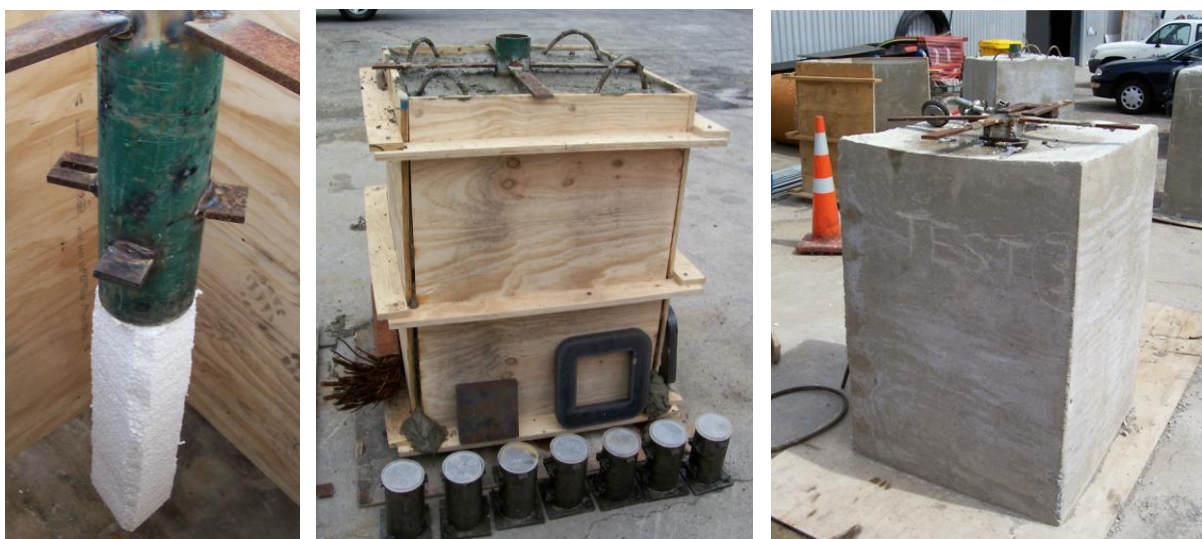
A number of trial mixes were carried out and specifically tested in 2006 for the BNZ Building basement. These included strength and pressure testing of mixes with appropriate fluid properties. A number of cylinders were made to assess the early strength gain. An applied water pressure of 200KPa was applied centrally for 3 days to assess permeability. Figure 2 shows the methodology adopted with the 1cu.m samples and the dry face after 3 days.

(Figure 2) Low Strength Mix Trial

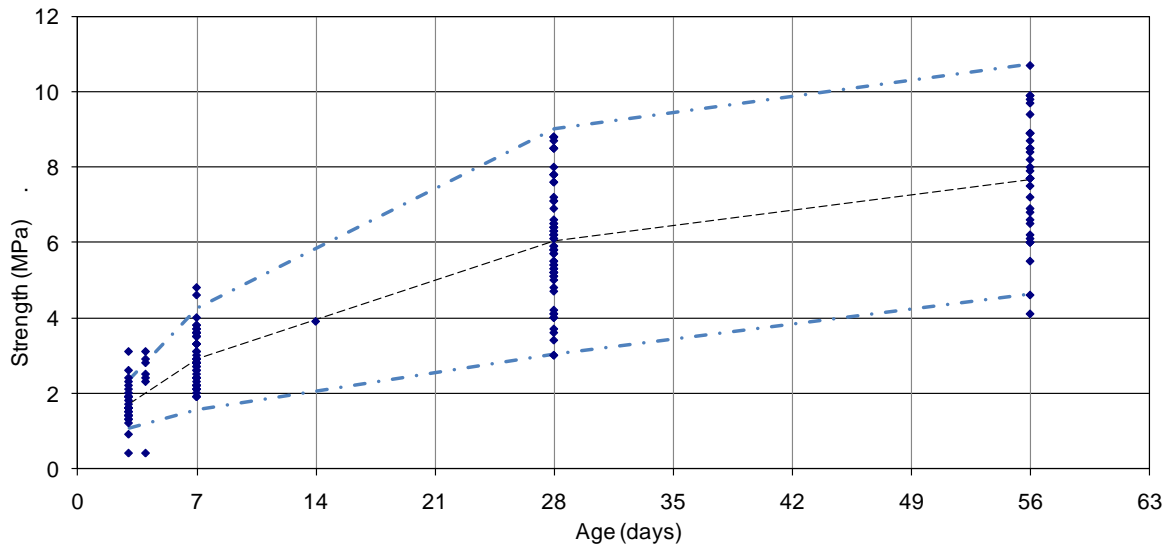
The cylinders were tested at 3 and 7 days to assess the early strength gain and likely difference that could exist between adjacent “female” piles. The 28 and 56 day tests provide the design strength information for earth and water pressure distribution. The strength testing also provides an early

warning and quality control mechanism for the hardened material. The project strength data is provided in Figure 3.

(Figure 3) Low Strength Mix Cylinder Test Data

What is clear from the strength data is that there is considerable variance in the strength at any given age; the following statistical outputs results:

Age	3 days	7 days	28 days	56 days
Average / mean	1.71	2.91	6.03	7.68
Sample standard deviation	0.65	1.36	2.99	3.05
95% confidence lower strength	1.06	1.56	3.04	4.63
95% confidence upper strength	2.36	4.27	9.03	10.73

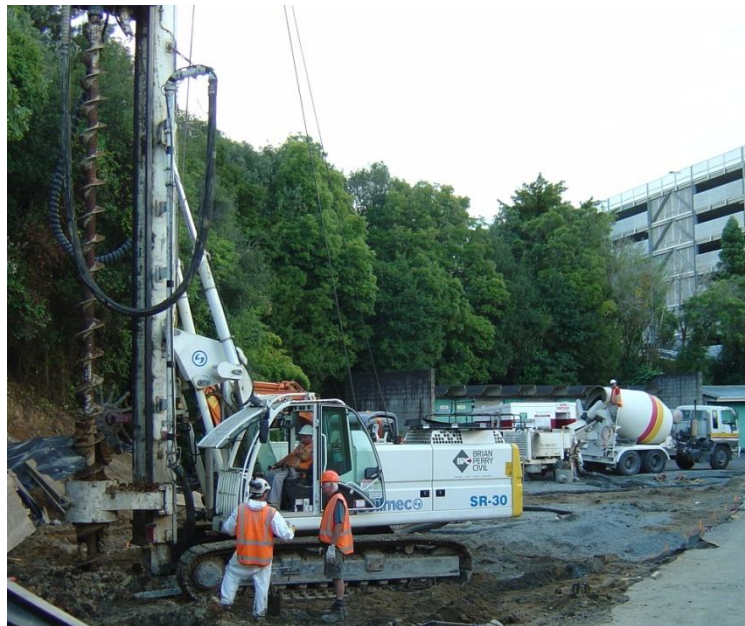
Since 2007 a number of secant pile wall projects have been completed using either conventional bored pile methods with temporary casing or Continuous Flight Auger (CFA) technology where the pile bore is supported by the spoil on the auger. The CFA method is a particularly cost effective option in unstable ground conditions with a high groundwater table where long casings and / or drilling support fluid would be required; the basic methodology is provided in figure 4 and 5. It should be noted that the use of an instrumented rig to provide real-time monitoring and records is essential to verify quality as other on-site observations are not possible.

(Figure 4) CFA Piling

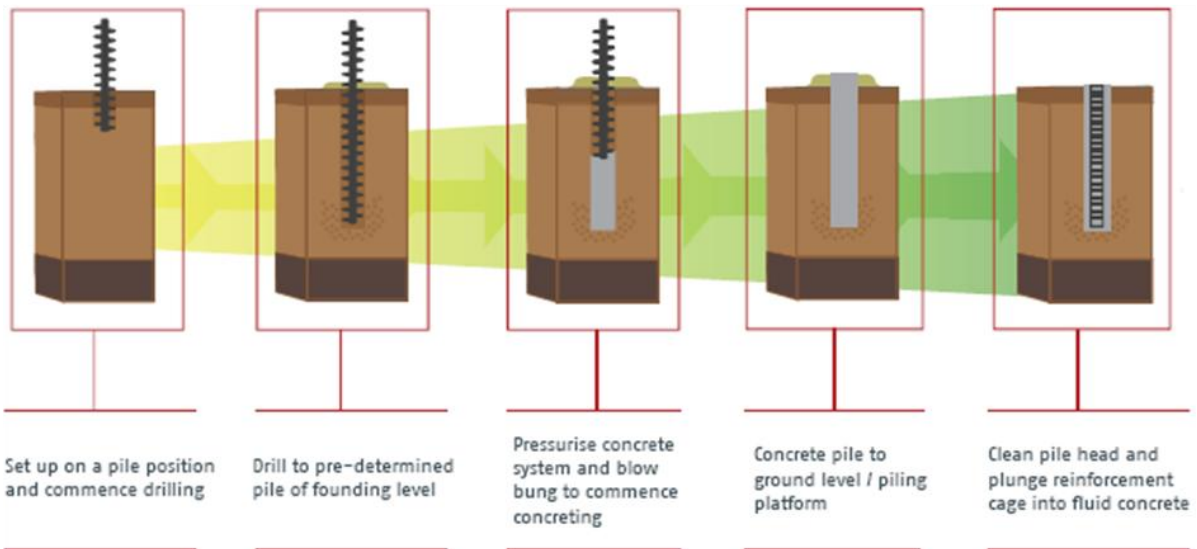
(Figure 5) CFA Pile Construction Methodology

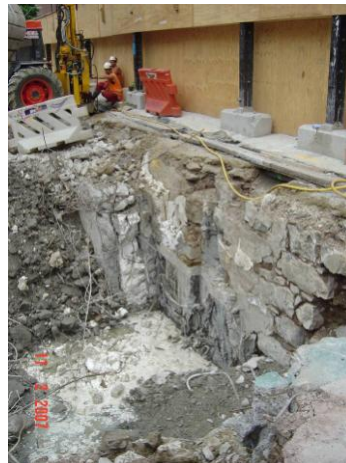
Bluestone wall obstruction

- 40 x 50m plan area x 12m deep basement (4 level)
- Conventional bored piles with rotated casings
- Proximity of façade slowed production
- Reinforcement too close / congested
- Obstructions can affect sequencing and tolerances achievable
- Internal shotcrete lining wall detail not effective

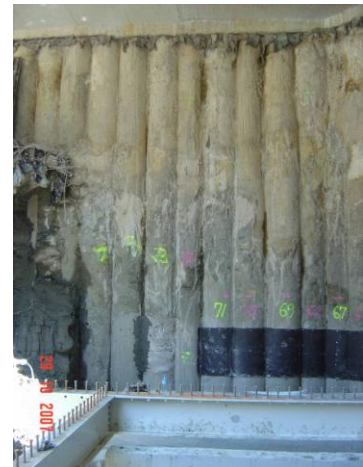
Exposed Wall

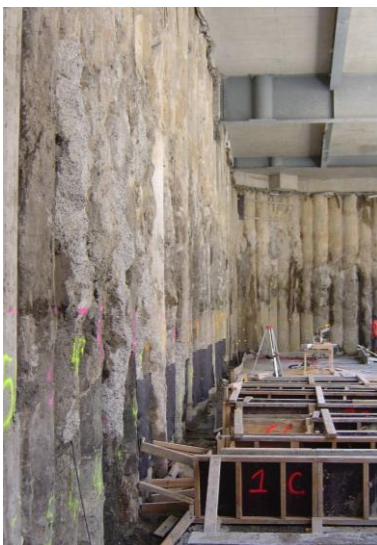
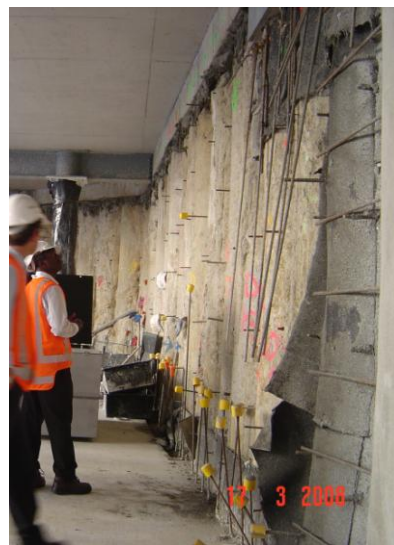
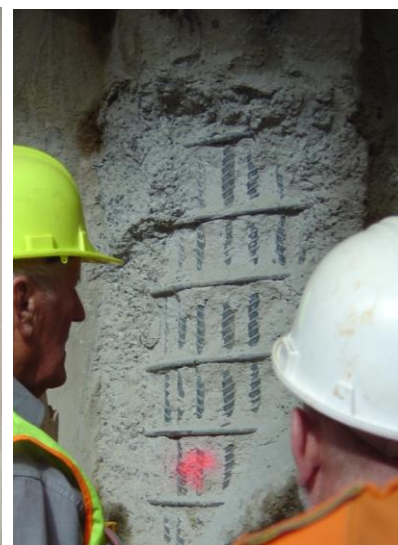
Exposed wall, membrane, dowels, , shotcrete lining wall and congested reinforcement

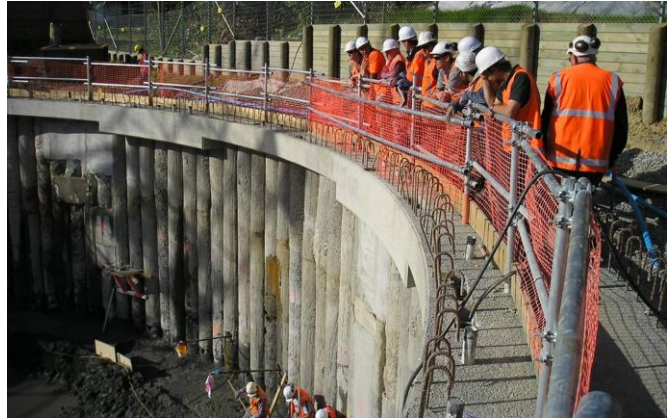
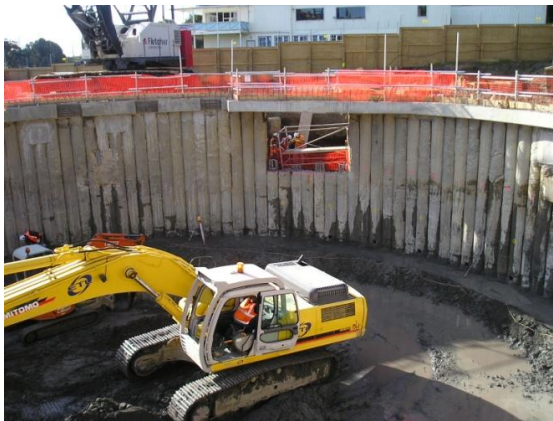
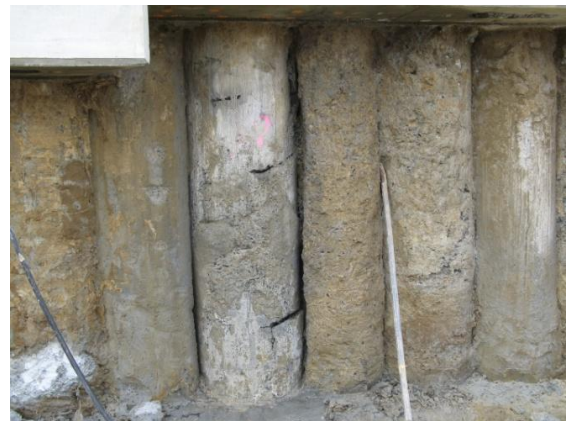
Exposed wall - pile with defects due to loss of workability prior to casing removal

- 25m diameter shaft with 6m retained height
- Conventional bored piles with rotated casings
- Preboring and casing shoe design can affect pile interlock and cause debris in joint
- High cement content can cause early loss of concrete workability

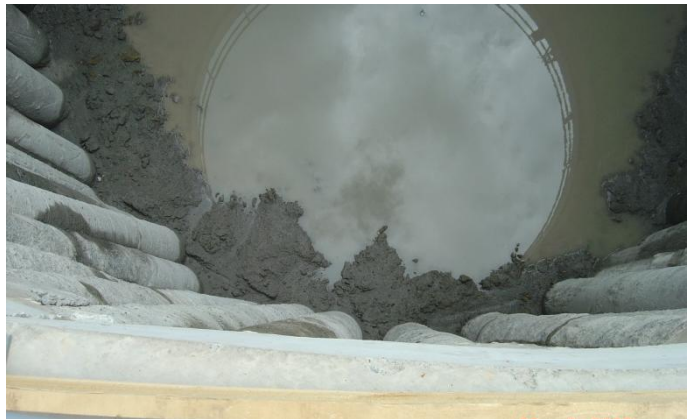
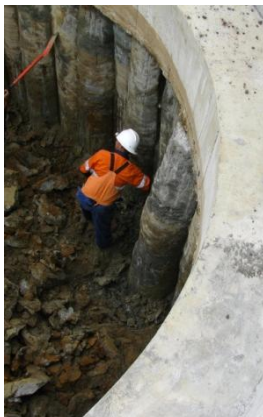
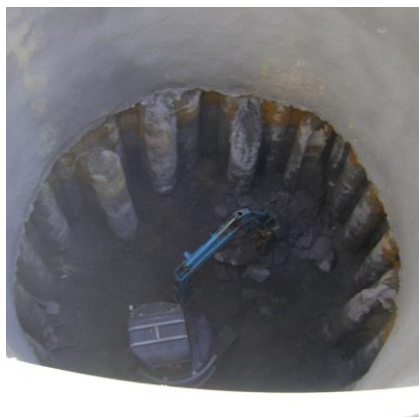
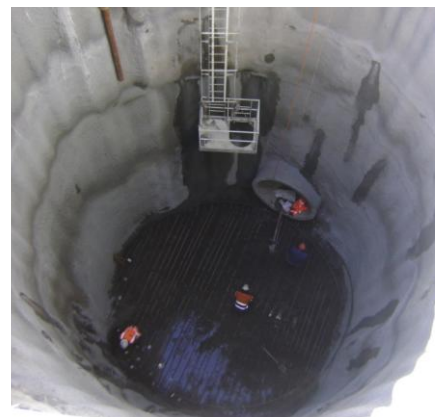
Misaligned secant piles, broken out piles and completed shaft prior to casting base slab

- 6.5m and 8.5m diameter up to 18m deep shafts
- CFA bored piles to 18.5m founding in ECBF deposits
- Low strength mix critical to achieve tolerance
- Contact and briefing of batching plant team
- Layout of piles and tooling assist tolerances

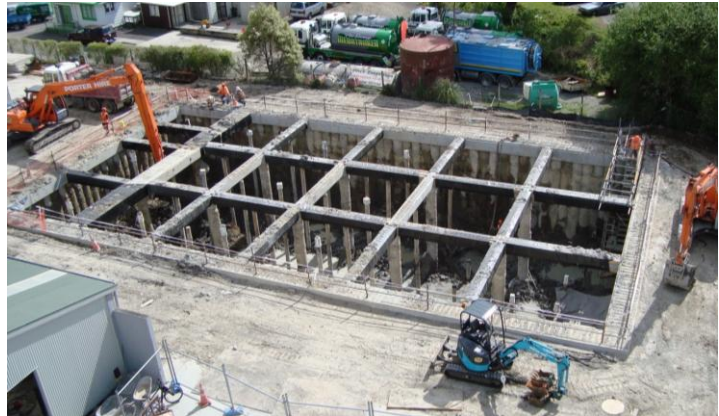
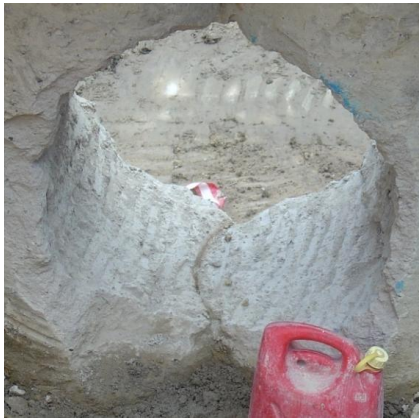
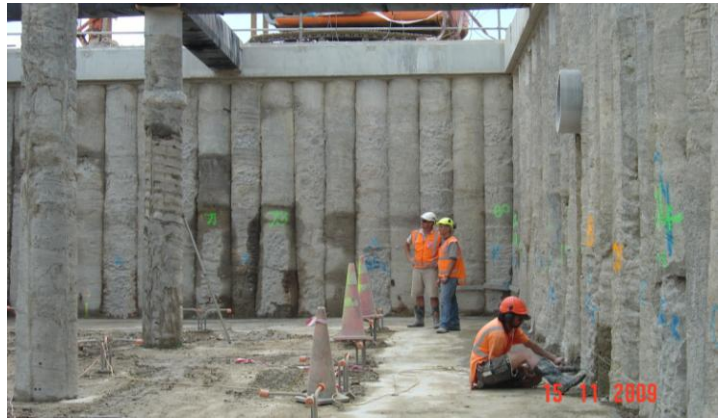
Exposed secant pile wall and pile interlock at pipe breakout location

- 30m x 15m plan area x 6.5 to 8.5m deep in ground tank
- CFA bored piles to 19m in very soft deposits
- Limit soil strength for CFA piles
- Large overbreak in very soft soils
- High strength variation in concrete mix
- Bore water chemistry effects on concrete additives

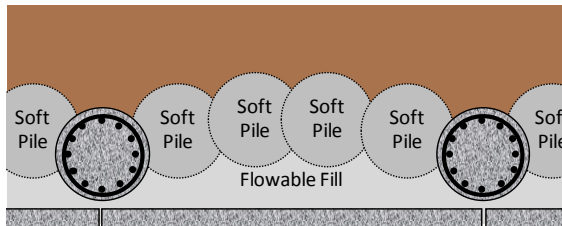
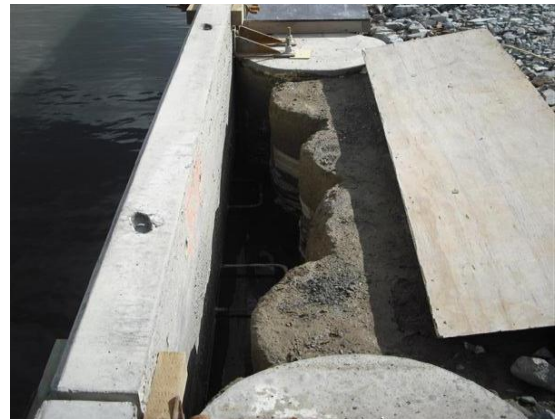
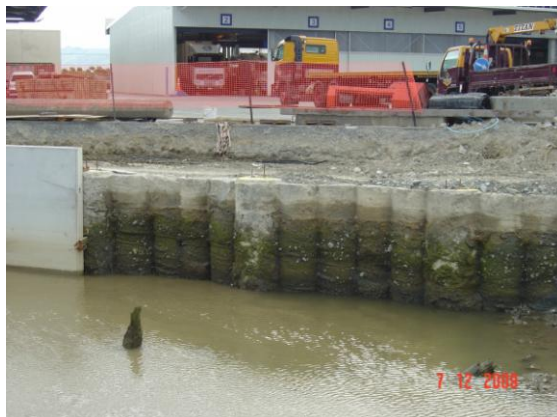
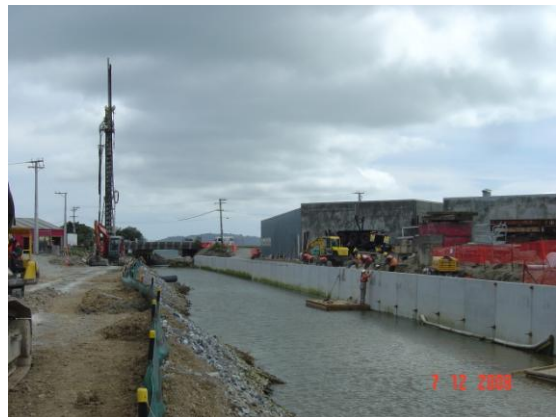
Arched soft piles / king piles exposed and with precast concrete facing panel

- 700m of 3.6m high river wall with scour control
- 750mm dia CFA bored piles to 18m
- King pile & arched soft pile retaining wall
- Cored guidewall through flowable fill

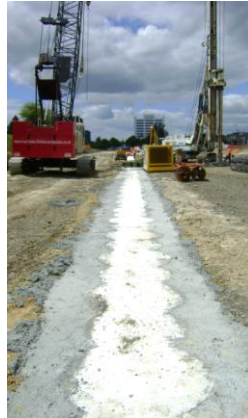
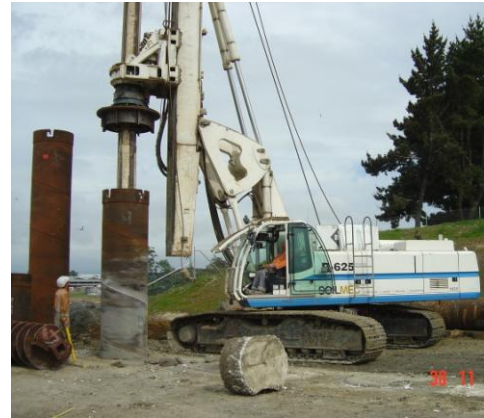
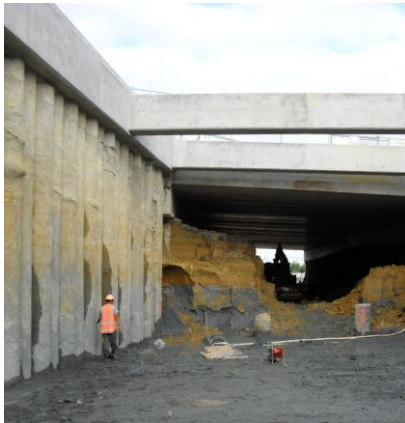
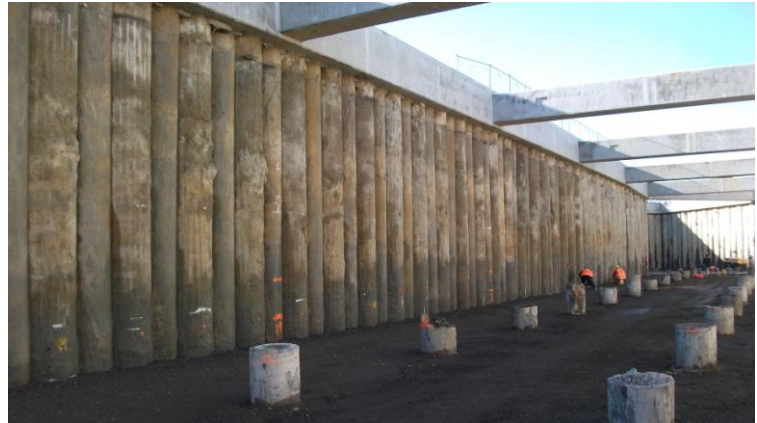
Polystyrene guidewall forms, installing casing and the exposed secant pile walls

- 310 x 17m plan area x 7m deep top propped station box
- Conventional 1050 & 900mm diameter bored piles with rotated casings
- Guidewall constructed using polystyrene effective
