REPLACEMENT OF AKATARAWA BRIDGES

JAMIL KHAN¹, GEOFF BROWN¹ & CHRIS HODDER²

Upper Hutt City Council (UHCC) has replaced the existing Akatarawa Bridges B 1/4, B 1/5 and B 1/6 with new Bridges. The terrain and geology of the site presented a lot of challenges to the design and construction team. The difficult site access, limited site space, construction of sub-structures close to a water way and a tight construction program presented major challenges. These challenges are discussed in the paper and include both the design and construction aspects of the bridges.

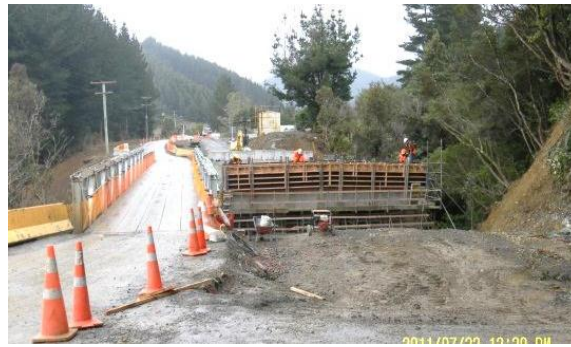
Figure 6: Bailey Bridge at B 1/4 Location

Hence, a temporary Bailey Bridge was provided at Bridge B 1/4 during construction, and temporary pedestrian Bridges were provided at Bridges B 1/5 and B 1/6. The Akatarawa Road was closed for a period of 23 weeks at bridge B 1/5 and B 1/6 while the bridges were constructed.

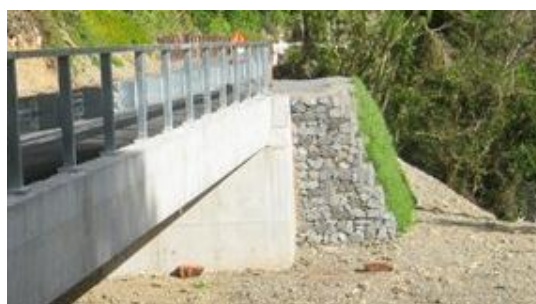
Figure 12: Green Terramesh Embankments

In the design, reinforced earth embankments, with green Terramesh were adopted for the approach widening behind the abutments, where the faces of the embankment can be planted with grass, to reduced the visual impact on the surroundings.

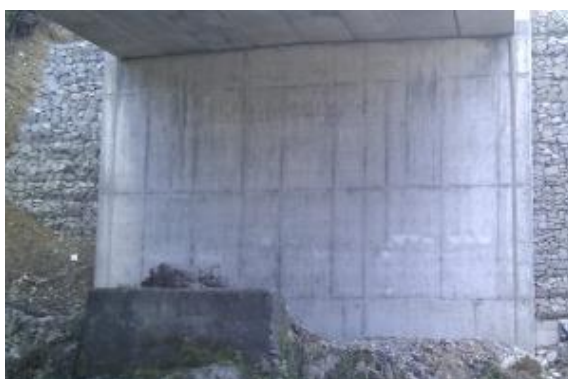
Figure 14: Bridge B 1/4 North Abutment

The project included a number of large concrete pours. The first large concrete pour was for the Bridge B 1/4 north abutment. The seven metre deep abutment required 90 cubic metres (20 truckloads) of concrete and was poured in a single continuous pour. The pour began at 3:30am in the morning and was finished at 5:00pm.

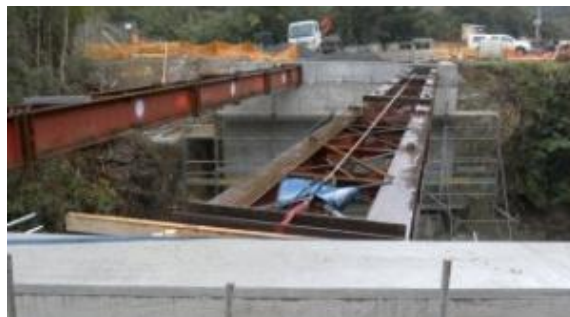
Figure 16: Temporary Props

Due to the topography of the site the abutments were of different heights and back filling of the abutments was not allowed until the abutments were propped by the bridge deck. However, the installation of the bridge deck was not possible until backfill was in place to form a platform for the crane. Therefore, for Bridge B 1/4 and Bridge B 1/5 temporary steel props were installed at the top of the abutments. The backfill was carried out simultaneously

from both sides in such a way that the difference in the backfilled was never more than 1m. The temporary props were removed after installing a number of the bridge beams.

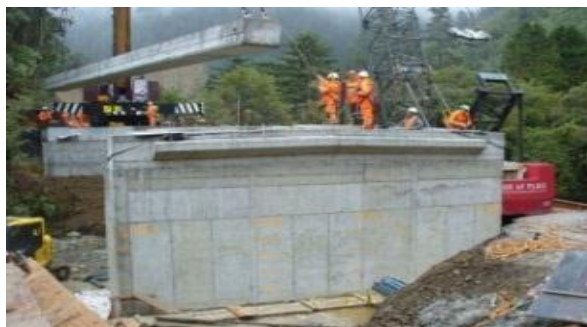
Figure 17: Bridge B 1/6 Revised Methodology

For Bridge B 1/6 the construction sequence was revised to catch up delays and the north MSE wall was modified to be a self-supporting wall with a physical gap between the MSE wall and the abutment. The MSE wall was built-up to form the platform for the crane and the bridge beams were launched from the north end. The physical gap was filled with drainage metal as the back-filling on the back of south abutment progressed and corners were sealed with the concrete.

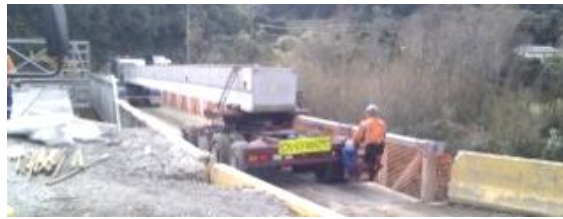
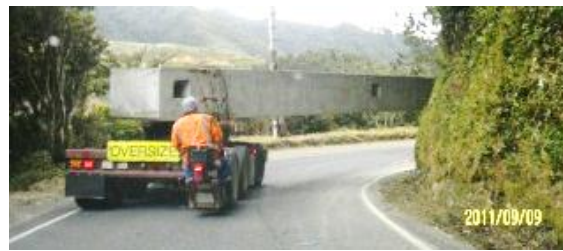
Figure 18: Beam Transportation

The alignment conditions on Akatarawa Road imposed challenges in the transportation of large span pre-cast beams. The transport company identified a number of sharp horizontal bends along the road which required some trimming to transport the 25m long pre-cast beams. The pre-cast beams were cast in Otaki and delivered to Upper Hutt during the night. A time slot between 10am to 1pm was reserved for the delivery of the beams from Upper Hutt to the bridge location, as at this time the Akatarawa road is less busy. The local residents were notified of this.

Delivery of the new bridge beams, 25 meters long and weighing 43 tonnes each, was a logistical challenge for the drivers. On tight corners, a second driver was needed to steer the rear axle of the truck independently. The combination of bad weather and the need for the drivers to determine the best method to negotiate each corner meant that the first trip from the Akatarawa Cemetery up to the bridge site took 3 hours and 20 minutes, whereas subsequent deliveries took one and half hours.
