ASPECTS OF THE SEISMIC PERFORMANCE OF CONCRETE BUILDINGS

RICHARD FENWICK

SUMMARY

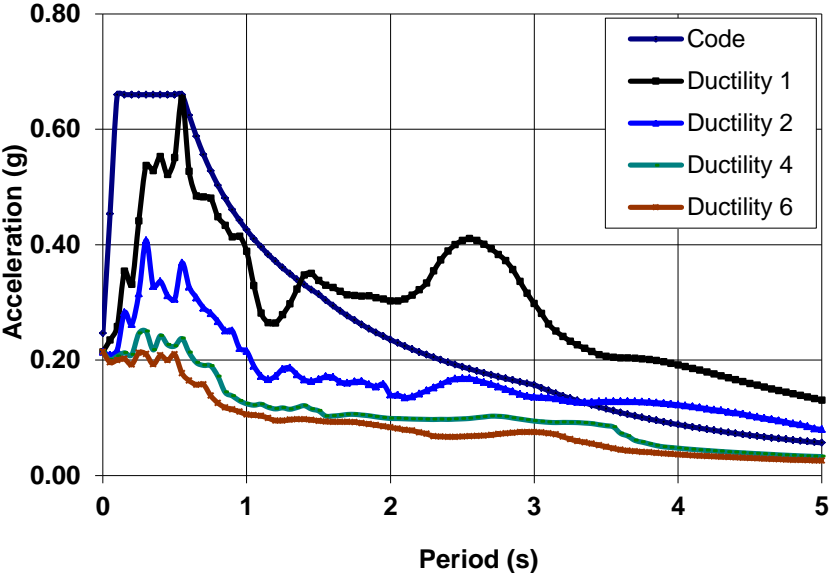
(a) Acceleration response spectra

(b) Displacement response spectra

Figure 2: Acceleration and displacement for September earthquake in north-south direction

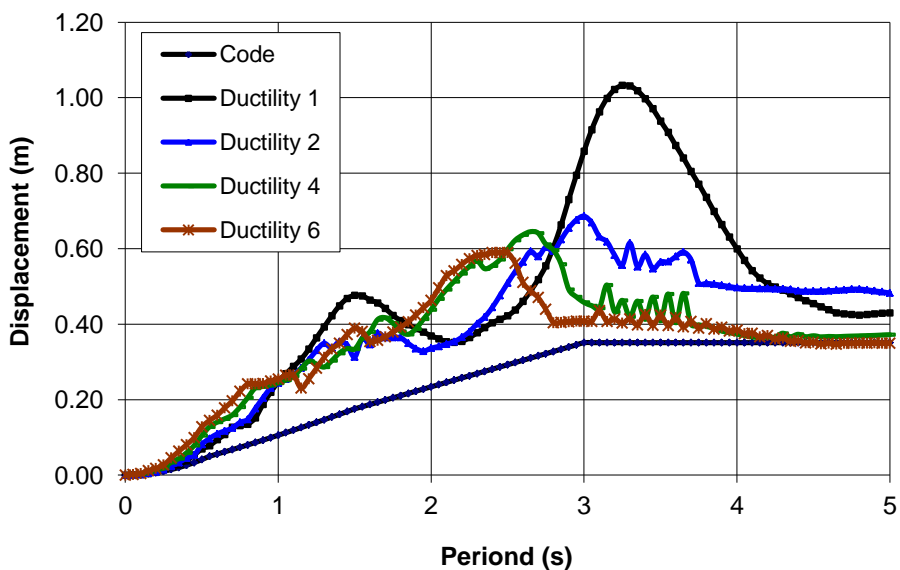
For the February earthquake the response spectral values are greater than the 500 year return design values. When averaged, without allowing for magnitude weighting (described in the next sub-section), the spectra are reasonably consistent with the 2,500 year return design spectra, see Figure 3. A particular feature to notice is the high accelerations and corresponding displacements in the period range of 2.5 to 4 seconds. However, it is important to note that while the elastic response spectral values in this period range are very

high the corresponding ductile response spectra are appreciably smaller. In this period range the equal displacement concept gives a poor prediction of the peak displacement. This is probably due to the short duration of strong ground motion (8-10s) and the relatively few fundamental cycles of vibration that could take place for structures with fundamental periods of vibration in this period range.

Figure 3: Acceleration and displacement for February earthquake in east-west direction

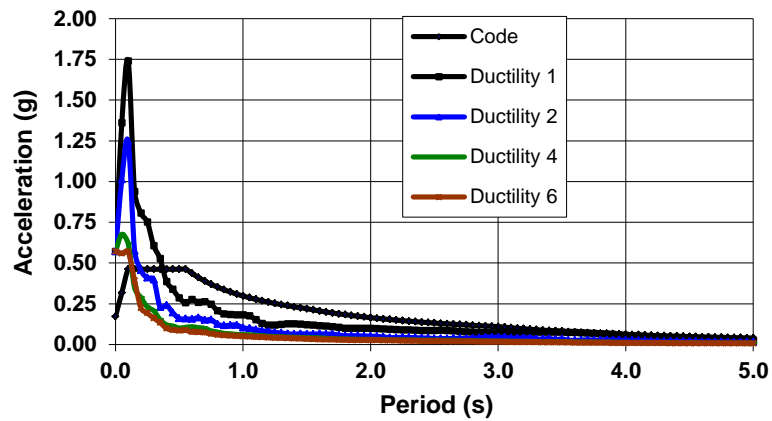
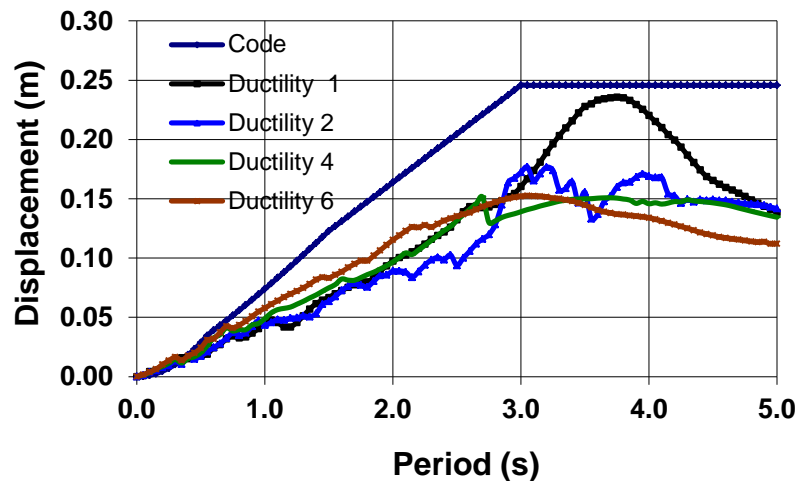
Figure 4 shows the acceleration and displacement spectra for vertical ground motion for the February earthquake. In this case the shapes of the design spectra are very different from the spectra calculated from the measured ground motions and a review of the design spectrum is justified. However, the high peak in vertical ground accelerations is associated with the shallowness of the earthquake fault and its closeness to the CBD, and this would not be typical of most other situations. While the vertical accelerations were very high for periods close to 0.1 seconds the associated displacements are only of the order of 4mm.

Figure 4: Response spectra for vertical earthquake motion

A revision of the design spectrum for vertical ground motion in NZS1170.5 is desirable.

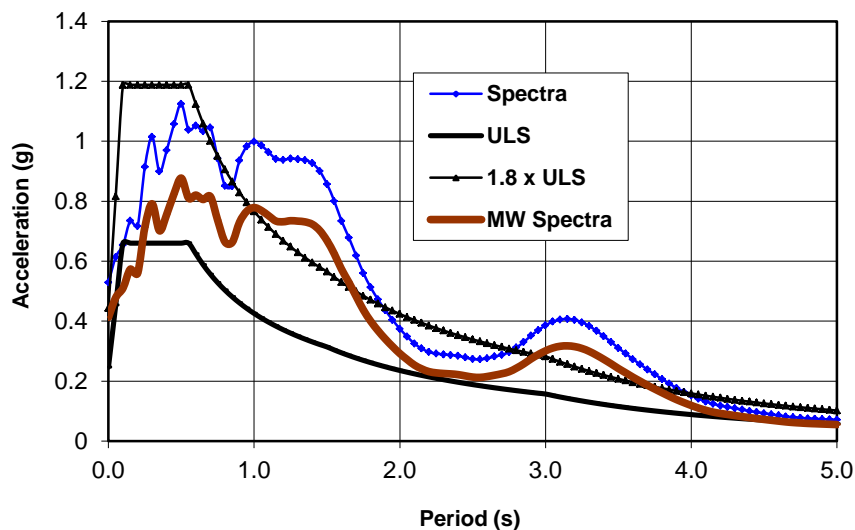
When the magnitude weighting factor is applied the response spectrum lies between the 2,500 year and 500 year return design spectra, while without the magnitude weighting factor the spectrum is generally in excess of the 2,500 year design values. Further study of the influence of duration of shaking on structural response is desirable given that the quoted magnitude weighting factor comes from liquefaction studies, and not studies on modern ductile structures.

Figure 5: Acceleration response spectrum for February earthquake with and without magnitude weighting compared to design values for 500 and 2,500 year return periods

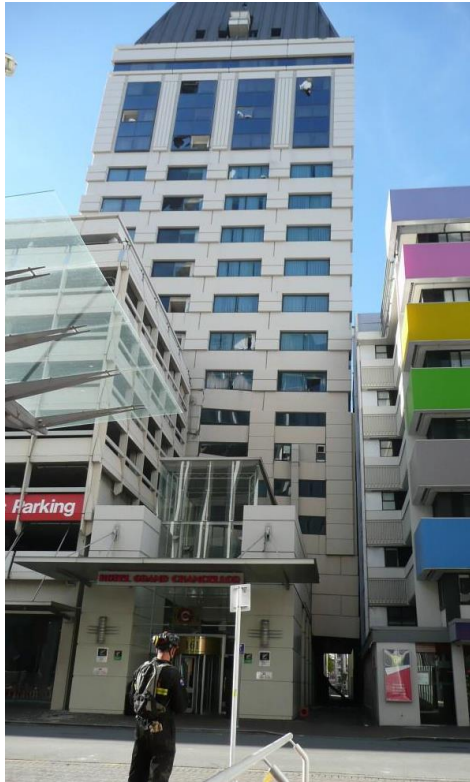
A lane on the east side of the building resulted in the eastern most bay of the building being cantilevered off the remainder of the structure. The lane can be seen on the right hand side of the photo in Figure 6 and in the structural arrangement shown in Figures 7 and 9.

Figure 6: Photo of Hotel Grand Chancellor looking north

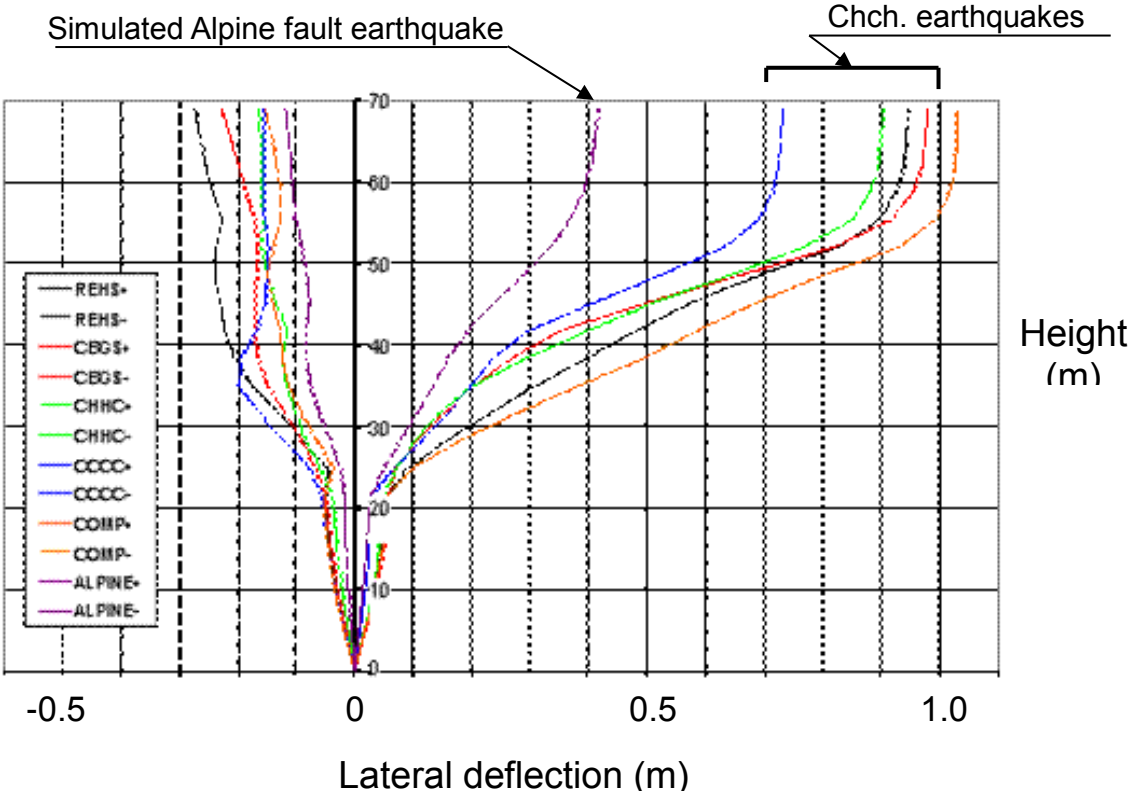
Figure 10 shows the predicted lateral displacement envelopes found from the analyses. The lateral displacements found from the four recorded ground motions in the CBD of the February earthquake were similar in magnitude to each other with the drifts ranging between 0.72 to 0.95 metres at a height of 70 metres. The corresponding inter-storey drifts are in the range of 3.5 to 4.5%. The compound record of the three earthquakes made little difference to the lateral drifts. The predicted displacements with the simulated Alpine Fault earthquake are about half of the corresponding values found using the February earthquake ground motions.

Figure 10: Lateral deflection envelope found from different earthquake ground motions

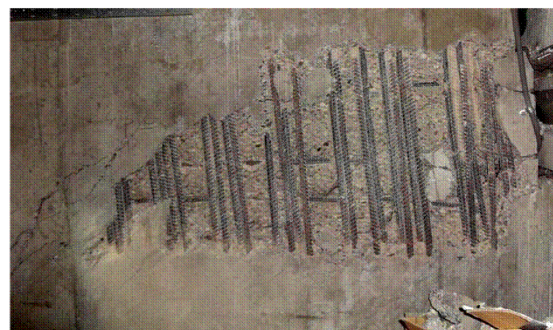
Figure 13 shows part of one of the transfer beams which supported the floors in the east bay of the building below level 12. In the February earthquake extensive spalling occurred in the beam close to the location where the longitudinal reinforcement from the member supporting the eastern bays of the building was anchored into the beam. The spalling occurred near the mid-depth of the beam where U shaped stirrups were lapped in cover concrete. The figure also shows a strut and tie model of the beam. Section A-A is shown on Figure 14.

Spalled concrete in lap zone of stirrups - 2nd

Figure 13: Spalling in a transfer beam in the HGC in the region where stirrups were lapped in cover concrete (Source of photo: Adam Thornton)

It is very likely that the spalling occurred due to the shock loading associated with the failure of the short wall in the first storey. High bond stresses would have been induced in the stirrups in their lap zone. As illustrated in Figure 14 bond forces induce radial tensile stresses in the concrete surrounding the reinforcement which generates hoop tensile stresses in the concrete. Cracking associated with these stresses may develop between the bar and the free surface of the concrete. However, where the cover concrete is thicker than half the clear spacing between the bars, or where the tensile stresses in the cover concrete

The problem of potential spalling caused by bond stresses associated by the lap between U shaped stirrups can be reduced by placing a high proportion of the stirrups so that they are lapped in the confined concrete in the central regions of the beam.

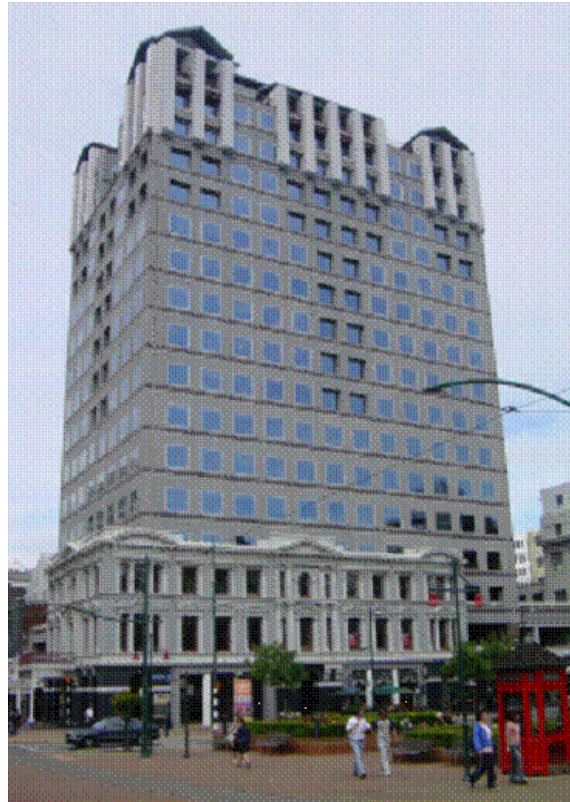
One of the structural details used in the Clarendon building illustrates the importance of detailed load tracking. Figure 15 shows a photo of the building and Figure 16 gives a simplified sketch of the layout of the floors in the tower of the building.

Figure 15: Photo of Clarendon Building

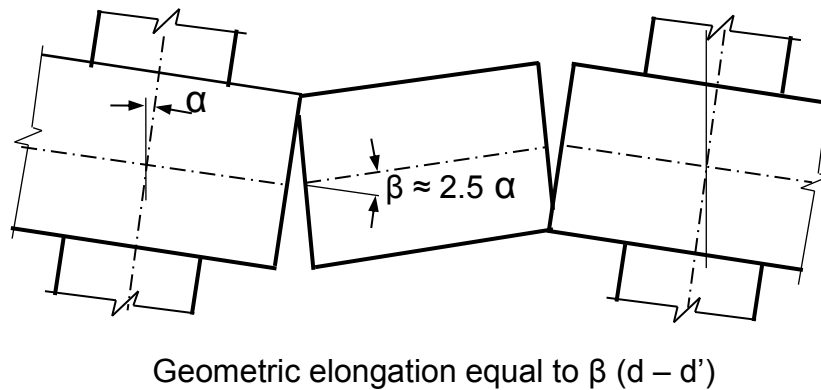
2. Displacing the plastic hinges away from the column face increases the inelastic rotation sustained by the plastic hinges. Figure 18 shows that the inelastic rotation of the plastic hinges (β) in the beams in the north and south frames is close to two and a half times the inelastic drift in the frame (α). This amplified rotation has two main effects. First, geometric elongation is increased and second, the increased inelastic rotation increases the potential for stiffness degradation. Tests on many beams have shown the resultant elongation on beams subjected to inelastic load cycles is generally of the order of two to three times the geometric elongation [Fenwick et al 2010]. This mechanism causes damage to floors, increases stiffness degradation and it can damage columns. For the frames on the east and west sides the plastic hinge rotations are close to one and a quarter times the inelastic drift on the frames. Figure 19 shows the stiffness degradation measured in tests of three moment resisting frames. The beams had different span to depth ratios (L/h). Two of these tests were made by Restrepo-Posada [1993] with one being a scale model of the beams and columns used in north and south sides of the Clarendon, and the second was identical except that the beams contained standard longitudinal reinforcement with plastic hinges forming at the face of the columns. The third test shown in the figure is taken from the test of a multi bay frame in which the beams had considerably longer span to depth ratios (L/h) [Wuu 1996]. It can be seen that the form of beam used in the Clarendon in the north and south frames degraded in stiffness more rapidly than the conventional beams. If the north frame initially sustained inelastic deformation before the south frame, the stiffness degradation

Figure 18: Diagrammatic illustration of inelastic deformation of a beam with diagonal reinforcement in central region

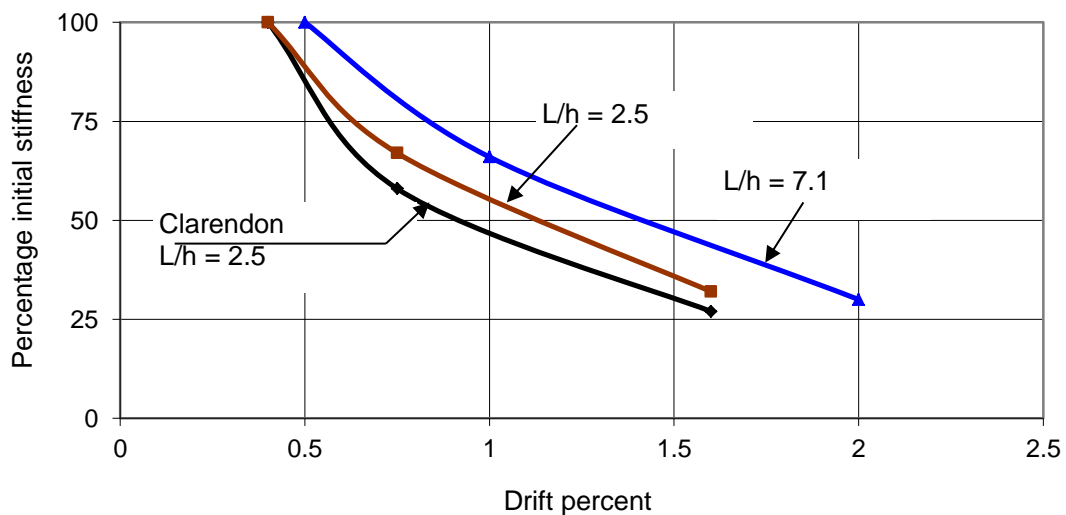
Figure 19: Stiffness loss with cyclic loading

Research is required on the torsional stability of buildings with the object of developing design criteria to guard against this form of instability.
