NEWMARKET VIADUCT REPLACEMENT PROJECT – END OF AN ERA

TED POLLEY *, PETER ELCOCK **

INTRODUCTION

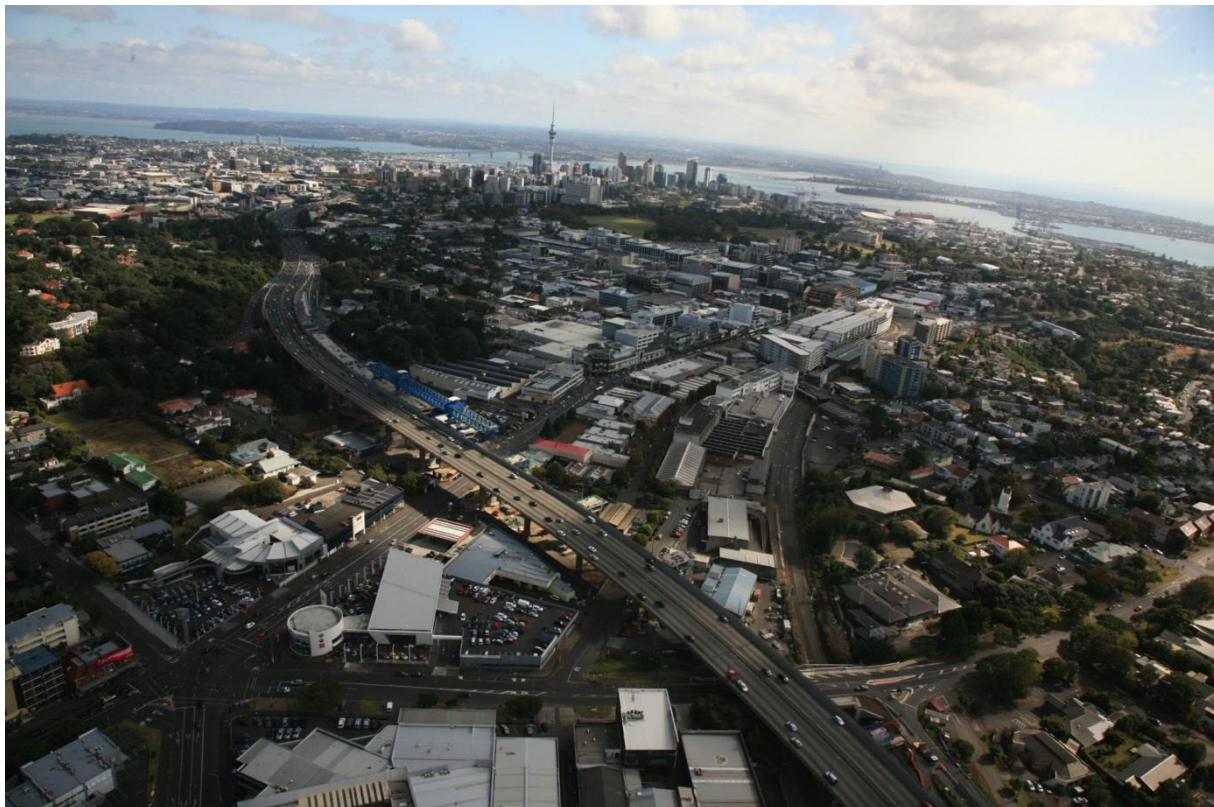
Figure 1. Aerial photograph showing the new southbound viaduct under construction.

The existing Newmarket Viaduct was constructed in the 1960s and forms a vital link in Auckland's motorway network. The dual three lane viaduct carries over 160,000 vehicles per day and is part of the busiest section of road in New Zealand. The viaduct passes over a busy urban retail area and the North Auckland Railway line (refer to Figure 1).

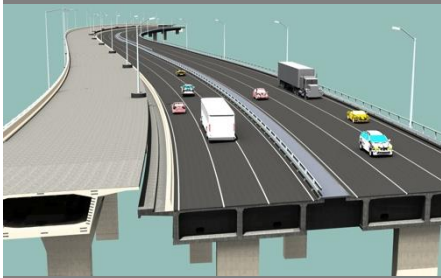
Stage 1 – Construct new southbound viaduct

The design of the new viaduct had to allow for a staged replacement of the existing viaduct; with the centre line of the new viaduct being shifted 13m to the east. This was to avoid major motorway realignment, land purchase, and to minimise disruption to the community. The construction and deconstruction work was carried out by a 810T overhead launching gantry. A detailed staging scheme was developed to enable the motorway to remain in full service throughout the project and the stages are illustrated below:

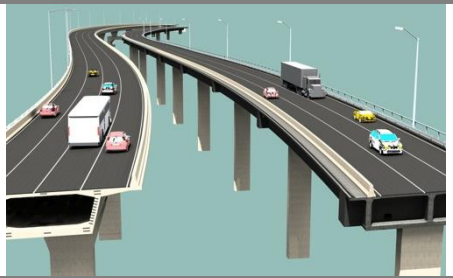
Stage 2 – Commission new southbound viaduct and deconstruct old southbound viaduct

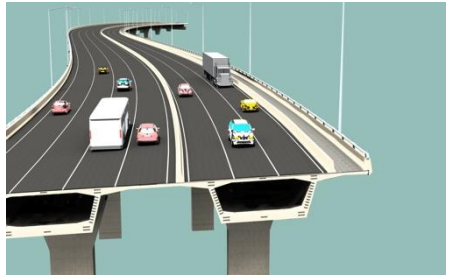
Stage 4 – Commission new northbound, deconstruct old northbound and extend cantilever

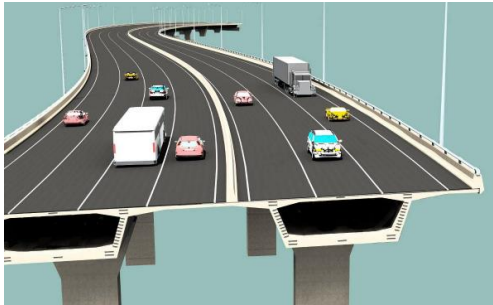
Stage 5 – Final Lane Configuration

A cast insitu median stitch slab joins the two boxes together and forms a continuous deck 28.7m wide between the two high performance Test Level 5 (TL5) edge barriers. The viaduct will initially carry 4 lanes southbound and 3 lanes northbound, but has the capacity to run 4 lanes in each direction in the future. This can occur by shifting the median barrier and reducing shoulder and lane widths.

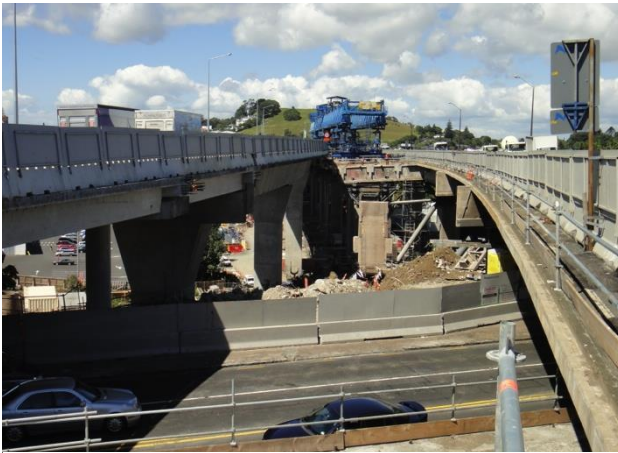
Figure 6. Deconstruction of the southbound viaduct.

The deconstruction process involved making irreversible changes to the existing structure, systematically removing elements and weakening the viaduct. In addition, the remaining structure was required to carry live traffic as well as supporting the 810 tonne launching gantry used for the deconstruction. Therefore robust controls on deconstruction activities

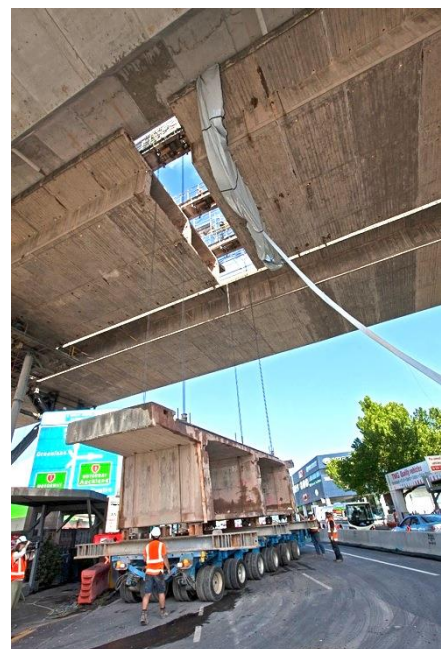
Figure 8 - Removal of closure segment over Broadway, Newmarket

Removal of the mid-span closure segments was generally carried out in advance of arrival of the launching gantry at that span. The ‘Closure Segment Deconstruction System’ (CSDS) was a combined arrangement of equipment and procedures. The CSDS was developed to safely release locked-in loads from the superstructure when the initial span cuts were made, and then lower the closure segment to ground level.

The philosophy behind the system was fairly simple. Firstly, jacks acting in the plane of the top slab of the box girder were used to decompress the concrete in that region while the upper part of the superstructure was cut. The jacks were then gradually depressurised to release the bending moment from the bridge. At this point a set of ‘stitching beams’ were engaged to control the release of shear forces as the final cuts were made through the cross section. Finally, after a second cut was completed to release the closure segment, strand jacks mounted on the stitching beams were used to lower the closure segment to ground level.

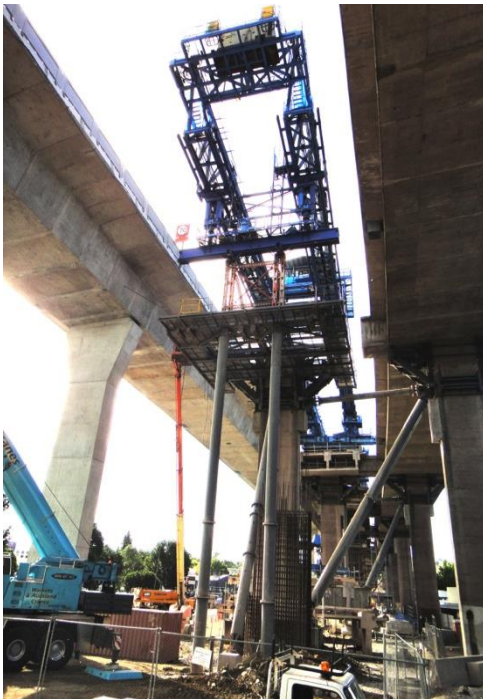
Figure 9. Deconstruction gantry supported on vertical props during pier segment removal.

As the project progressed, opportunities were identified to maximize use of the deconstruction gantry in order to reduce reliance on mobile cranes. For example, a method was developed of using the gantry during its launch cycle to remove the pier-cap segment that had, up to that point, supported its rear leg.

This was achieved by supporting the gantry on the shield beam/vertical prop system while cutting the pier-cap segment (up to 120 tonnes) free of its column and lowering it to the ground using the gantry winch. Implementing this involved significant changes to the gantry kinematic sequence that pushed both the gantry and the propping system to their limits of safe operation (80% of ultimate capacity in the case of the propping system).

Strict controls were placed on this activity including proof loading the pair of vertical props before cutting the pier-cap segment free to confirm that both props would attract equal load during segment removal. Continuous live loading of the props was also carried out during the lift to allow corrective action to be taken in the event that uneven loading of the props started to develop.
