THE DESIGN AND CONSTRUCTION OF A CAST IN SITU CONCRETE HELICAL STAIRCASE

An examination of design and construction techniques to cast a complex three dimensional helix in concrete.

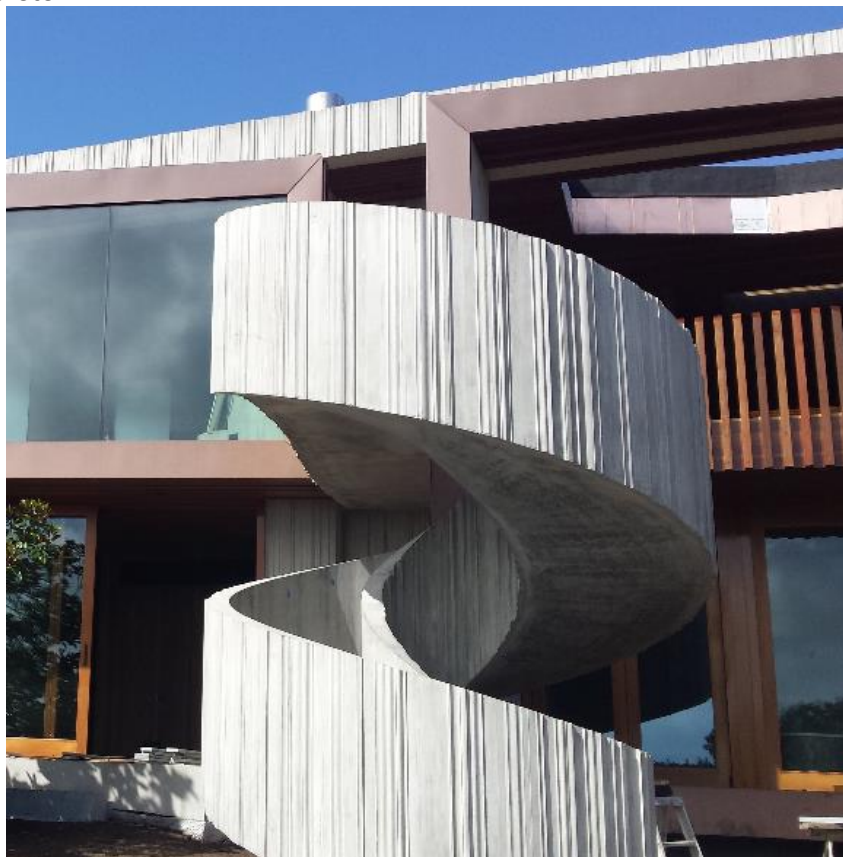
Figure 1 – completed staircase

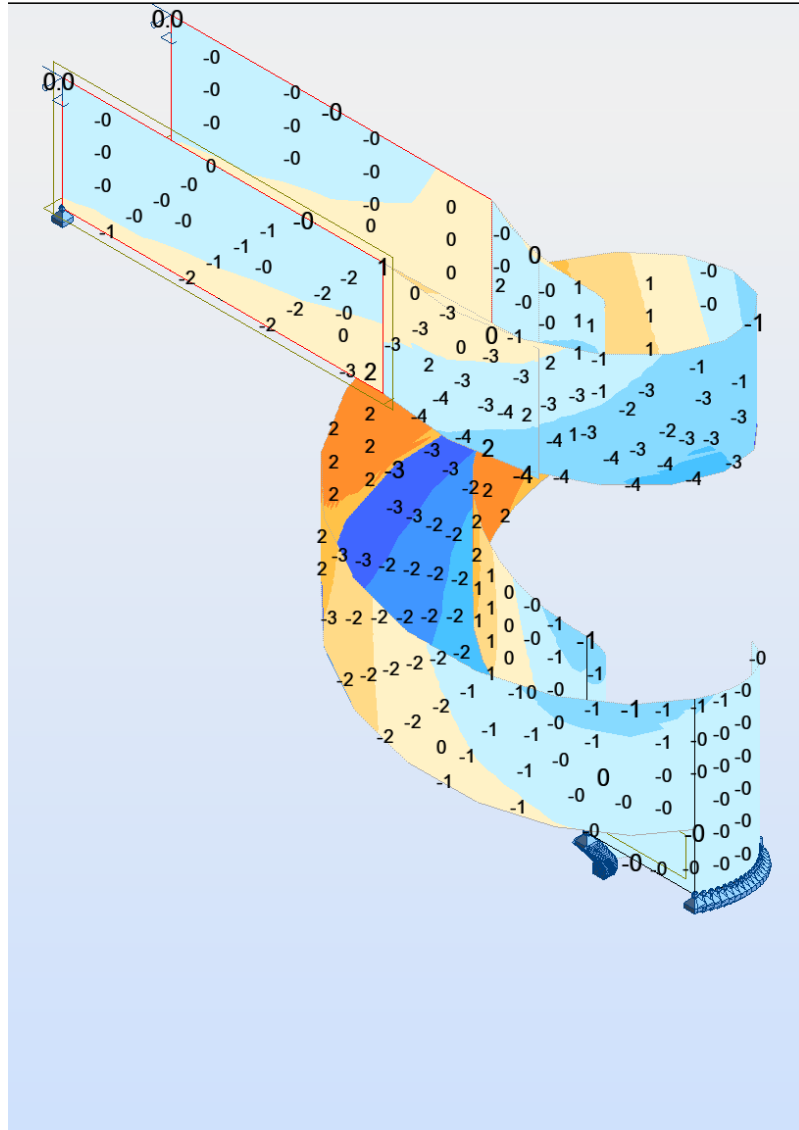
Figure 4 – Scenario 2 - deformation in the vertical direction spring (15kN/mm).

Initially the model was constructed with pins (fixed spatial position, free rotation) at ground and second floor level. This resulted in peak moments and stresses at the point of fixing at the second floor level. The model was refined to have pins at the base and springs at the top of the handrail at the second floor level. This alleviated the stress concentration at the supports but increased the deformation in the helix. A range of spring stiffness's were examined to understand the sensitivity and impact of fixing points.

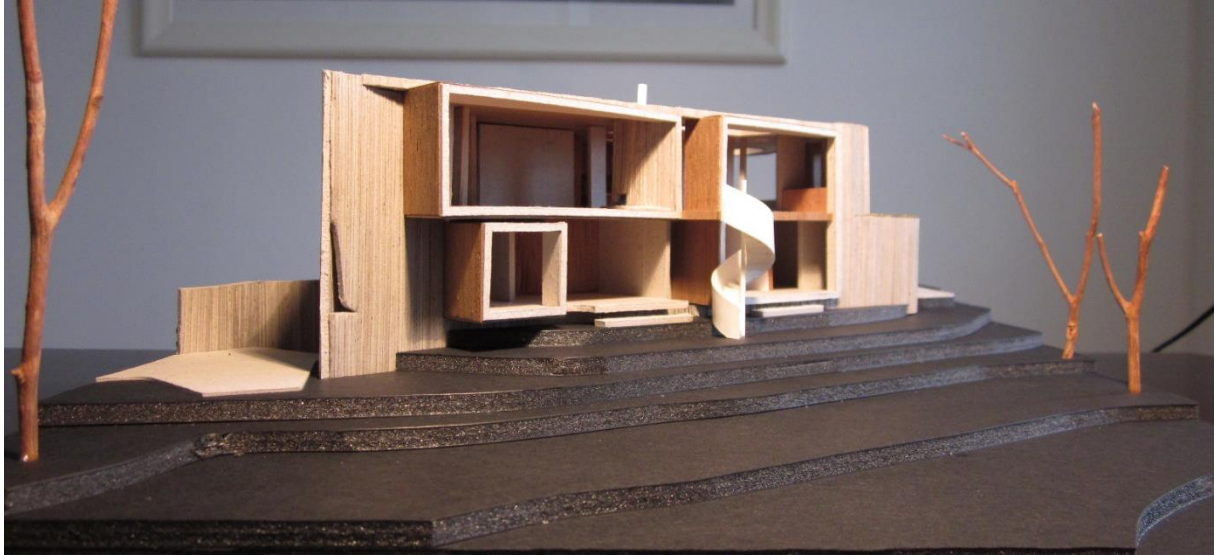
Figure 5 Physical scale model of the house constructed by Stevens Lawson.

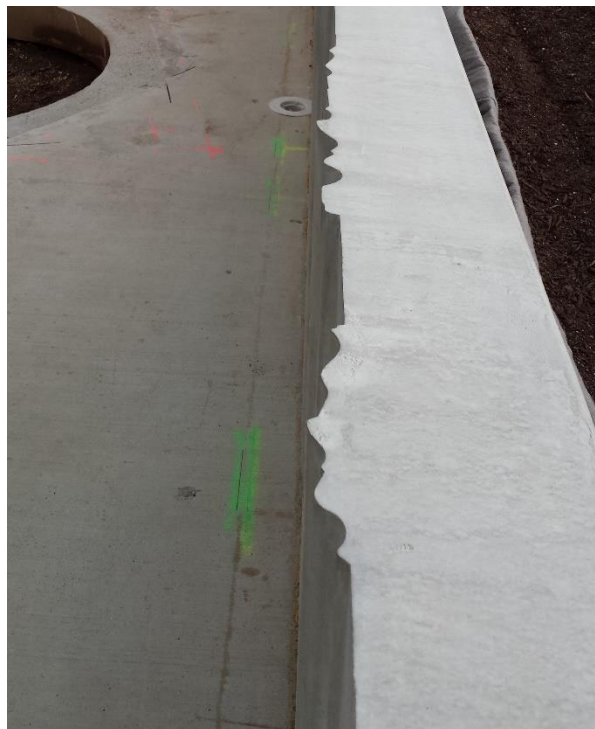
Figure 6 Example of relief generated by timber profile

Smooth Victorian architrave profiles enlarge by 200% where selected as the external finish for the concrete on both the home and the signature piece of the house which was the self-supporting Helical Staircase to the north of the home which gave access from the top deck to the external gardens.

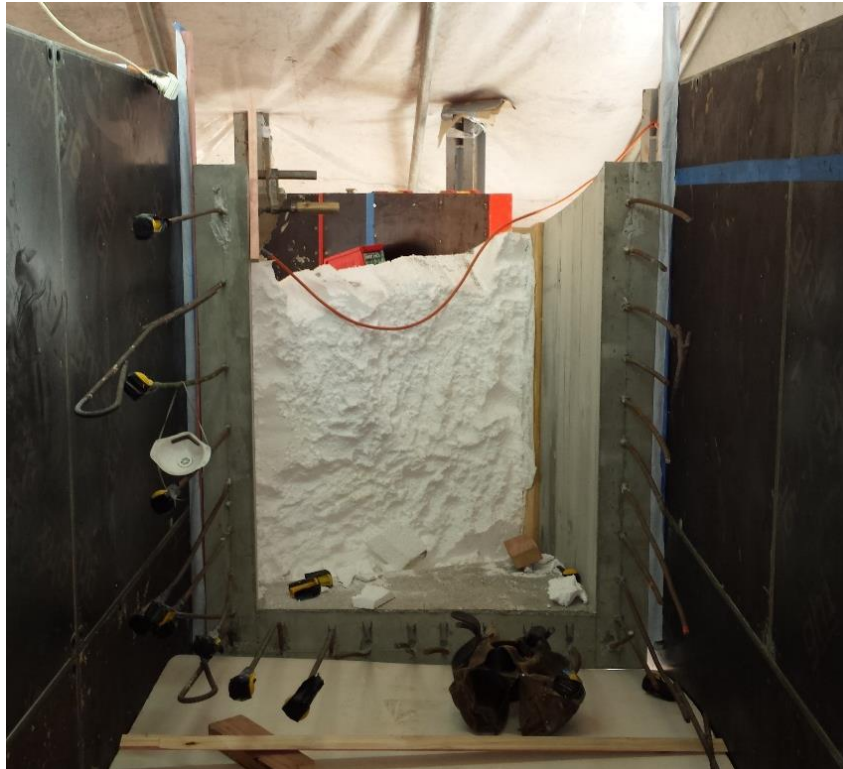
Figure 8 – showing polystyrene core, timber form, pour staircase and protruding reinforcing for bridge

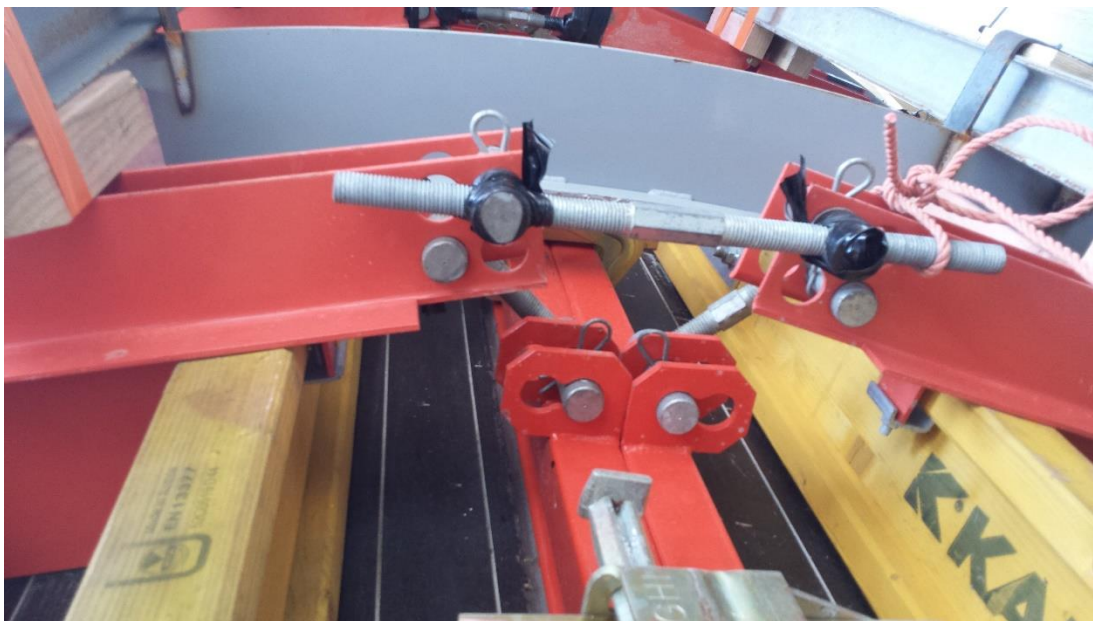
Figure 9 Formwork set up on external barrel

The piles and footing bed were constructed and accurately placed reinforcing protruding out to capture the helical base. Bannan Construction commenced with the mould form using formwork specifically purchased German manufactured bendable formwork to create the outer barrel.

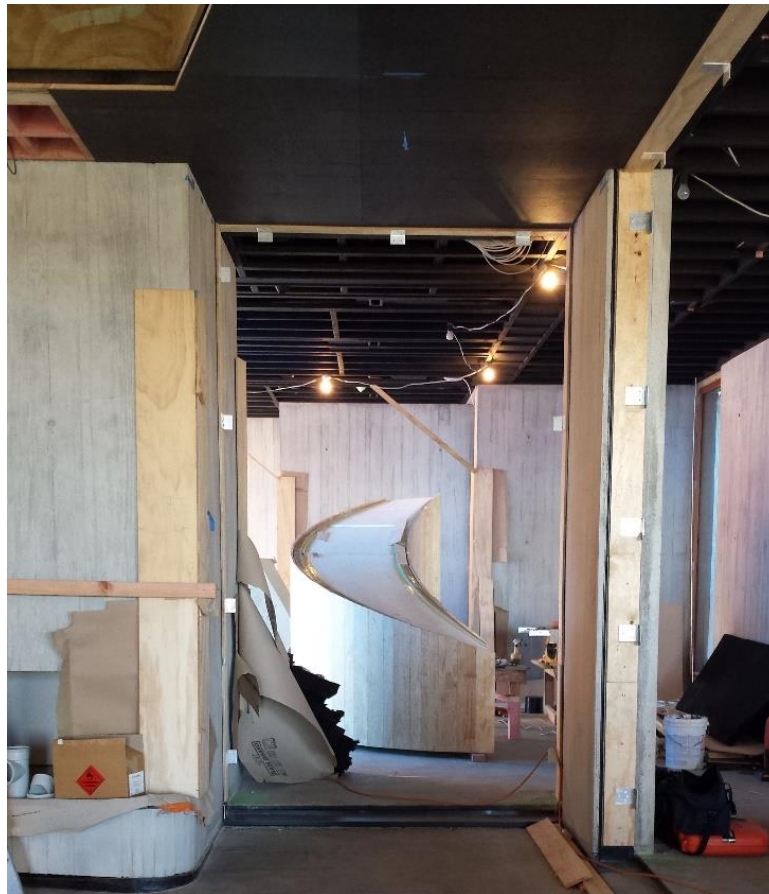
Figure 10 Picture of the Tread Moulds in staging area

The internal moulds were then placed which would form the internal side of the rails and the treads and risers. These forms came in small sections of four treads each. Before placement the wooden form liner was placed and then each one carried carefully in place and locked to the section in front by a specially designed system created by Bannan Construction. Placing these moulds in a confined space tested the construction team. Once in place, a scaffold and steps were erected to facilitate with both final adjustments of the forms and then the eventual pour.
