## CONSTRUCTION OF TEKAPO A NEW INTAKE GATE AND SHAFT

MARK HEDLEY<sup>1</sup>, ALEX PARFITT<sup>2</sup>

### SUMMARY

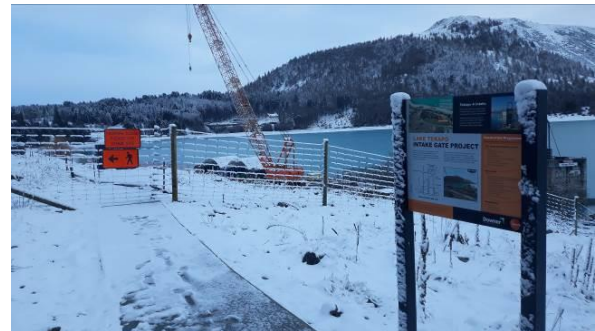
*Figure 2: Extreme temperatures were a risk to concrete quality*

Some winter concreting was required but fortunately, during this time, the temperature in the tunnel and shaft was slightly higher inside than the ambient outside temperature. This helped to mitigate the risks posed by cold temperatures.

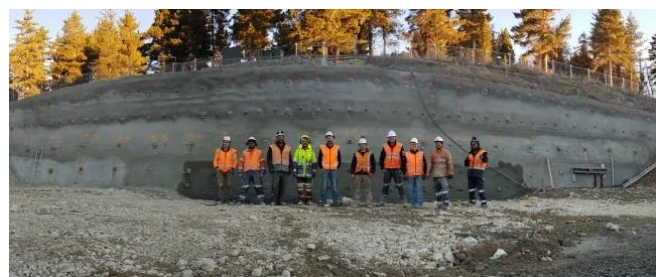
*Figure 3: Completion of 6m high retaining wall*

To facilitate a clear, level construction area, a 6m high retaining wall was constructed, containing 100 x 5.5m long soil nails and shotcrete. These works were completed 22 days ahead of programme. This work also provided an opportunity for the design and construction team to refine procedures for installing the soil nails and shotcrete for the shaft leading down to the tunnel.

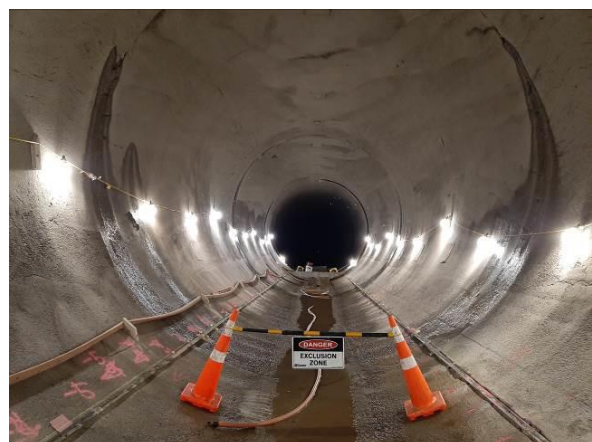
*Figure 5: View inside the existing tunnel*

To access the tunnel, a 'letterbox' opening was cut into the crown of tunnel. This opening was restricted to 4.2m in width. This size determined maximum size of liner plates (and the amount of welding). A wire saw was used to cut a neat hole in the tunnel crown. (Bolts were present!) The existing tunnel, now 70 years old was found to be in excellent condition, and very close to dimensional expectations.

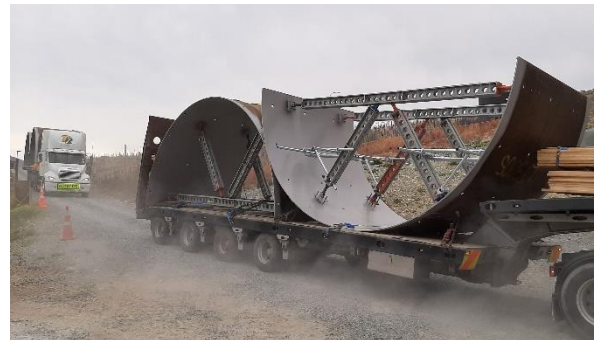
*Figure 7: Tunnel liners arriving on site*

The tunnel liners were manufactured in halves, totalling four curved sections upstream and four curved sections downstream. The restriction in 'letterbox' size provided a challenge to install the liners in a short time. The bottom half was lowered in to the tunnel on its side (3m wide), rotated to horizontal within the tunnel and slid on skids using a snatch block and the crane winch up into the tunnel, away from the opening. The top section was then lowered in and rotated to horizontal inside the tunnel, before the bottom half was then pulled back beneath the top half (using a tirfor) and secured. The liner set was then winched along the tunnel and into position. Comprehensive lifting and rigging plans were prepared well in advance to ensure this lifting could all be done safely without damaging the liner sections. A trial tunnel was set up at the Parfitt fabrication workshop to check the method. All eight liner rings were installed over a one-day period using this very efficient method. The liners were levelled, doweled, welded, grouted and painted in place.

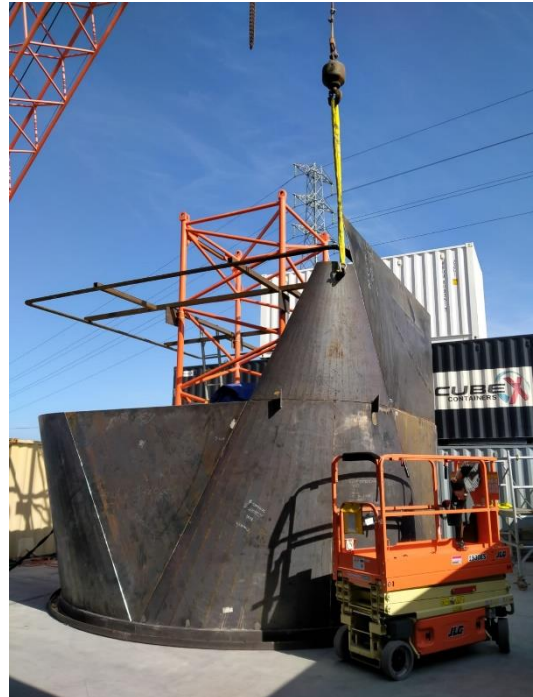
*Figure 8: Fabrication of stent underway in vertical position*

The stent was made of 8mm skin plates and a series of fabricated T sections of web and flange at 300mm centres. It transitioned from an upstream egg-shaped tunnel to the rectangular gate and back to the downstream egg-shaped tunnel, making for quite a complex, fully welded geometrical structure more akin to an ocean going ship than a civil structure. The 40t stent was fabricated and painted at the Parfitt workshop in a vertical orientation to minimise jig costs (a set of 120t crane booms in the vertical position were used). Vulcan supplied, cut and tip folded all plate. Each stent was rotated to horizontal and transport was via an ultra-low bed trailer designed for tank transport and operated by Jackson Heavy Haulage.

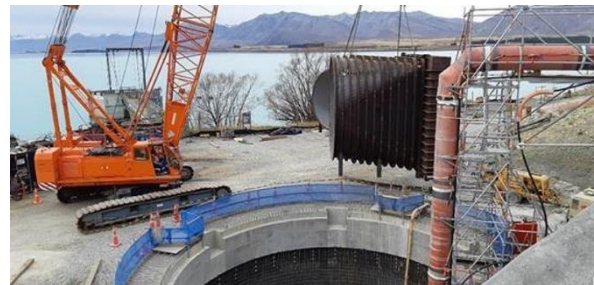
*Figure 9: Installing the Stent in two halves*

With the liners in place, and the existing tunnel removed within the shaft footprint, the two stent halves could be lowered into place. The two sections were lifted in one at a time. The cylindrical ends were butted against the sawcut faces of the tunnel with the square ends meeting in the centre of the shaft. Placing the second section was a challenge, with extremely tight tolerances at either end. There was only 100mm of space between the stent piece and the stair tower, and a similar distance between each section once these were actually in place. Although challenging, each section was successfully slotted into place and connected using a combination of temporary and permanent sealing plates. To ensure stability of the stent during full tunnel operation (6m diameter of water), 1.5m of concrete was poured at the base of the shaft to encase the invert of the stent. Pour heights were limited due to the concrete pressures acting on the stent.

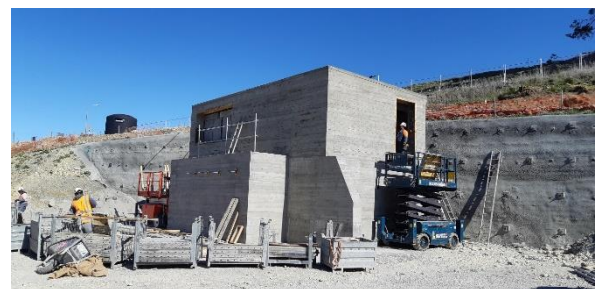
Figure 12: Control room structure

The control room was a “Ministry of Works” style, fully in-situ concrete bunker. Doka Frami formwork was used to form wall, floor and roof elements. A horizontal rough sawn timber finish was provided in keeping with the surrounding concrete work.

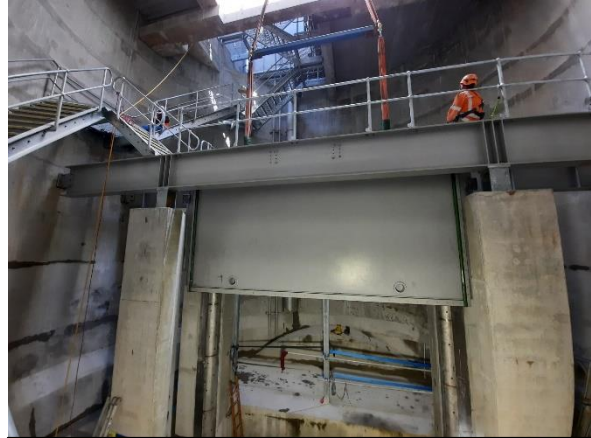
Figure 13: Gate installation

The gate was manufactured in two halves – a 32t lower half and a 17t upper half, and fabrication was an exacting task. Installation tolerances were extremely tight and placing the gate was challenging.

Each section was lifted into place in the pre-formed metal slot with just 5mm of free space each side. Care was needed to avoid damaging the all-important gate seals and seal faces. Installation was successfully achieved in just nine hours, a testament to the good planning, precision engineering and the quality assurance carried out in the manufacture of all of the static and moving parts.
