Maintaining Aging Titanium Clad Equipment

John G Banker, President, Clad Metal Consulting

Reactive Metal Clad in CPI

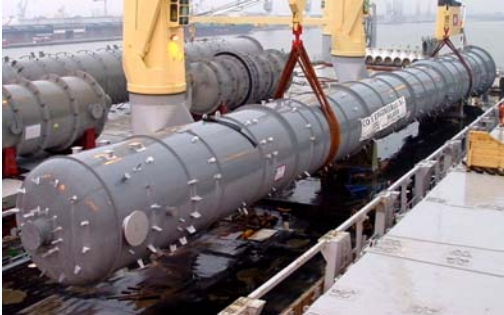
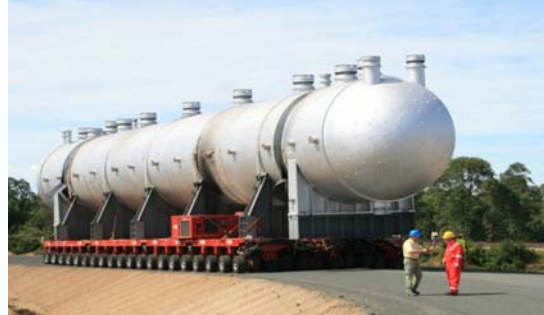
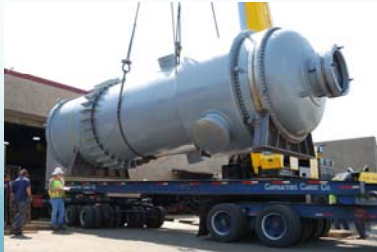
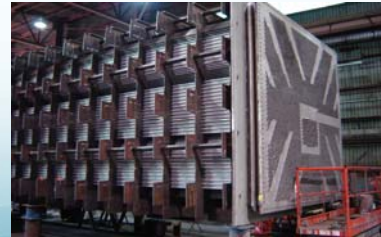
Typical Ti-Clad Equipment

- Typically Ti, Zr, Ta, Nb – Ti Dominates, presentation focus' on Titanium but generally applicable to all four metals
- Clad is commonly used in stationary CPI equipment--- pressure vessels, columns, heat exchangers
- For over 50 years, >95% of titanium clad has been made by Explosion Cladding

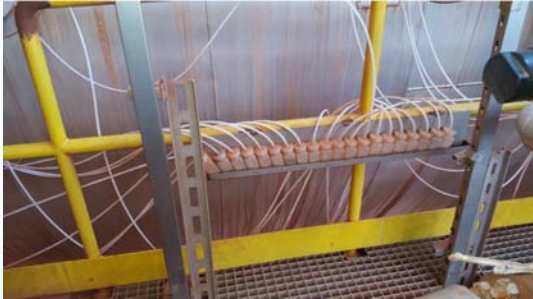
Telltale Detection of Batten Weld Failure

- Tubes attached to the telltale ports can be located where frequent monitoring is easy.
- Modern, automated monitoring systems can be used.
- This photo shows a poorly managed telltale monitoring bank. Regrettably the importance of telltale tube maintenance is often not understood by operators

- Telltale inspection access to the hidden backside of the batten strip is an important feature of the design
 - Batten strip fabrication welds necessitate backside inert gas purge
 - The purge is achieved via a hole drilled through the steel backing metal to access the titanium weld root
 - This same hole provides a non-intrusive “telltale” monitoring tool during operation.
- When **properly maintained and monitored**, the telltale’s will reliably provide early warning of a weld failure.

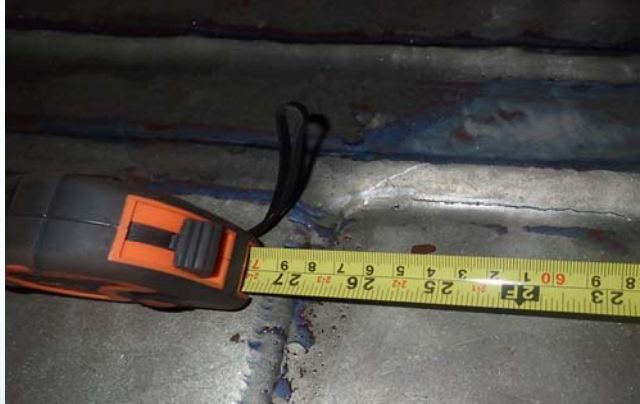
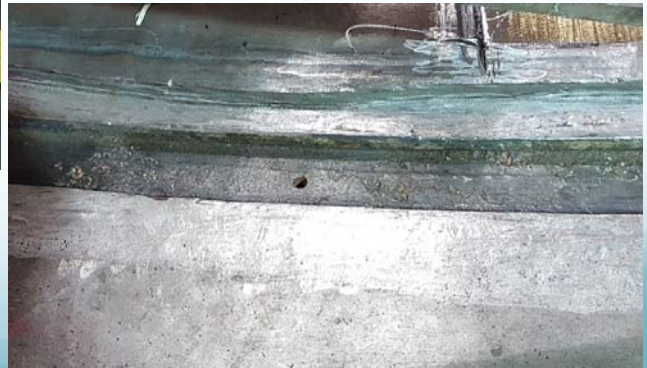
Repair of Batten Weld Defects

- When found early, batten repairs can be made without major complications
- Repairs should be made on-site by an experienced titanium clad fabricator using best titanium welding, fabrication and inspection practice
- It is critical to fully clean the area behind the failure prior to installing a new batten strip.

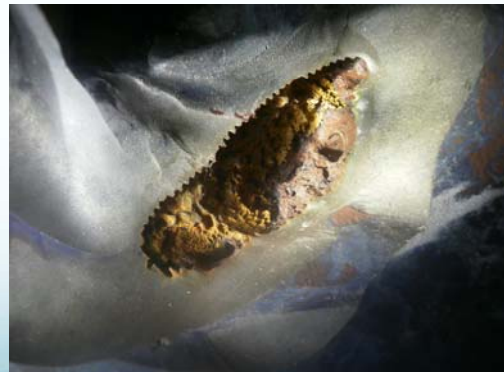
Cladding Metal Thickness Damage

- Rare but Real operational problems can cause cladding metal thickness loss
 - Corrosion- most commonly pitting/crevice
 - Erosion
 - Mechanical damage –
- In the absence of proper design and/or monitoring, full thickness cladding loss can result.

- When the thickness monitoring proves provides early warning, areas of reduced cladding thickness can be repaired by overlay welding. Typically OK when around 1.5mm (0.060 in) cladding remains
- Defects shown in the prior photo are more challenging
 - Cladding alloy patches have been used successfully. See photo on following sheet
 - In worse cases, full through-thickness vessel sections have replaced to salvage the equipment
