## NON-DESTRUCTIVE INSPECTION OF TITANIUM JET ENGINE DISKS

Materials Engineering and Research Laboratory  
Pratt & Whitney Aircraft  
Middletown, Connecticut

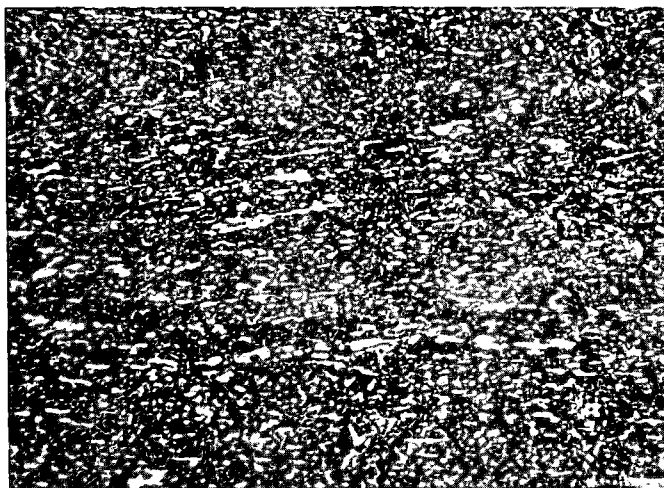
Figure 4

Microstructure resulting in Reject Signals in Production Ultrasonic Inspection. Evaluation with Focused Transducers Identified Area as Acceptable.

inspection methods have been adequate to insure quality on these thin disks. On thick fan disks, however, a major emphasis has been placed on ultrasonic inspection. For these disks, the forgings are machined to an ultrasonic inspection configuration (LS SHAPES) designed to create flat surfaces parallel to the plane of the disk. The flat surfaces permit undistorted sound entry perpendicular to the plane of the disk. Because the forging operation tends to make defects become planar in the plane of the disk, maximum detectability is obtained with sound transmission in this direction. The inspection is an immersed pulse echo method utilizing a 3/4-inch diameter 5MHZ lithium-sulfate transducer. Both broad band and tuned pulse ultrasonic units have been used. The present inspection level is approximately equal to the response of a #1 Flat Bottom Hole (.015" Dia.). To maintain this inspection level, it is necessary to control scanning speed, indexing and alarm systems to insure that random defects will not be missed because of insufficient response time or lack of signal amplitude. Setup procedures utilizing step blocks with flat bottom holes at varying metal travel distance have been established to obtain uniform distance-amplitude response and to verify front and rear face resolution. Because of resolution limitations, material near the surfaces is not inspectable. This is compensated for by allowing additional material in the inspection configuration which is removed during final machining. Scanning of each part is performed from each face and from the periphery to provide complete coverage and optimum orientation to non-planar defects. The largest source of problems in maintaining the inspection level has been random signals obtained from variable macro- and/or microstructures which are not necessarily detrimental to part operation. Because of these random signals, it has been necessary to develop methods of reviewing indications obtained during routine production inspection. The most successful method which is presently being applied utilizes focused transducers. By using focused transducers, a very small beam diameter is obtained and the random signals created by the accumulation of reflected energies from multiple grains are greatly diminished. Because more energy is concentrated on the small area of true defects, their signals become more prominent. The limited depth of field and small beam diameter make this method unattractive for part scanning but it has worked well for signal evaluation studies. Results have been verified by extensive metallography of many indications from production runs. An example of a microstructure that resulted in random signals identified with this method is shown in Figure 4. As evidenced by the defects detected, ultrasonics has been a viable tool in establishing disk quality. However, additional work is continuing to further improve inspection sensitivity, reliability and uniformity. Efforts are being made to establish equipment and transducer standardization; to obtain improved microstructures for greater sensitivity, and to establish improved inspection shapes.

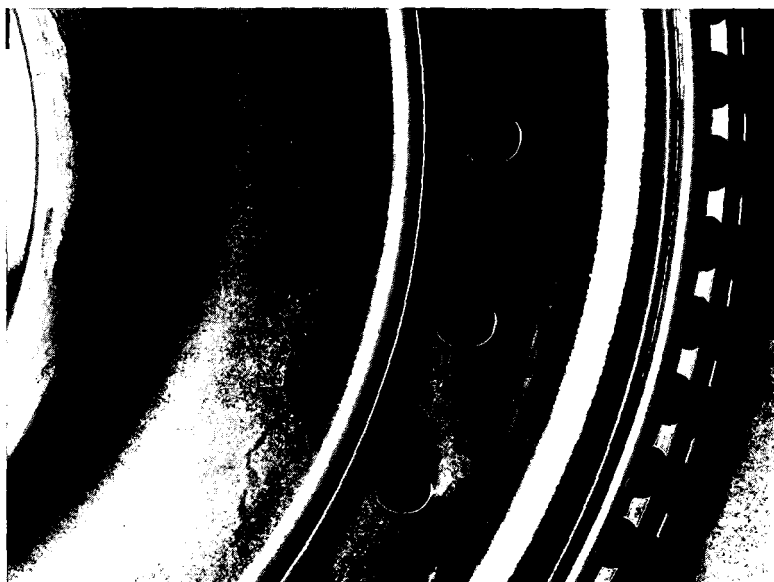
Fig. 5. Blue etch anodize indication of alpha stabilized structure in 6-4 alloy. Indication is deep blue on a light blue background. Note: Black and white photograph does not indicate full color contrast on actual part.

- Aluminum-Stabilized Alpha Segregation - This appears as an irregular deep blue line with or without branches in a light blue background. A black and white photograph of a typical defect is shown in Figure 5. The true contrast is not appreciated without color but prominence of this defect with this method is evident.
