Case Study 2

CASE REPORT – INSTALLMENT #2

Wayne M. - Most Maryland Bridges in one mouth

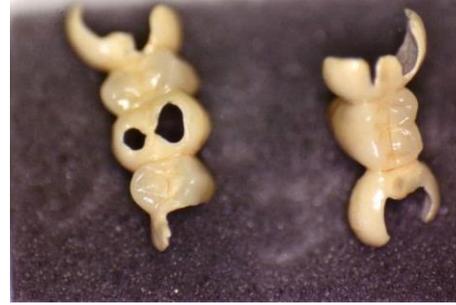
That's the inside scoop of all four posterior quadrants after 2 decades use. Here are the photos of the 4 bridges before seating – open air abutment on a bicuspid- 2/6/89. Top and underneath views. Then you see his mouth - what a bite or lack thereof! Now you go to upper right 2x6 combo bridge - all 4 ways. Next is 13x15 with some more 2x6. Another view shows the lower left quadrant 18-20 all four ways. Last, skip over to lower right quadrant 29x31. And now the fun begins, 17 years into the lower right, #31 abutment decays around top of root canal. I redid the root canal as you see and made a 3/4 reverse gold crown - the MB is tight as a tick on the mesial portion of the molar #31! Follow these three slides. Whew! Got that fixed in Jan 2007. Then Jan 2008, #15 decays just like #31 and I have to clean it up and do a reverse 3/4 gold crown (no root canal- WOW) to cover #15. The MB wing is tight as a tick on the mesial and lingual! He's back in the saddle again riding the range, over 6 or 7 years later on those two teeth. The bridges were never altered nor loosened!

Each lasted 23, 24, 25, and 25 years until his death. That is a quarter century! Think about that for success! Comspan bonding.

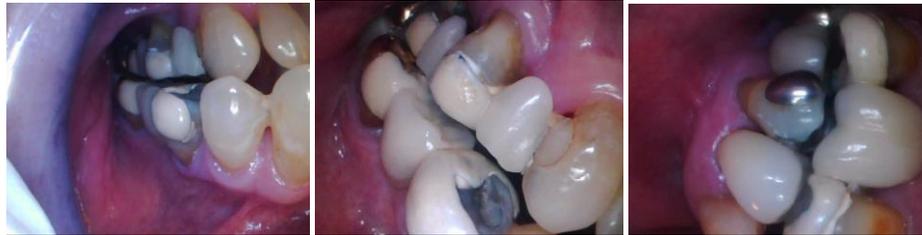
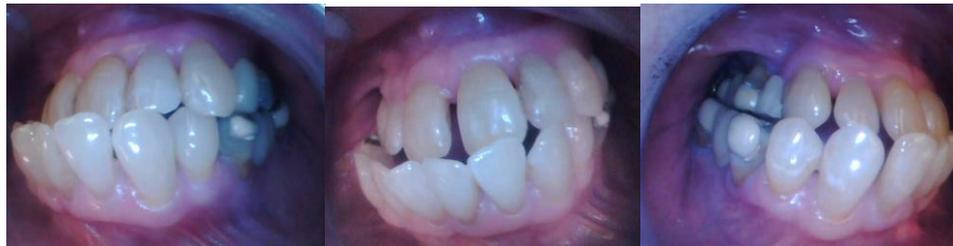
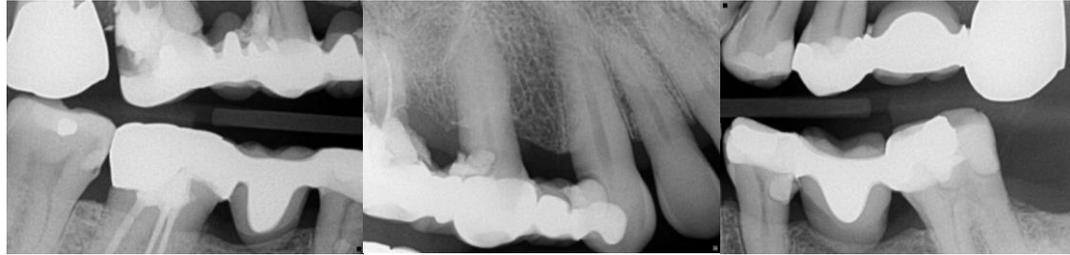
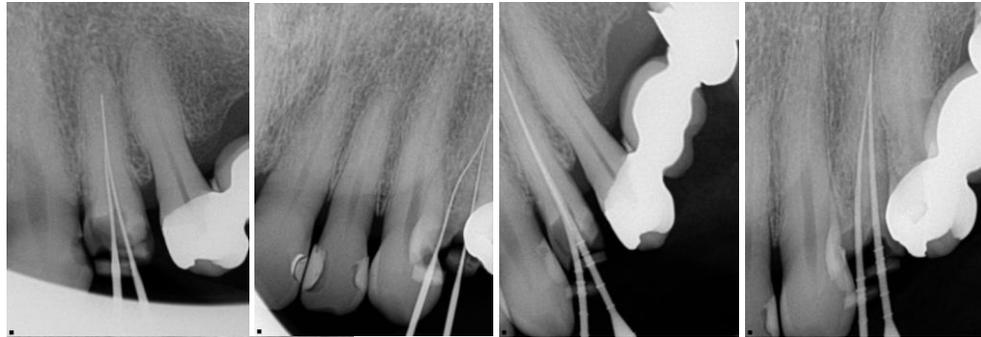
Bo Braize Lab. Notice how the abutment teeth decayed in the posterior as he slacked in home care, requiring a root canal and reverse 3/4 crown on one molar abutment, and just a reverse 3/4 crown on another abutment molar. Never was the bonding of that wing jeopardized! It held firm the entire time. Look at the excellent margins on all abutments over 20 years into service!
