# Case Study 7

**CASE REPORT – INSTALLMENT #7**

**Pat D. – Anterior Long Span (long span is 2 or more pontics)**

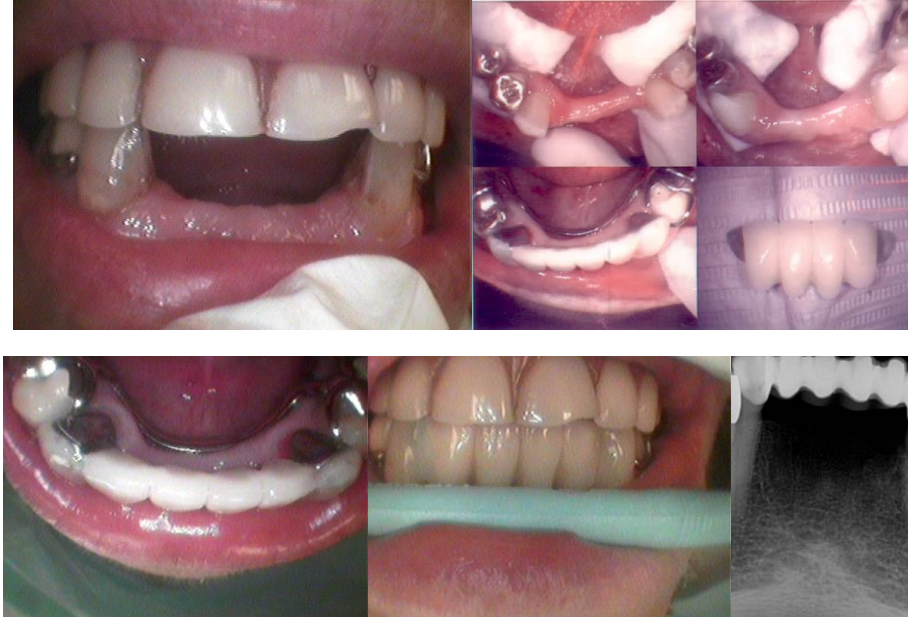
This patient suffered loss of all lower anterior teeth from smoking and periodontal compromise. The cuspids #22 and 27 were strong and never decayed. Patient did not want fixed standard bridge that destroys all enamel or a removable partial. Seated 12/3/1990 with Comspan. Debonded on #22 at 15 year milestone. We used cavitron ultrasonic to debond #27. After removing all bonding from enamel, sand-blasting and re-etching both wings with HCl/HN<sub>2</sub> acids, we rebonded with RelyX ARC. Note the metal had turned loose, no bonding on it just on tooth. Thus a metal failure that is easily remedied. Now over 25 years same bridge service! Note patient has had full upper denture since 12/20/1990.

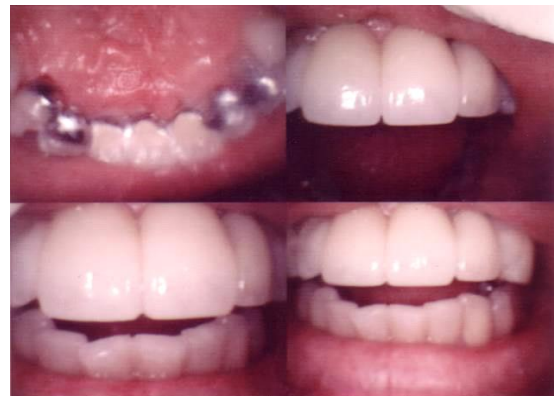
**BOBBY W.**

Note 3 teeth replaced here with double abutments on each side.

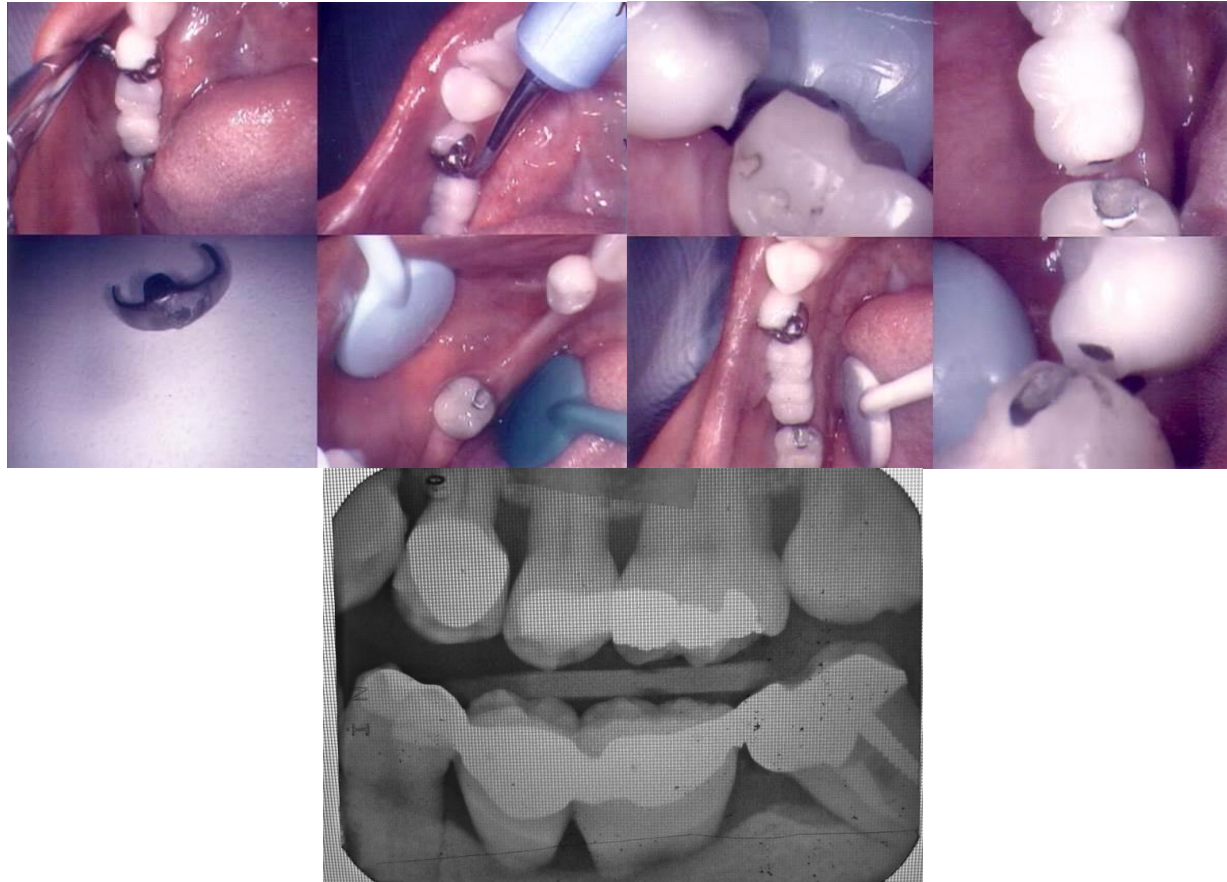
**DIANA F.**

Lab failures can be the cause of breakage. Such was the case with this MB #17X21. Hidden by porcelain, the major metal connector was cast only 4mm diameter and within weeks had led to breakage at the junction of pontic #18 and wing/rest #17. Remade with thickness of metal attaching wing, the bridge is now over 6 years old. Note broken rest/wing on porcelain fused to metal crown #17 over root canal tooth and nice rest/wing on #21. Patient's perio condition remains largely untreated and may dictate failure of posterior abutment. Patient compliance with homecare and office recall hygiene appointments remain an enigma to quality care.
