INDUSTRIAL TECHNOLOGY

Martempering to Improve Wear Properties of Aircraft Brake Steel Rotors

By Dr. Sudershan Jetley

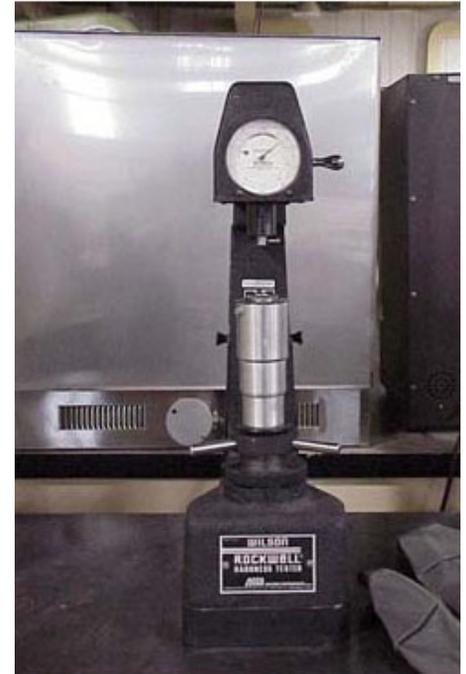
1. Hardness Testing Machine
Wilson Rockwell Hardness Tester machine was used to measure hardness.

This is shown in figure 3. The Hardness machine can be used with several different scales including Rockwell A-G, H, and K. In this study Rockwell scales B and C were used.

Figure 3. Rockwell Hardness Tester

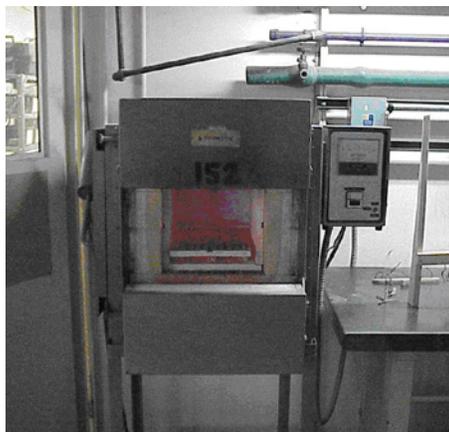
An electric oven was used to austenize the pucks before they were placed into the quenchant. Figure 4 is a photo of the furnace. The large furnace is made by Therolyne, and model number F-A1730. The furnace has a temperature range of 0° to 2500° F.

Figure 4. Large Electric Furnace

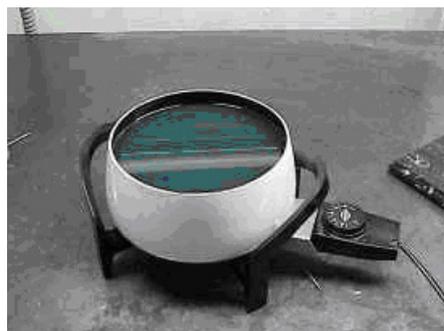
An electric pot with a temperature setting control was used to quench the pucks. The electric pot is a domestic kitchen pot and has a half gallon holding capacity. The temperature range on the pot is 0° to 400° F. The temperature control was used to set the quenchant temperature and a ‘Suregrip’ thermocouple temperature probe was used to actually monitor the quenchant temperature. This probe has a temperature range of -40° F to 1994° F. Figure 7 is a photo of the electric pot.

Figure 7. Electric Pot
