AWPCA 2006 WATER REUSE PROJECT OF THE YEAR

Salt River Pima-Maricopa Indian Community Section 319 Non-Point Source Pollution Wetland/Riparian Demonstration Project – Phase II

By JOAN GABLE and ROLAND WASS, WASS Gerke + Associates, Inc.
and MARILYN R. ETHELBAH, Salt River Pima Maricopa Indian Community

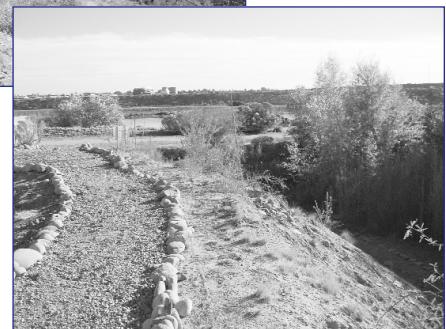
Completed trail area.

During Phase II an extensive trail system was installed to improve the safety and welfare of the visitors and wetland operations personnel. Additionally, an outdoor ‘classroom’ was created to serve as a platform for educating school children on culturally significant plants and their uses. Further, the site can be visited by members who can see vegetation that may not be present elsewhere in the Community. These visitors can also enjoy viewing numerous birds, both local and migratory, and wildlife that frequent the wetlands.

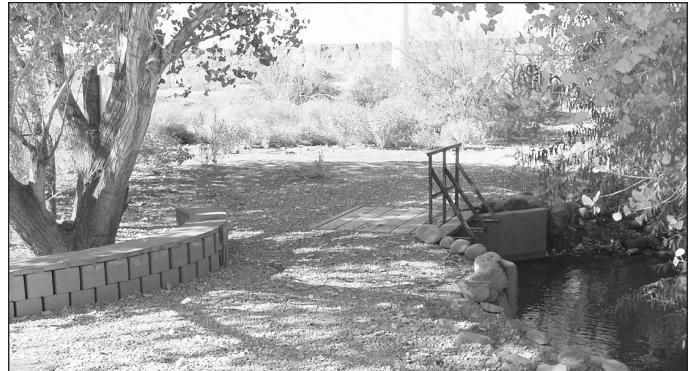
Outdoor classroom area.
