# CATHODIC PROTECTION OF THE HISTORIC BOERENTOREN (KBC TOWER)

## ANTWERP, BELGIUM

BY KRIS BROSENS, BERT KRIEKEMANS, AND DAVID SIMPSON

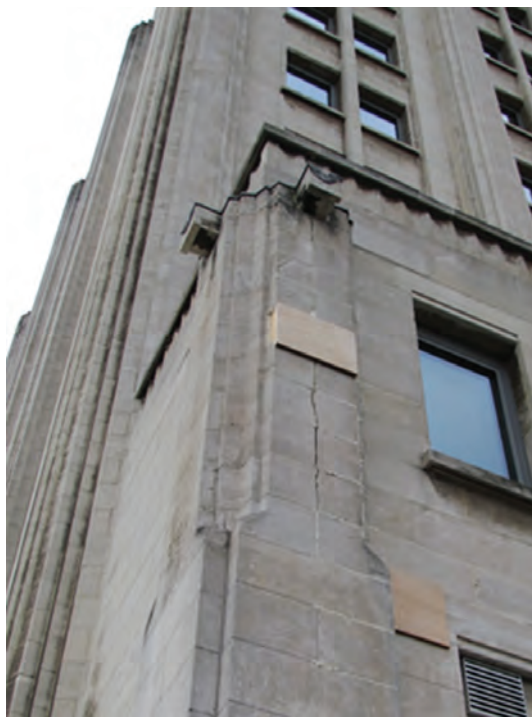
Inspections in 2009 and 2010 again detected severe stone damage, including long vertical cracks near steel columns (Fig. 3) and horizontal cracks beside the beams. As such, KBC commissioned a thorough study of the building.

Fig. 3: Vertical cracking at column

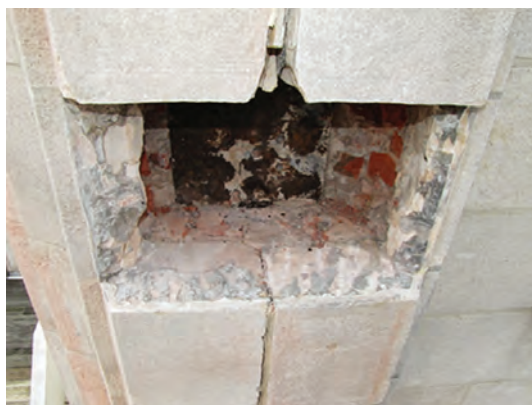
The investigation concluded that damage was caused by corrosion of the structural steel frame and that traditional repairs would not succeed in mitigating ongoing corrosion damage. Although the concrete or masonry mortar infill that encapsulated the steel frame (Fig. 4) is naturally alkaline and allows the formation of a stable thin protective oxide layer on the steel, carbonation combined with moisture from rain penetration, porous stone, unsealed joints, and internal condensation over 80 years caused the steel frame to corrode.

Fig. 4: Brick infill around steel column

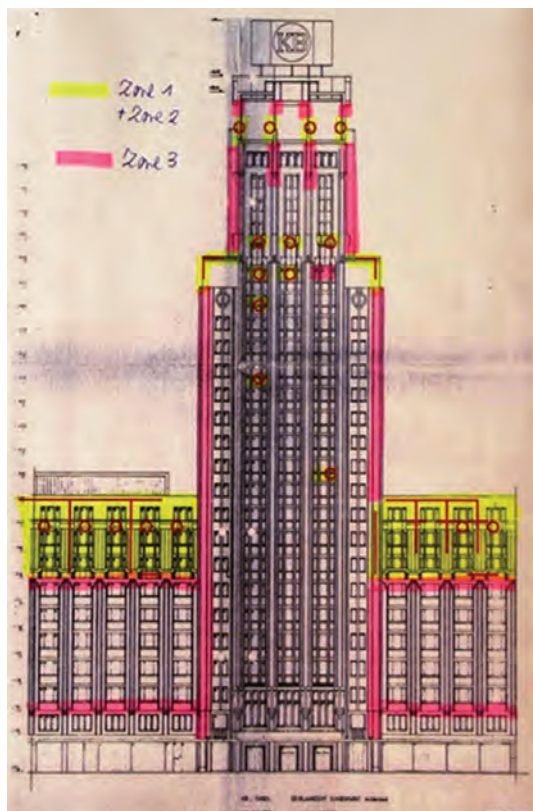
Based on the investigation, various areas of the structure were categorized based on their condition (refer to Table 1 and Fig. 5).

Fig. 5: Illustration of damage zones

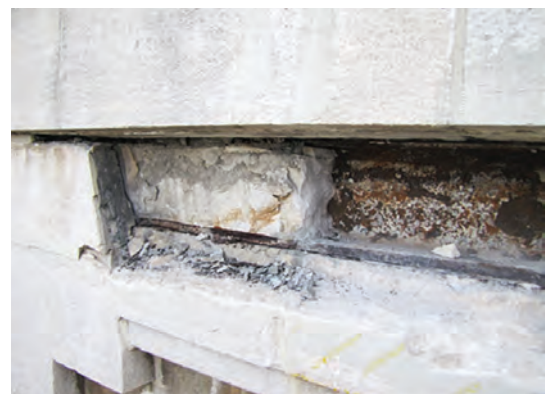
Corrosion is an electrochemical process whereby an electrical discharge occurs between different sections of the steel (Fig. 6). Anodic sites, where electrical current leaves the steel, cause oxidation and rust formation. In cathodic locations, the current flows to the steel, where a chemical reaction improves the corrosive conditions around the steel.

Fig. 6: Beam corrosion above window

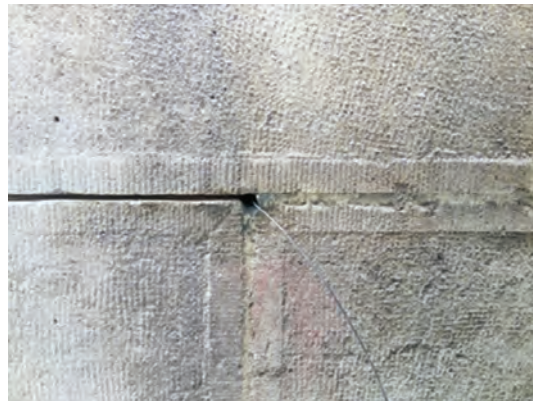
The pilot installation proved the feasibility of cathodic protection as a solution to the façade corrosion problem and a specific, final design was prepared. Discrete ICCP anodes were selected to minimize the risk of near shorts to the anchors and allow for easier resealing of the joints versus tita-

Fig. 7: Discrete anode in masonry joint

anium ribbon mesh anodes. Because they are installed in the joints, the discrete anodes are not visible after installation.

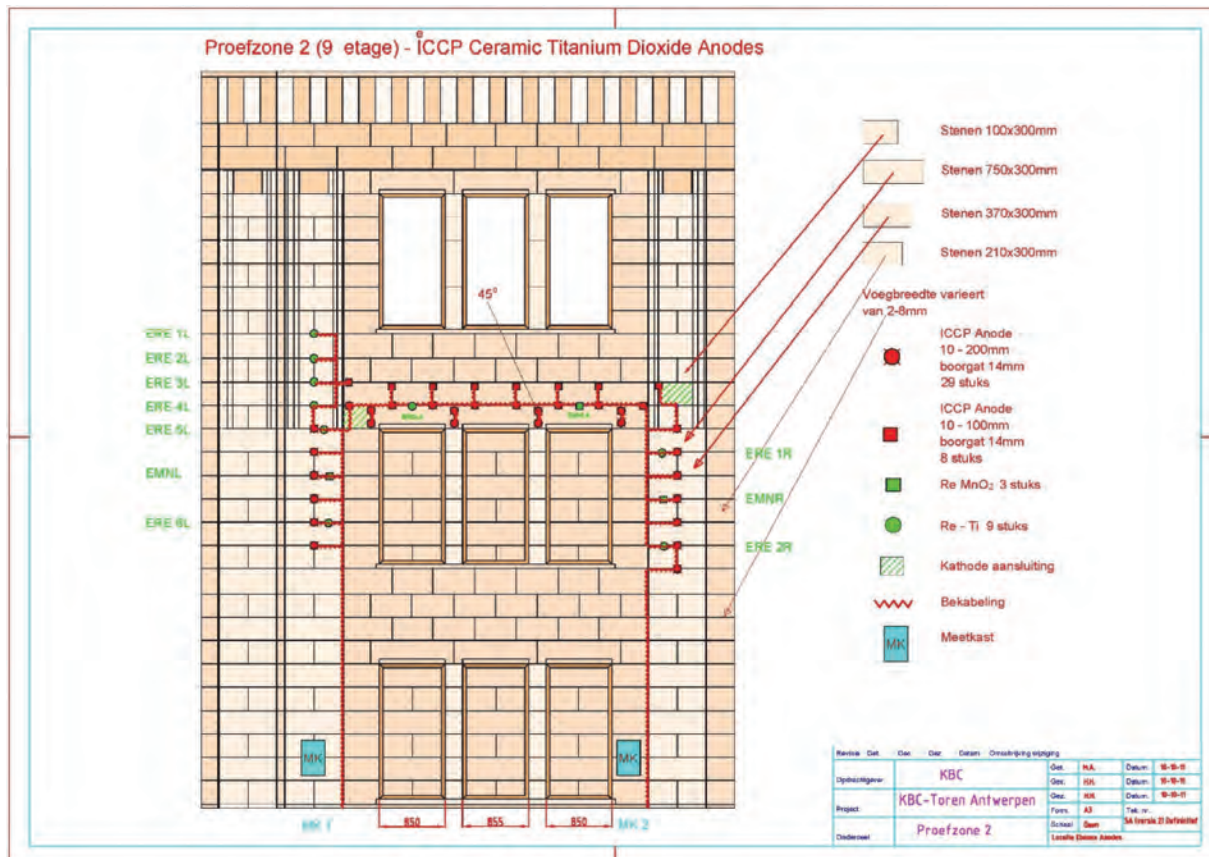
The information collected from the pilot installation was used to refine the preliminary design. The pilot project proved that a single vertical line of discrete anodes could effectively protect the outer flange of the large steel columns at an anode spacing up to 35 in. (900 mm). The final design spacing was 24 in. (600 mm, two blocks high) but the anodes could technically be further apart if required during the cathodic protection implementation. At the beams, the anodes were to be placed in a plurality of rows to protect flanges and the web (Fig. 8).

Fig. 8: ICCP anode layout

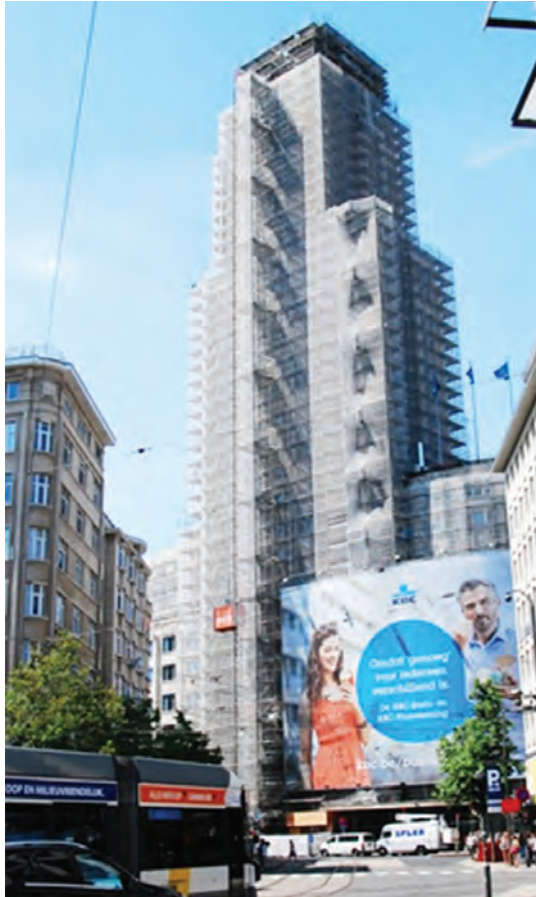
Implementation of the façade repair program occurred from March to December 2014. The scope of work included scaffolding the building for access (Fig. 9), light general cleaning while retaining existing patina, repair/replacing stone cladding affected by corrosion, moss-repellent treatment, concrete repairs, new sealant around

Fig. 9: Scaffolding at building façade

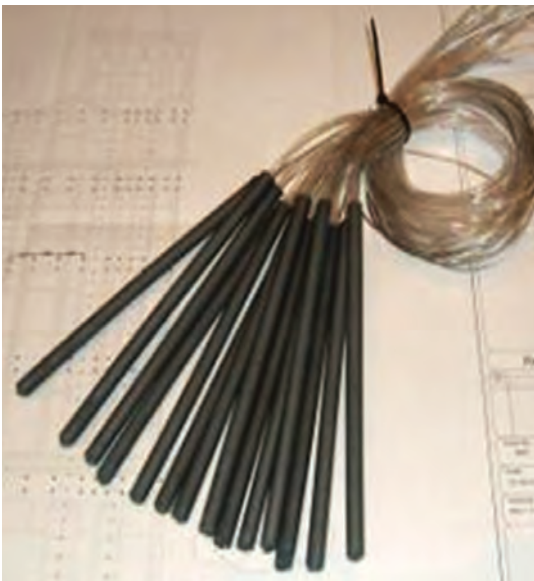
- Provide ceramic titanium dioxide probe anodes, 0.28 in. (7 mm) diameter by 3.94 and 7.87 in. (100 and 200 mm) long (Fig. 10);
- Protect column with one row of anodes placed at 24 in. (600 mm) spacing in the middle of the outer flange;

Fig. 10: Ceramic titanium dioxide ICCP anodes

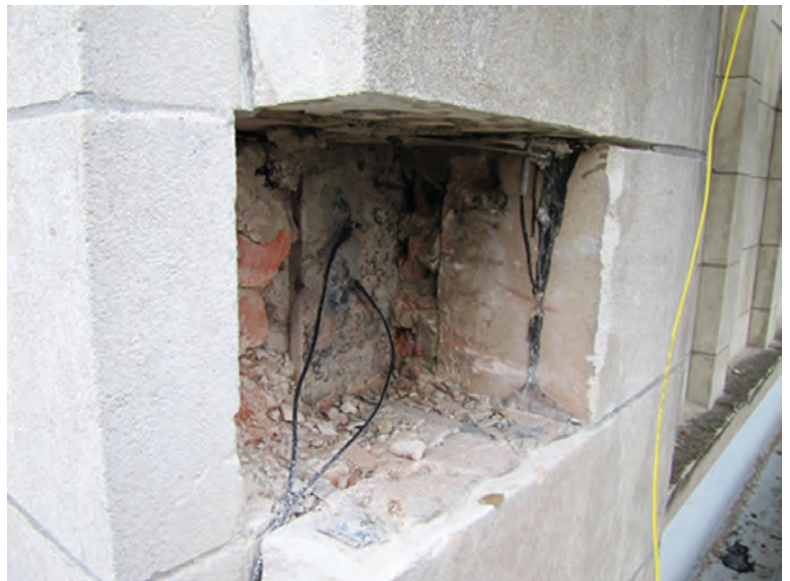
- Test down hole for potential shorts to steel;
- Provide redundant cathode connections to the steel frame (Fig. 11);
- Saw-cut and drill anode holes in joints (Fig. 12);

Fig. 11: Cathode connections to steel column

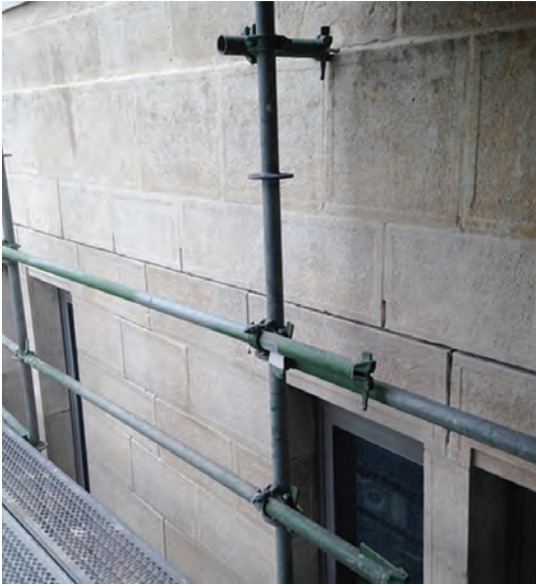
Fig. 12: Joints saw cut and holes drilled for anodes and associated wiring

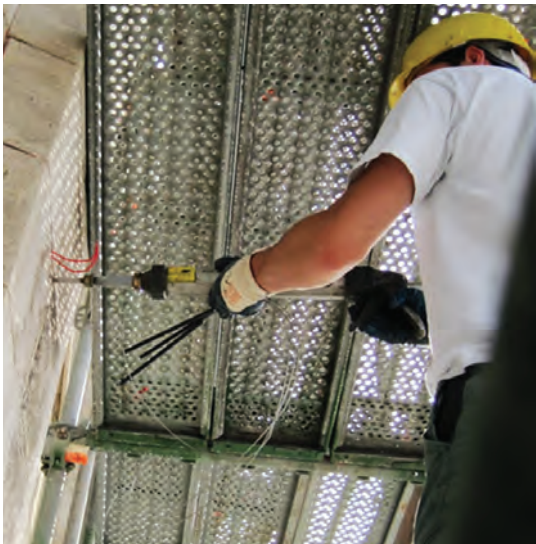
- Use conductive, acid-resistant grout around anodes (Fig. 13);
- Install conductive ceramic ICCP anodes into drilled and grouted holes, assuring no air pockets exist around anodes (Fig. 14);

Fig. 13: Conductive anode grout placement

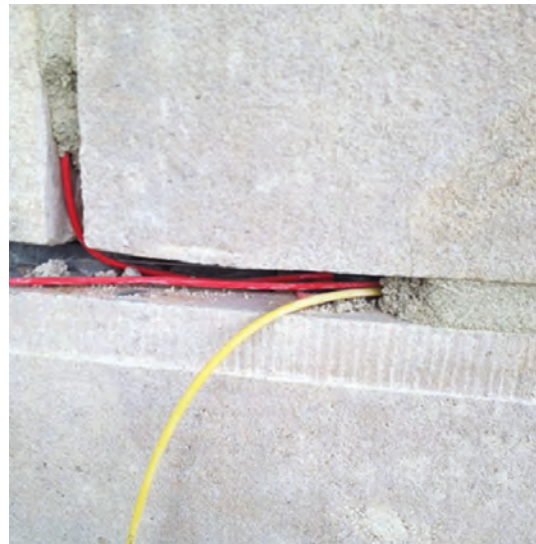
- Install manganese dioxide reference electrodes;
- Install cathode, anode, and reference electrode wiring in joints saw cut to a minimum dimension of 0.31 in. (8 mm) width x 0.70 in. (20 mm) depth (Fig. 15);

Fig. 15: Wiring concealed in the mortar joint

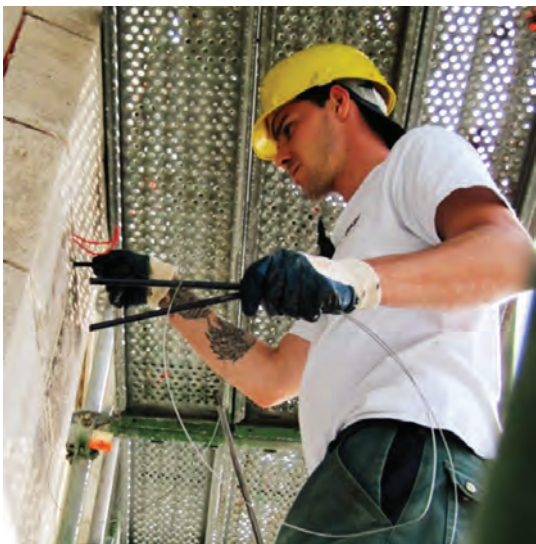
Fig. 14: Conductive titanium dioxide ICCP anode placement

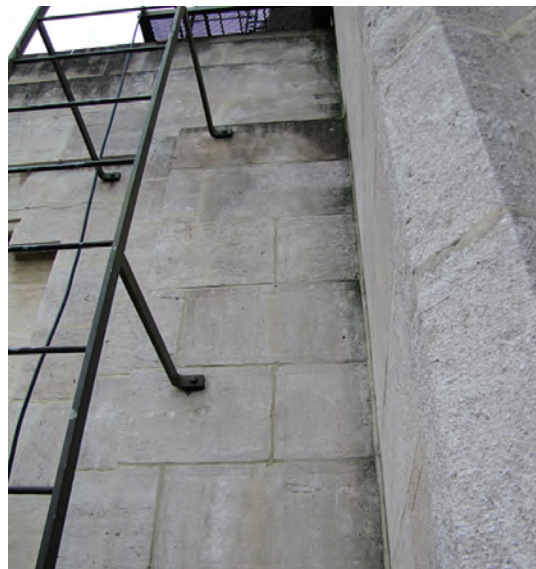
- Fill slots and top of drilled holes with mortar to match adjacent masonry joints (Fig. 16); and
- Provide power supplies with remote monitoring and capabilities to adjust system voltage.

Fig. 16: Anodes and wires concealed
