FINALIST—2019 PROJECT OF THE YEAR
HISTORIC CATEGORY

Napa Valley Courthouse

NAPA, CALIFORNIA
SUBMITTED BY PULLMAN

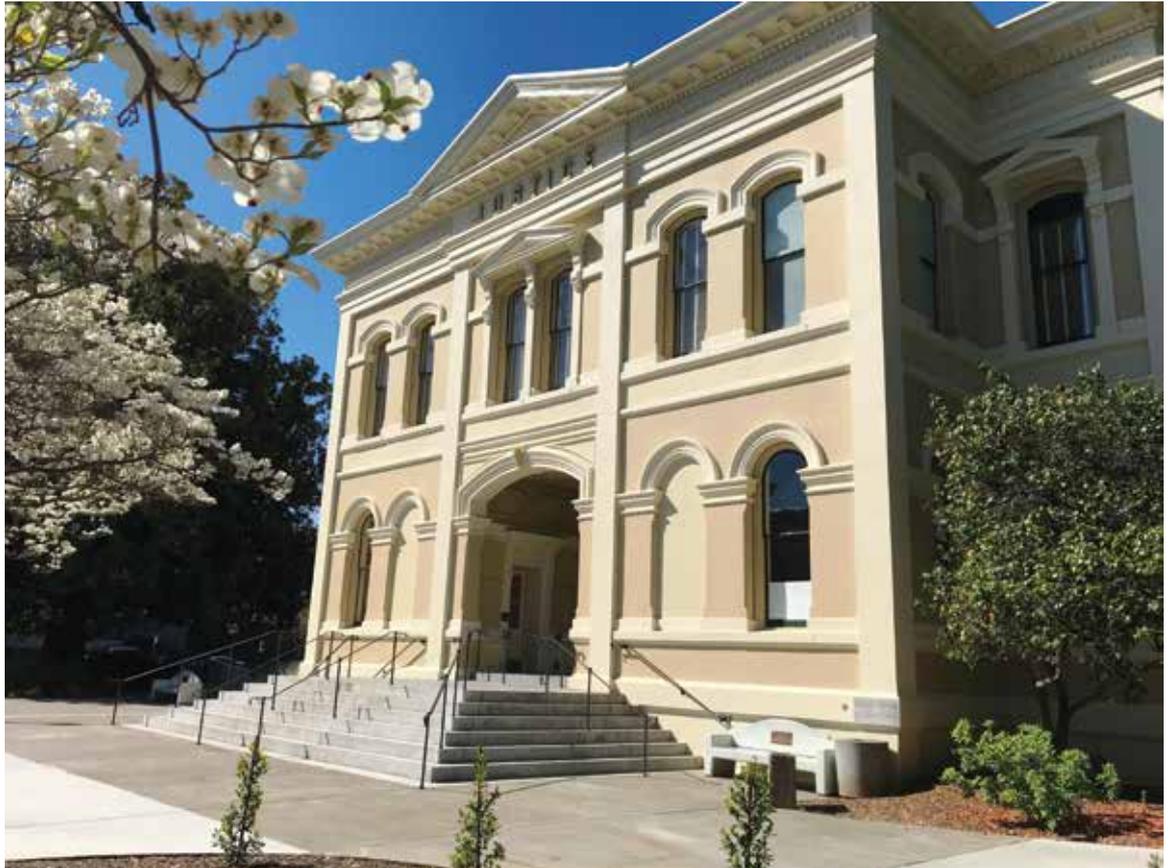
Fig. 1: Napa Valley Courthouse after repairs

Constructed in 1878 in the high Victorian Italianate architectural style, the Napa Valley Courthouse is listed on the National Register of Historic Places (Fig. 1). The 18,000 sf (1,670 m²), three-story building consists of a concrete foundation with a full basement, a brick and stucco wall assembly, and a metal roof. The outer walls consist of masonry assemblies covered in Rosendale cement, held in place by iron bands embedded in the foundation. A hipped roof frame is supported by brick walls and timber trusses. The cornice is galvanized iron supported by block modillions. Frieze and dentils wrap the building, along with a simple molding delineating the first and second story. The structure also boasts segmental arched hoods above the wooden windows and double door entrance.

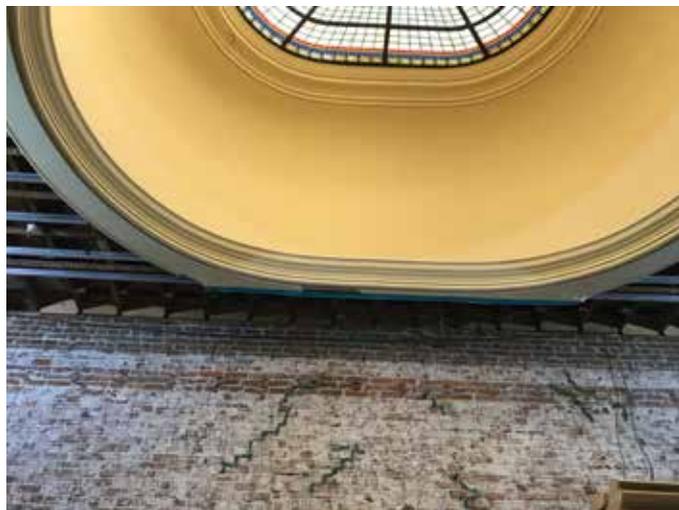
The Courthouse suffered extensive damage after a 6.0 magnitude earthquake struck the region on August 24, 2014. The load bearing masonry walls, plaster, and wood trim exhibited severe damage from the excessive movement (Fig. 2). Shear cracks ran through many of the exterior and interior walls, coupled with diagonal cracking through many of the window spandrels. A gaping hole was visible at the southeast corner roofline, and portions of the interior walls were in danger of collapsing. HVAC, fire sprinklers, and electrical systems were also impacted.

Fig. 2: The unreinforced masonry walls crumbled while the glass from the vaulted glass dome on the second floor was undamaged

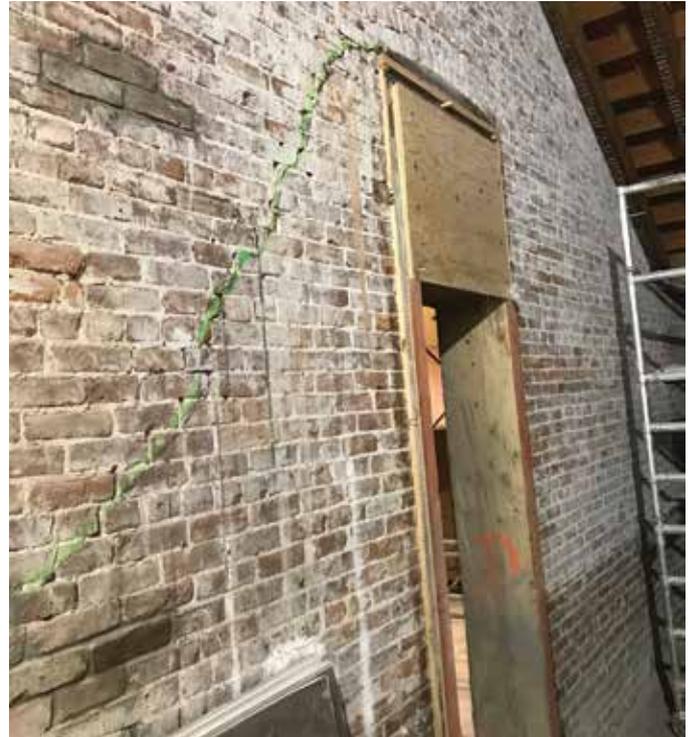
Fig. 3: Traditional masonry repair strategies, including grout injection and masonry ties, stabilized the structure to receive seismic upgrades

The design team's repair strategy enhanced the structure's resiliency by evaluating each structural element for deficiencies (Fig. 3). The seismic retrofit consisted of a multi-pronged approach to address these deficiencies. Because the original masonry was unreinforced, the walls that were completely destabilized needed to be demolished, shored, and rebuilt with grout filled and reinforced concrete blocks (Fig. 4). Load bearing brick walls that did not collapse received externally applied reinforcement. To stabilize walls that were only partially damaged, helical anchors were used to tie various wythes of bricks together.

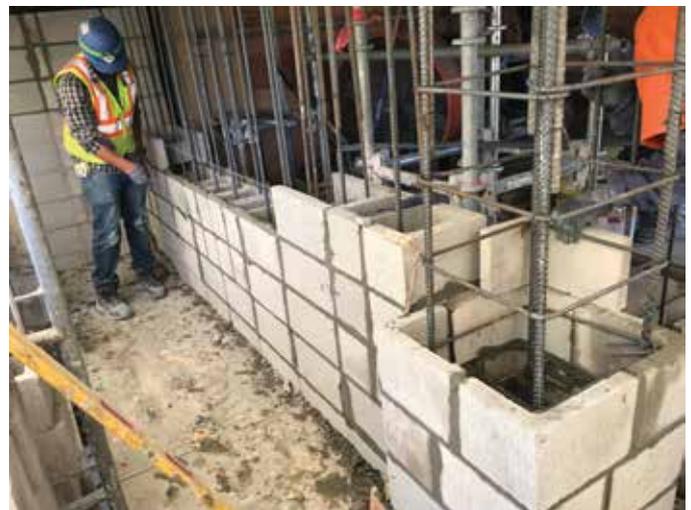
Fig. 4: The versatile building block enabled reconstruction in areas that were completely destabilized

Localized damaged portions of the existing load-bearing masonry walls were rebuilt with existing brick. Walls that were beyond repair were demolished and newly constructed

with grouted concrete masonry unit (CMU) blocks. All new walls were constructed with a specially designed expansion joint system to mimic the thermal expansion properties of

the existing wall assemblies. Over 3,800 ft (1160 m) of crack injection with high strength grout was performed. Twenty-five wall assemblies were rebuilt with CMU blocks and over 300 cy (230 cm) of grout was placed within the blocks.

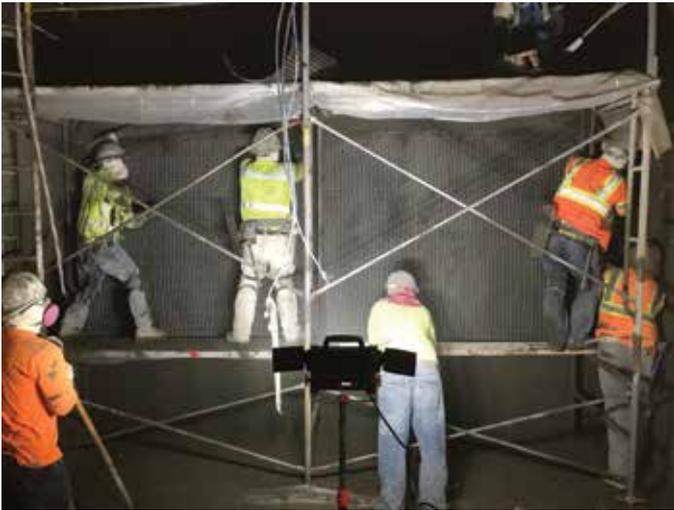
Fig. 5: Reinforcing a wall with the FRCM system

To upgrade the structure for seismic conditions in the event of another earthquake, all unreinforced masonry was repaired using a fabric-reinforced cementitious matrix (FRCM). A new technology in the United States, FRCM is an externally applied composite system which combines a carbon-fiber reinforcing grid into a layer of sprayable high strength mortar (Fig. 5). The application is conceptually similar to traditional enlargements with additional concrete and steel reinforcement, but without adding significant weight or volume. The installation process is faster and requires less preparation than traditional shotcrete repairs. The system also withstands harsh environments and service conditions, including elevated temperatures, humidity, and ultraviolet (UV) light.

To implement the FRCM application, the bricks were brought to the correct moisture content and nominal 1 in (25 mm) thickness for FRCM to properly adhere. Teams sprayed the walls with water and covered them with burlap to retain the moisture two days before applying the FRCM. The FRCM was completely concealed behind new plaster and salvaged wooden wainscot. These steps were taken to accurately reinstall the historical trims. Over 15,000 sf (1395 sm) of FRCM was installed on 43 different wall locations.

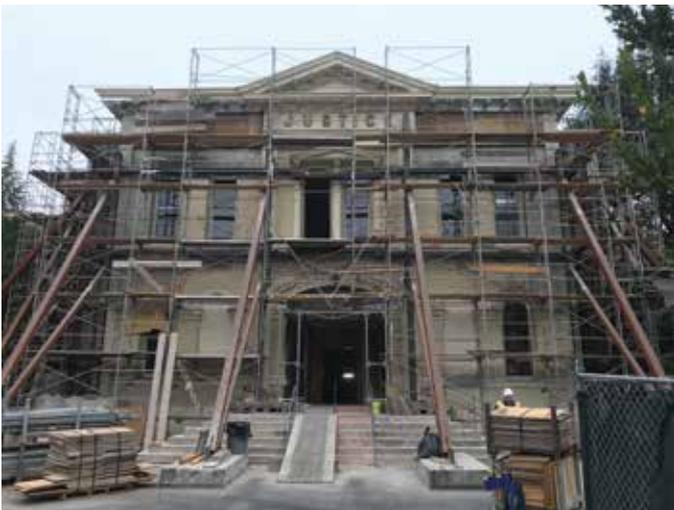
Fig. 6: The Courthouse after removing the sheathing, and prior to exterior plaster and coating work

Refer to Figures 6 and 7 during Courthouse repairs after removing the sheathing and construction near completion.

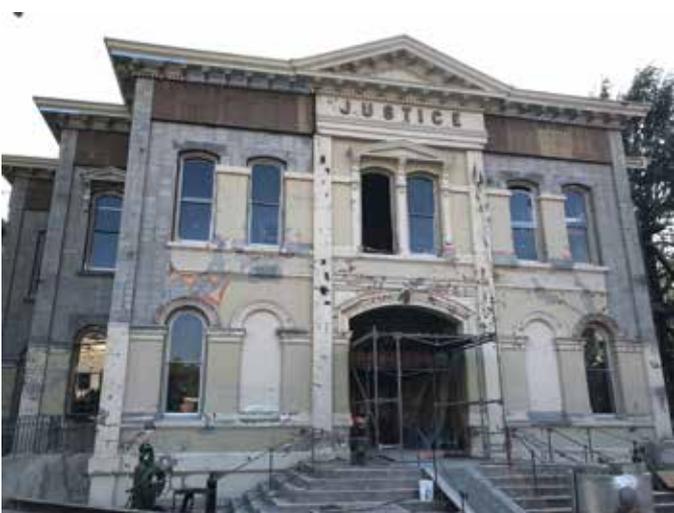
Fig. 7: The Courthouse construction near completion
