# Rehabilitation of the Sumner/Callahan Tunnels

By Henry A. Russell, Jr.

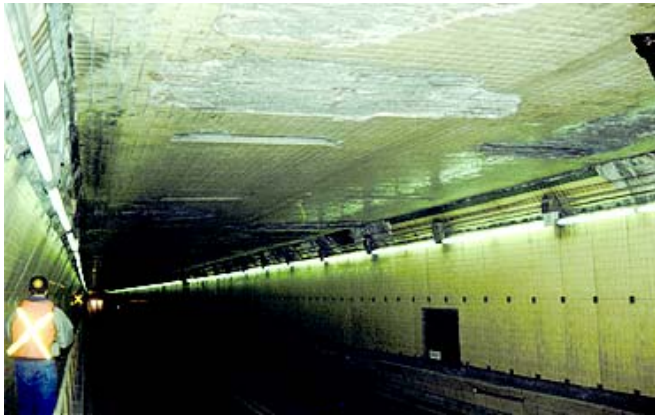
Figure 1: Tunnel prior to repair

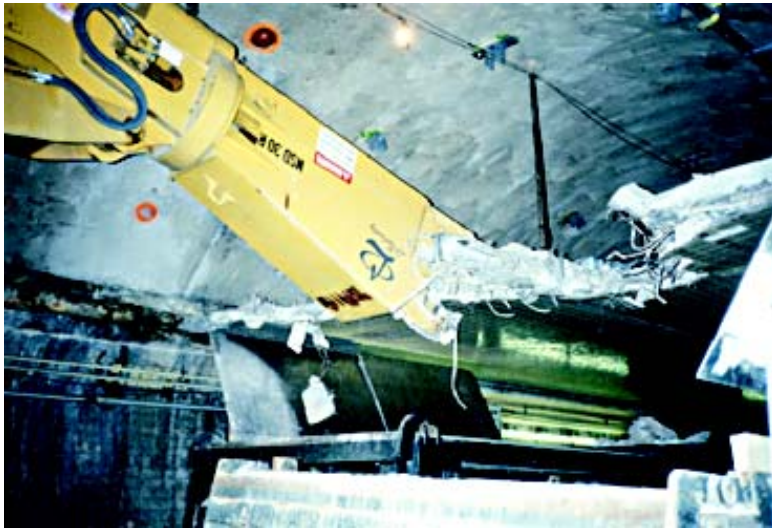
Fig. 3: Concrete demolition of the existing ceiling

The existing 6-in. (15 cm) cast-in-place ceiling was removed by use of a concrete shear that nibbled the concrete ceiling and sheared the reinforcing at a rate of 108 ft (33 m) per work shift. The debris was dropped into two large dump trucks and hauled to an off-site storage area for disposal during the day. During the preliminary construction, it was noted that the soot on the top of the ceiling was contaminated with lead from the combustion of leaded gasoline. As such, it would make all of the debris from the ceiling demolition a hazardous material, thus increasing the disposal cost by over 300%. To prevent this additional cost, the ceiling work was stopped and a power wash and vacuum-cleaning program was instituted. The work was delayed one month for the cleanup. Once the cleanup was completed, the concrete from the ceiling was placed in an ordinary landfill.

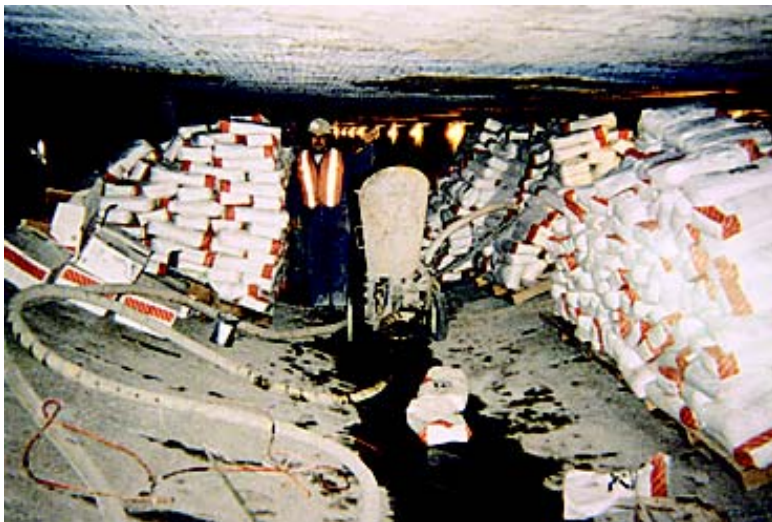
Fig. 4: Work done under roadway. All shotcrete material came in 50 lb bags which were transported to the project location by hand through manholes

and tunnel to traffic within 5 hours of the start of work, the General Engineer/Consultant worked with a manufacturer to develop a rapid-setting, high-strength, polymer-modified shotcrete that would allow the work to progress without interfering with the revenue stream of the tunnel system. Based on field tests, an existing product was modified to meet the needs of the project. The material was a dry-spray, polymer-modified shotcrete that was shrinkage-compensated and chloride-resistant. The material had an initial set within 20 min. and a compressive strength of 5000 psi (34.5 MPa) at 24 hours, and an ultimate strength of 8000 psi (55.2 MPa) at 28 days. The use of a polymer-modified shotcrete also provided for minimum rebound and dust creation, which would have caused severe problems for the operating ventilation system. A total of 33,000 ft<sup>3</sup> (935 m<sup>3</sup>) of polymer-modified shotcrete was used on this project.

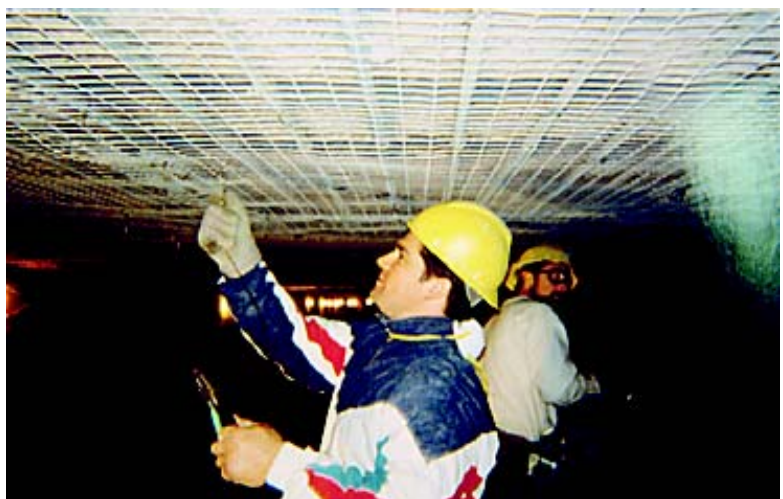
Fig. 7: Placing 2 in. x 2 in. galvanized welded wire fabric over reinforcing to aid in build-up of shotcrete material and to make the repair monolithic with the substrate
