# Cape Girardeau's South Sprigg Street Bridge Adventure

South Sprigg Street Bridge, Cape Girardeau, Missouri

In southeast Cape Girardeau in 2007, an event of unexpected impact and duration occurred. This became our story of an adventure from hellish geology to an award-winning bridge.

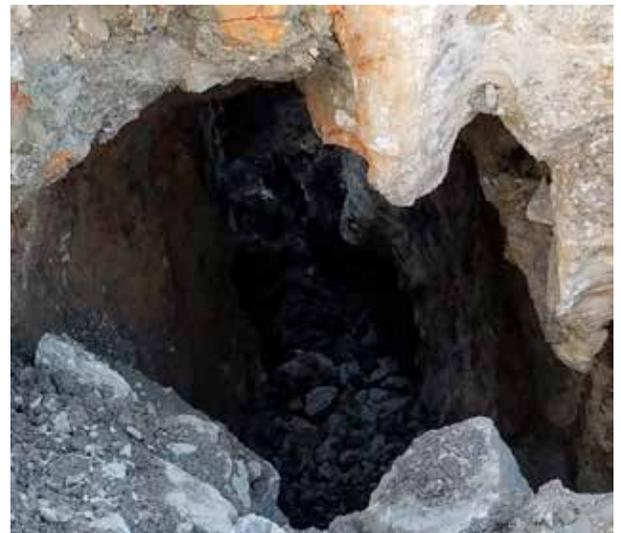
**Several of the holes close to the South Sprigg Street Bridge caused the paved creek bank to fall in, and also caused the road pavement on the north end approach to cave in.**

The City began fixing the holes by filling the large, deep cone-shaped vortexes with boulders and various sizes of rock. Concrete was pumped into some holes to try and seal off the cavity. With the holes filled, the City repaired the road

pavement and opened the road to motorists and industrial site users. It was an exciting and demanding effort, and things seemed back in order by late 2007 or, so we thought. The holes near the north side of the creek and bridge approach formed again in spring of 2008. The City again filled the holes and fixed the road. Surely, it was fixed this time! But, not for long. The holes near the north end of the bridge came back in 2011. The City filled them with concrete and rock and fixed the road again. The process was repeated in 2012. In 2013, the holes came back even larger than before, and new ones appeared. The City closed the road. City staff began a detailed review searching for a sustainable solution to this monumental problem.
