# Field Monitoring of the Hygrothermal Performance of a New Class of EIFS Walls

Achilles Karagiozis<sup>1</sup> and John Edgar<sup>2</sup>

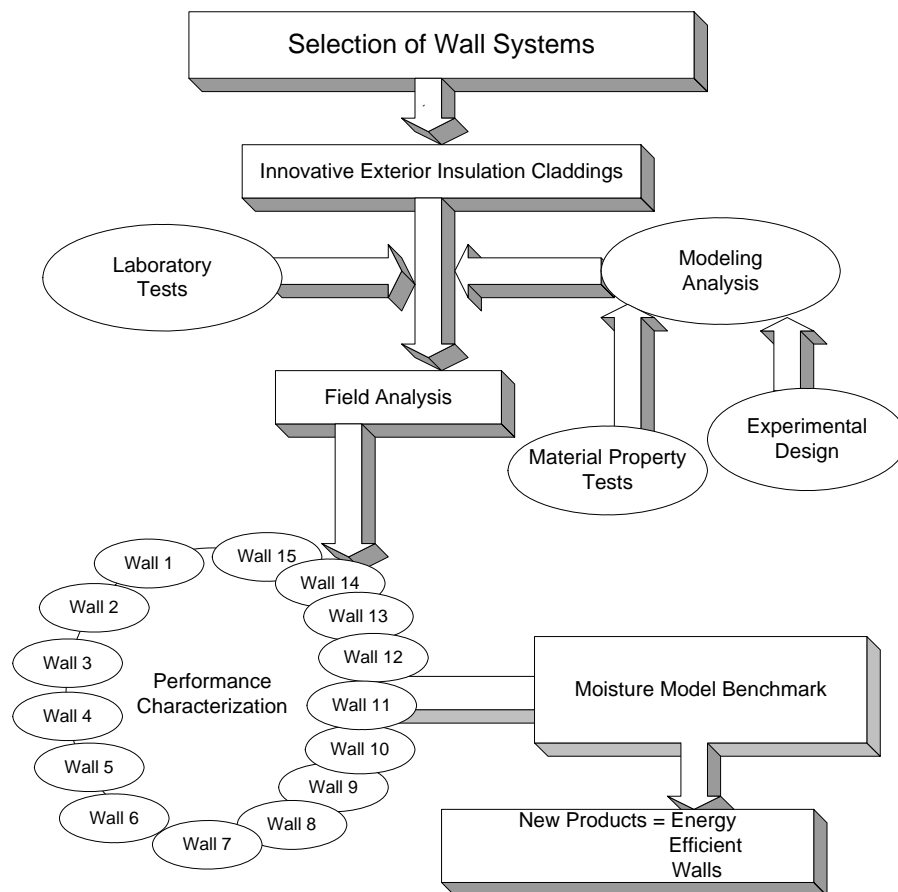
Figure 1: Research Approach for the EIMA/DOE/ORNL Project

A number of steps are involved in the research for Phase I and II. Figure 1 provides an overview of the main tasks that are required to achieve productive end results.

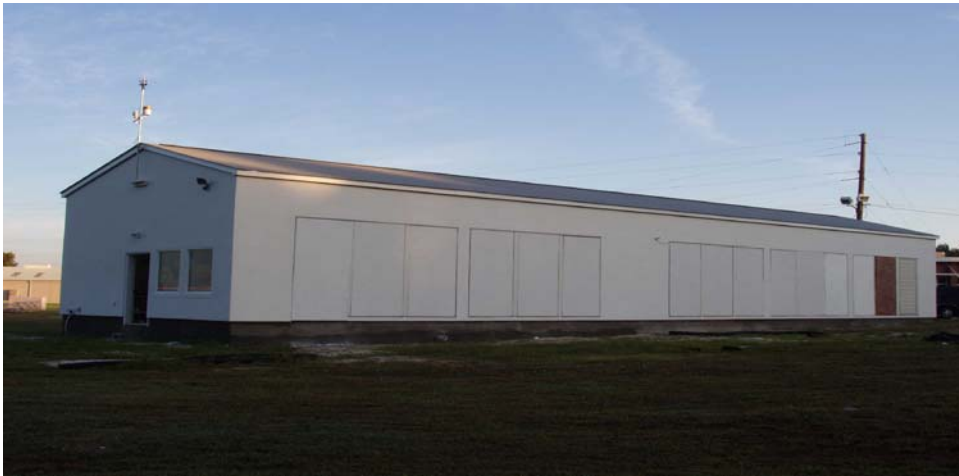
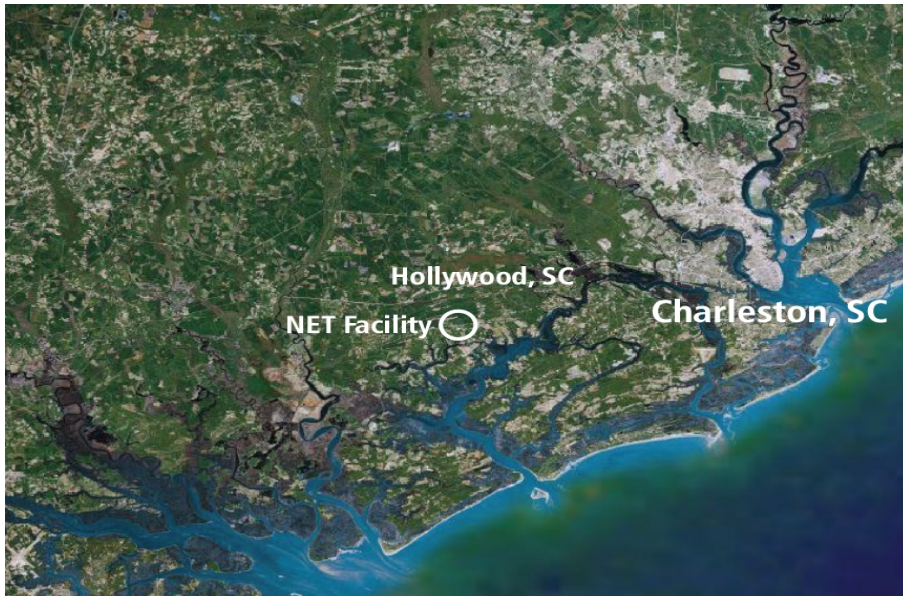
Figure 2: Natural Exposure Test (NET) Facility in Hollywood, SC

To achieve these goals, a special building was designed and constructed at Hollywood, SC, a Zone 3, mixed climate location, on near the Atlantic coast, south of Charleston (Figure 2). A flexible design was implemented to allow the change of wall panels with ease, to compartmentalize the building into two zones, and to allow control of the interior conditions. In Phase I, a total number of 15 wall assemblies were integrated into one side of the building (south-eastern exposure). In this way, all of the assemblies would be exposed to similar weather conditions. Building orientation and placement of the exterior wall test panels were determined after careful consideration of historical weather patterns in that location, including the prevailing direction of wind driven rain..

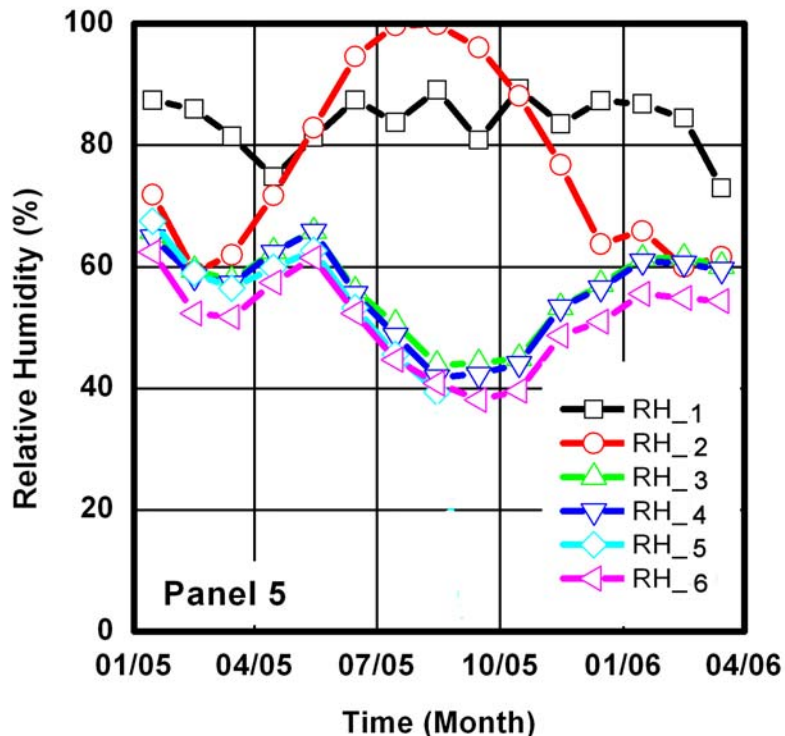
Figure 5: Monthly Average Relative Humidity Distribution in EIFS

In Figure 5, a clear yearly cycle is exhibited, showing the decoupling of the thermal and moisture performance due to the presence of the exterior foam insulation. The sensors bounding the exterior sheathing board show very low relative humidities that have not

exceeded 68 % at any period of the year RH\_1 and RH\_2 show close agreement with the exterior environment, with a condensation period present in RH\_2 during late August and the beginning of September. However, as this occurs in the vicinity of the air gap close to the interior side of the foam, no damage is expected to occur.

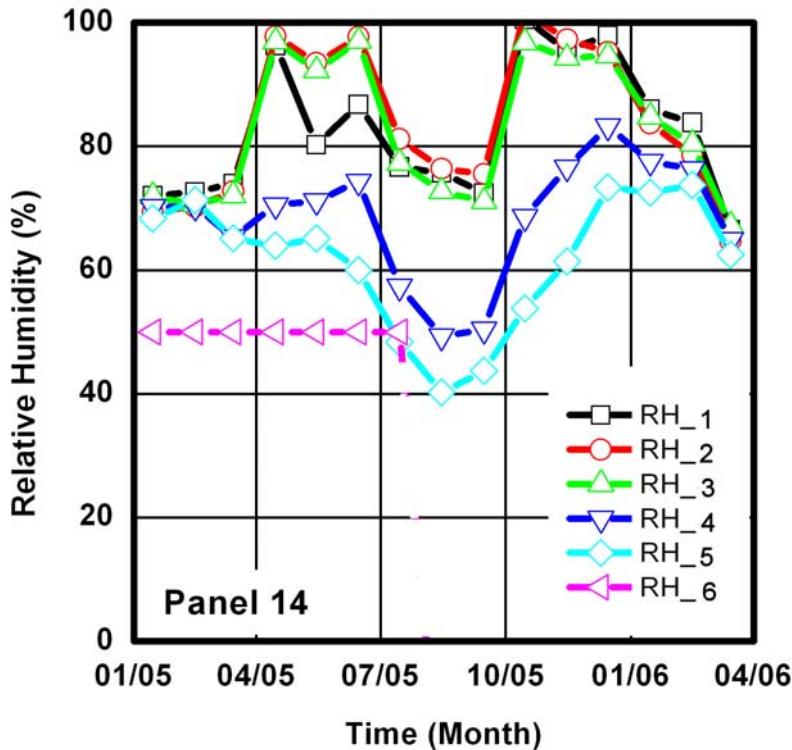
Figure 6: Monthly Average Relative Humidity Distribution in Brick Wall System

In Figure 6, the inner portions of the wall system (i.e. the wood framing and sheathing) are coupled to the brick exterior. As expected, very high relative humidities were found in sensor RH\_3 (imbedded in the exterior sheathing board). For at least 7 months of the year, the average monthly relative humidity at that sensor exceeded 80 %. According to the proposed ASHRAE 160P such hygric conditions can cause mold damage to a material. Indeed, even on the interior side of the sheathing board, the readings for one month (December) showed average monthly relative humidity exceeding 80 %. It is evident that this brick wall arrangement is not performing satisfactorily for the climatic conditions present in the Charleston region.

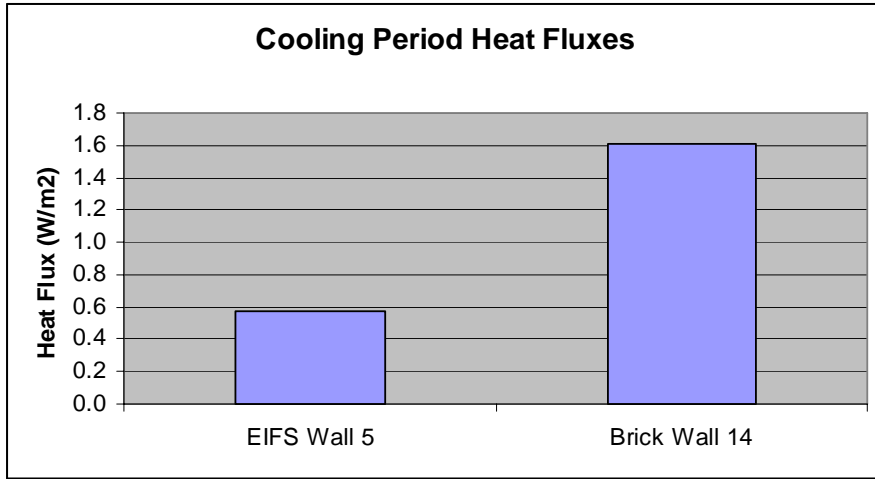
Figure 7: Cooling Period Positive Heat Fluxes into Interior Space

The cooling heat fluxes into the interior of the building are shown for Wall 5 (EIFS) and Wall 14 (brick) in Figure 8. The average cooling season values are plotted for each wall. A heat flux sensor was located at the exterior side of the gypsum board. The measured heat fluxes from the brick wall are approximately 2.6 times higher than those measured in Wall 5. This represents a substantial savings in energy required to cool the space insulated with exterior foam vs. fiberglass batts in the wall cavity. To a lesser yearly degree the opposite effect occurred during the winter months. The brick stored energy and conducted it inwards reducing the heating load. It should be pointed out that the EIFS wall has a higher nominal R-value and that better performance should be

expected. It is interesting however, that the ratio of the R-values is approximately 1.4 times.
