DRAINAGE AND RETENTION OF WATER BY CLADDING SYSTEMS

Donald Onysko¹, Constance Thivierge², Silvio Plescia³, and Barry Craig⁴

ABSTRACT

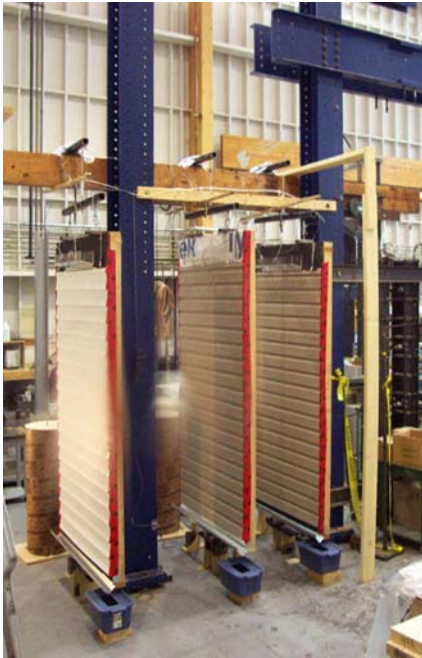
Figure 2 Overview of test set-up for weighing test walls during drainage/drying testing.

The drainage set-up was composed of three weight-balancing systems to accurately measure the weight of water added and retained in each test wall during the wetting/drying test. This allowed three 1.22 m x 2.44 m (4ft x 8ft) wall systems to be evaluated at essentially the same time.

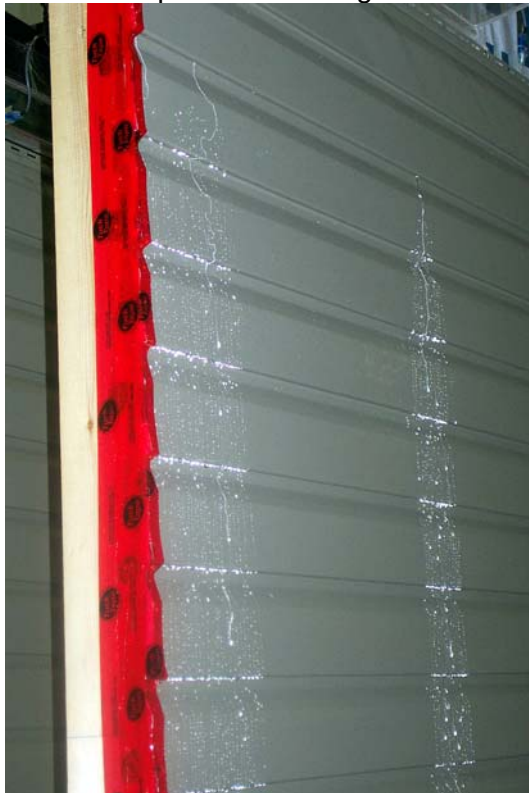
Figure 6 Example of face drainage from drain holes in vinyl siding (Profile #2)

On the other hand, Walls 2 and 3 (utilizing vinyl siding having Profile #2 with SPBO and building paper WRB membranes) demonstrated less extensive moisture loss by edge leakage. The profile of this siding simulated a different type of wood siding as shown in Figure 1. Water draining from these drainage holes was retained along that surface and drained down for collection by the gutter. An example of drainage down this profile type is shown in Figure 6.
