Lessons in Insulating Glazing Unit Failures

Failure Mechanisms and Re-Glazing of an all Glass Tower

→ Graham Finch, MASc, P.Eng
RDH Building Engineering, Vancouver, BC

BEST 3 Atlanta – April 3, 2012

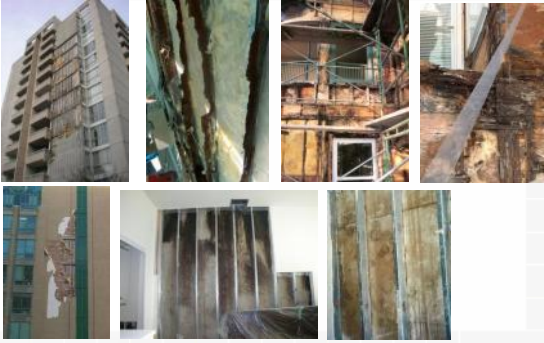
→ Failed Building Enclosures – Rot and Corrosion

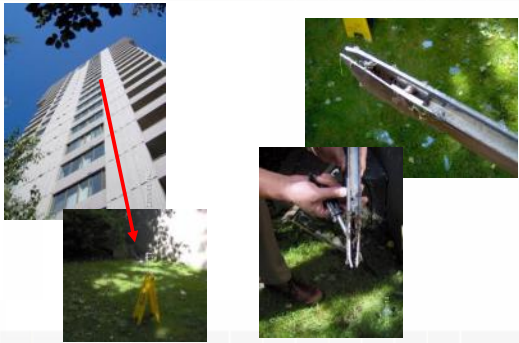
→ Failed Windows – Corrosion & Wind

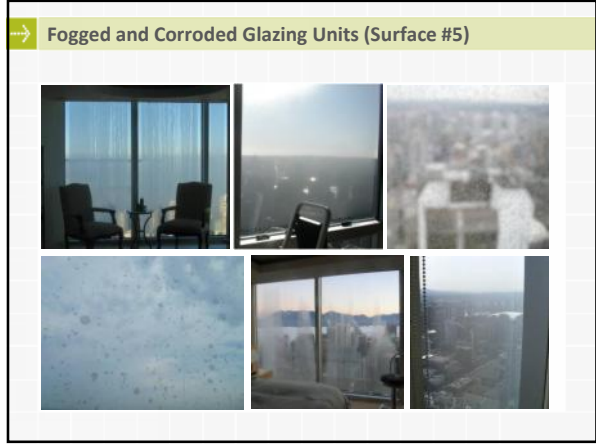
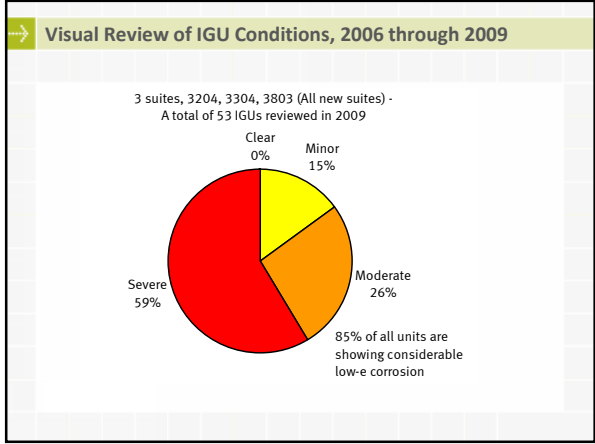
Quantifying IGU Failures in the Field

- Visual Review
 - Rating based on visual observation and level of fogging and low-e corrosion damage visible from 10 feet away
- Dew/frost-point testing (ASTM E-576)
 - Measures how dry the IGU airspace is and estimate the saturation level of the desiccant
 - Can estimate remaining service life of IGUs
 - Can quantify failed units and units close to failure

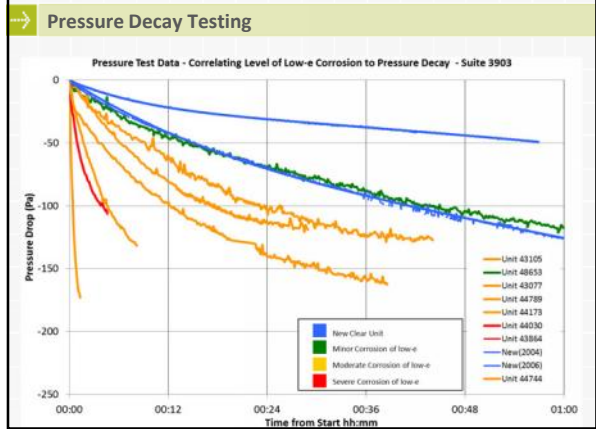
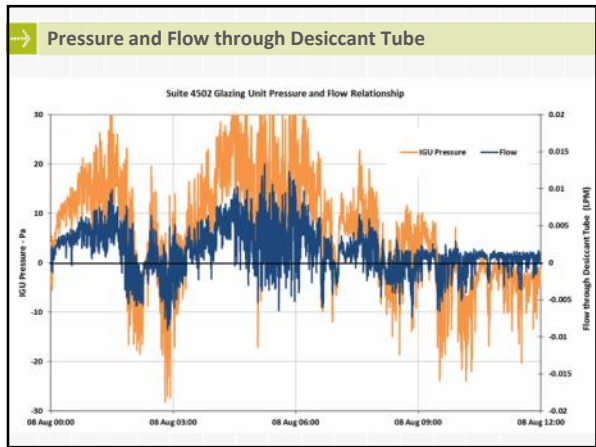
Pressure Testing Theory

- A completely sealed IGU will retain applied pressure indefinitely (i.e. car tires, basketball etc).
- A leaky unit will exhibit a loss of pressure with time (pressure decay).
 - Air is leaking out through perimeter glazing seal
- The pressure decay can be measured and an approximate leakage area calculated
 - Correlate with corrosion and dewpoint measurement
- Units that cannot be pressurized are very leaky (i.e. like a flat tire)
- Can also use to test new units (originally the IGU company was going to replace all fogged units)

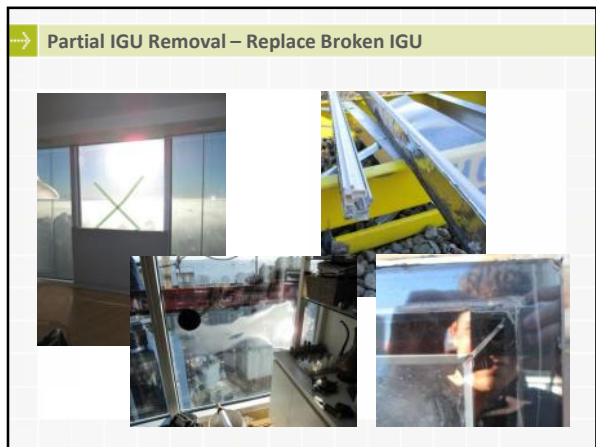
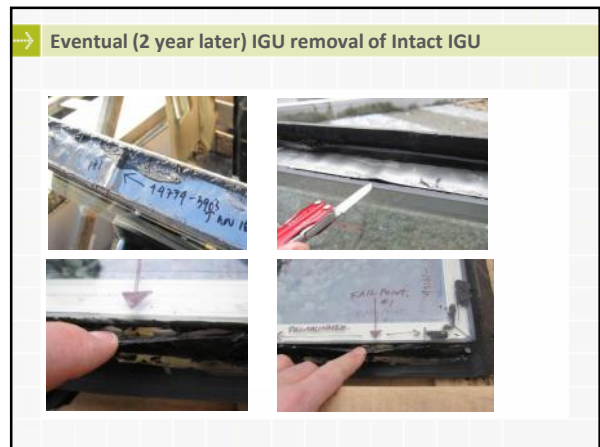
In-Situ Monitoring Results

- Air flows from outside into the IGU through edge seal defects then into suite through desiccant tube – driven by wind pressure differences and thermal expansion/contraction
- Desiccant tube flow rate of 0.01 L/min resulting in exchange of 1-5 Liters of air per day just from wind
- Estimated service life of external desiccant tubes with these average flow rates is <math><5</math> years to saturation
 - Not accounting for other leaks (as indicated by pressure decay testing)
 - Could this replaceable desiccant tube design have worked in theory? 10x more desiccant by volume within IGU edge seal anyway

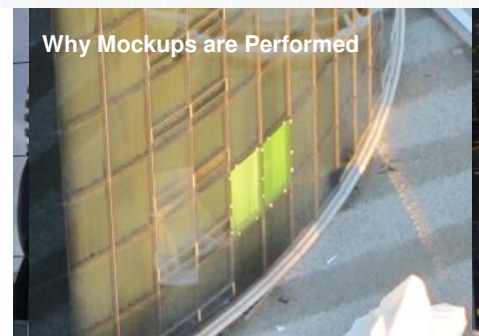
Selecting New Glazing Units

- Criteria: Match existing residential portion plus improve performance
 - Lower SHGC to reduce overheating and issues with undersized AC units
 - All-glass triple vs previous PET suspended film triple
 - Durable edge seal spacer (thin stainless, dual seal with proven track record)
- Original low-e coating not available (old AFG) and hard to match
- Narrowed down hundreds of new alternate options for Owners and City to choose from
- Many plant and site mock-ups for color

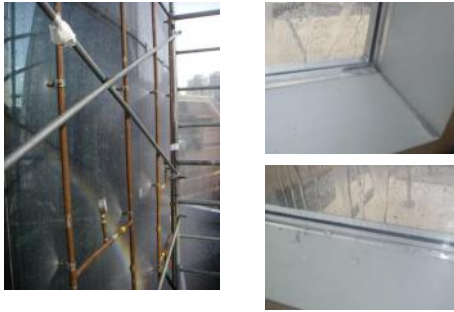
→ Why More Mock-ups are Performed
