Swimming Pool Interior Finishes and Chemical Etching Deterioration

Swimming Pool Interior Finishes & Chemical Etching Deterioration

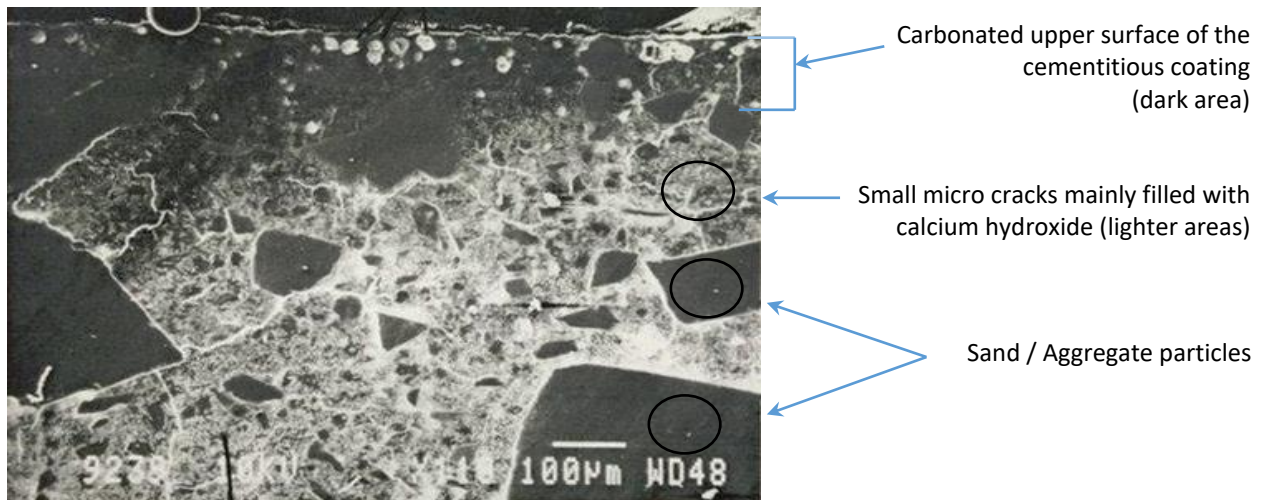
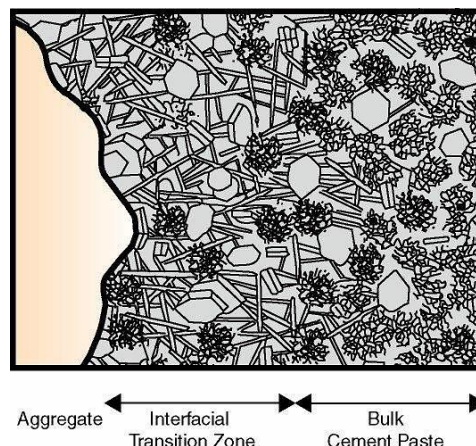
Inherent in cementitious coatings are many small void spaces and micro-cracks. There is a special region in cement/aggregate mixtures called the Interfacial Transition Zone (ITZ). These ITZ's exist at the interface of the cement binder and the aggregates; ITZ's also exist at the interface of the cement binder to the tile, around lights and/or PVC pipes and other dissimilar materials in the plaster. The chemical and physical properties in the ITZ's are different from the bulk cement paste in that they contain significant amounts of calcium hydroxide and have a higher water / cement ratio and greater porosity.³⁴

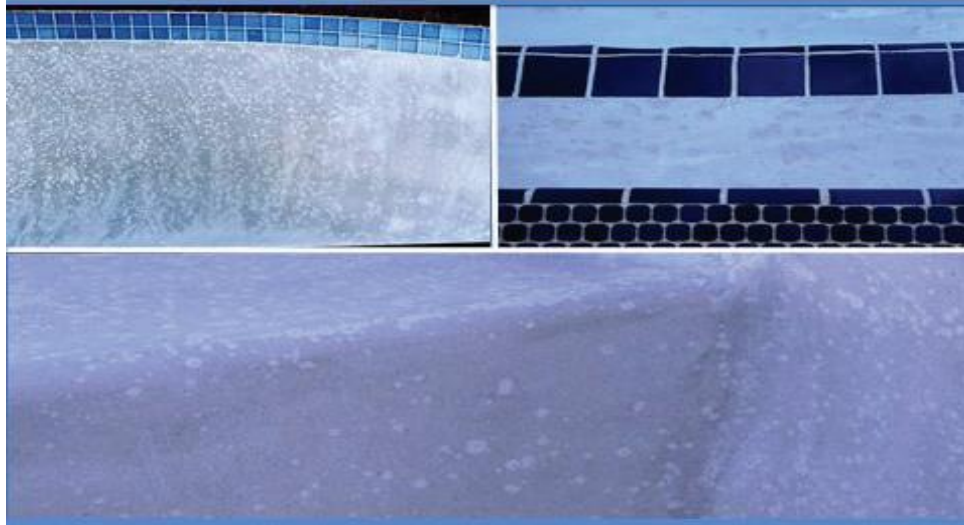
Etching Deterioration

Reactions with the soluble cementitious materials can take place whenever water, or moisture, is allowed to permeate through a cementitious surface coating. Water that is not maintained in the "ideal ranges," as defined by ANSI/APSP to be "balanced"⁶, can deteriorate a cementitious surface coating by dissolving components of the cement/aggregate matrix, resulting in the leaching of cement compounds. Leaching generally appears as etched areas on the surface, especially where calcium hydroxide is most abundant. Calcium hydroxide is the most soluble cement compound and is the first compound to be dissolved.

These etched areas are around aggregate particles, tile inserts and other interfaces and often appear as small spots. As with all chemical or physical action on a surface that is capable of removing or dissolving away elements or compounds of that surface, water chemistry will play a key role in the etching process. Low calcium hardness, low carbonate alkalinity, and/or low pH create an aggressive environment that will lead to etching in the areas with the greatest solubility and porosity such as in the ITZ's. Continued leaching can cause complete dissolution of the cement paste over time in those regions of the coating.⁷
