THE EFFECT OF ROOF TRAFFIC AND MOISTURE ON THERMAL ROOF INSULATIONS

Executive Summary

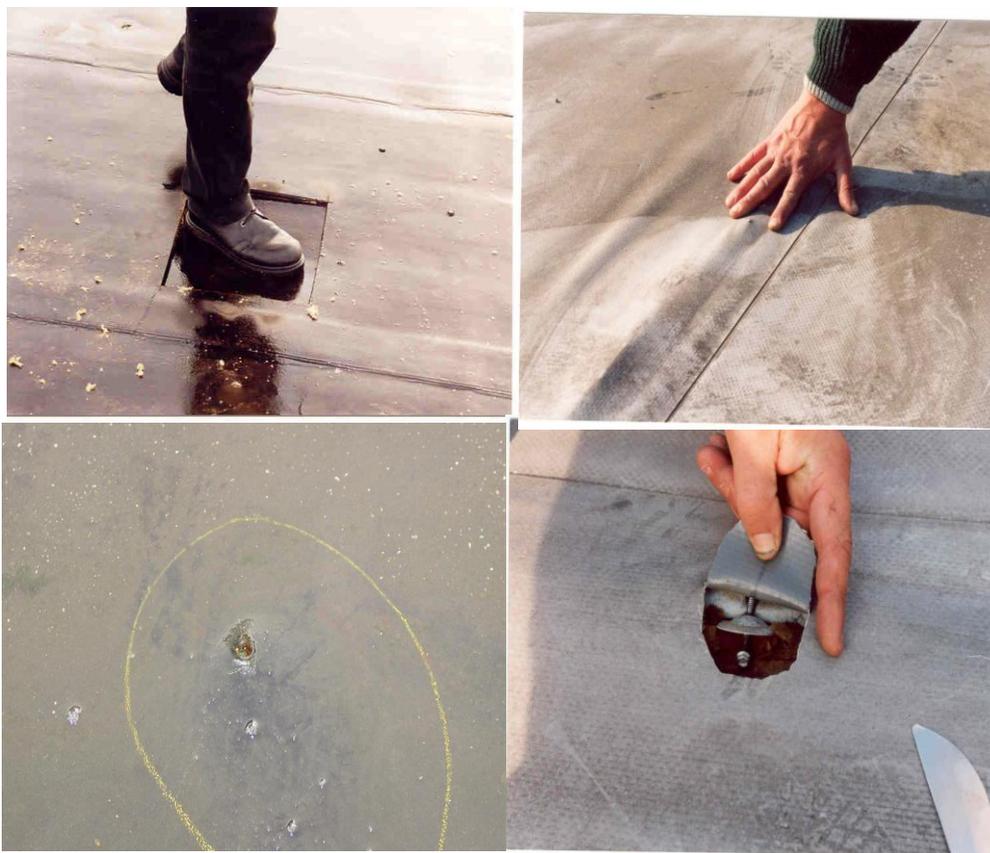
Figure 1:
Roof failures in single-ply/mineral wool roofs showing insulation collapse due to frequent foot traffic and the screw heads penetrating the single-ply membrane
(Source: Hendriks, 2010)

According to available field reports (Hendriks, 2010; Spilker, 2012), roof system failure of the combination of single-ply roof covers and mineral fiber insulation appears to be related to one or a combination of two primary factors: 1) the degradation of mineral fiber insulation beneath the single-ply roofing membrane when subjected to moisture intrusion within the roof, and 2) the impact of roof traffic associated with the maintenance required to service rooftop PV systems.. Although their resistance to natural weathering is well established, single-ply roofing membranes are relatively soft and flexible materials. As a consequence, when the supporting insulation substrate beneath the membrane is damaged or compromised, the membrane itself may be exposed to an increased potential for punctures, cuts, and abrasions, especially around insulation joints and membrane fastener screw heads. In turn, this may lead to water leaks, additional damage to the insulation substrate, and further damage to the entire roofing system. A typical mode of roof insulation collapse followed by penetration of the roofing membrane by exposed screw heads is illustrated in Figure 1.
