Modeling a Railroad Embankment Failure as a Dam Breach

Gerald E. Blackler, PhD, PE, DWRE, M.ASCE
David Williams PhD, PE, DWRE, PH, CFM, CPESC, F.ASCE, F. EWRI

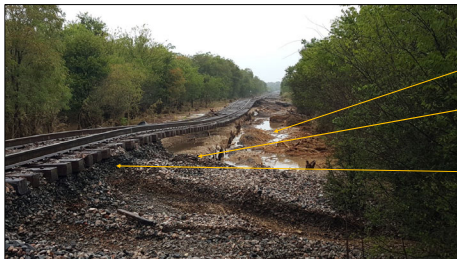
Image of Railroad Embankment after Failure

- Items to note from Image
1. laydown of vegetation.
 2. Movement of Ballast Material (rock, gravel).
 3. Functions like a low head dam (less than 10 feet), or embankment, and its failure caused a massive flood wave

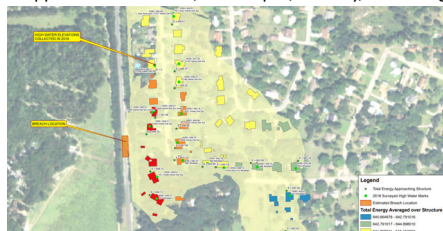
Image from one of the many GIS Maps produced as Evidence

- Mapped each structure, with depth, velocity, and energy.

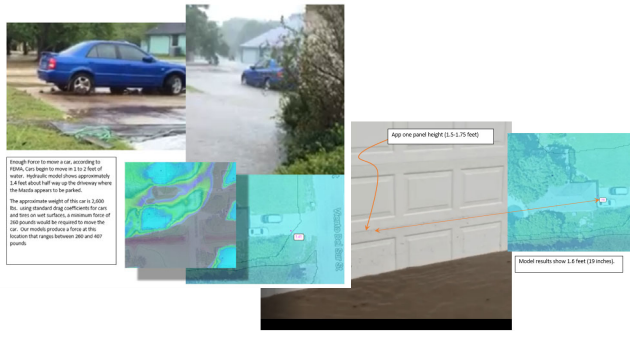
Pre Flood Photo From Exhibit 44

- A lot of information was available to calibrate our model, we had videos, highwater marks, and location of moved vehicles.
