## **LESSONS LEARNT FROM CANTERBURY EARTHQUAKES: DAMAGE ASSESSMENT AND NUMERICAL ANALYSIS OF CONCRETE BRIDGES**

ALESSANDRO PALERMO, MARIA BRANDO

University of Canterbury

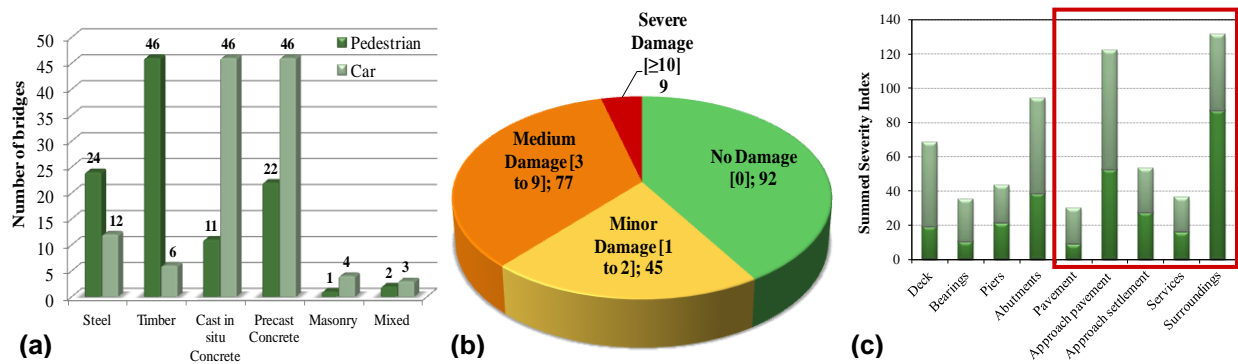
Results are shown in Figure 3b. The general bridge performance during the earthquake was satisfactory, with only 4% of bridges sustaining severe damage [5]. In other words, for the majority of bridges in the database, the Christchurch earthquake was a 1/500 year design level event. Considering that the NEHRP Recommended Seismic Provisions (National Earthquake Hazards Reduction Program) recommend that in a maximum credibility event (1/2500 year event), the probability of collapse should be less than 10% for an ordinary structure, the amount of severe structural damage to bridges for these 1/500 year events is appropriate.

Lastly Figure 3c gives a preliminary estimation of damage to the bridge components after February 22<sup>nd</sup> 2011 event. From the histogram it is evident that of all bridges examined, 70% presented damage to the “non structural parts” of the bridge system. Lateral spreading was identified as the main cause of the damage. Results clearly demonstrate that a new holistic approach, which involves an integrated design between structural and non-structural parts of bridges, is needed.

**Figure 3. a) Proportions of the bridge category of use for each structural material type; b) Christchurch Bridges stock grouped on the basis of the damage severity after the February 22 earthquake; c) Summation of the damage severity index for the different categories of damage. With bridges divided into those affected and not affected by lateral spreading.**
